Landmarks Preservation Commission Planning and Development Services Department

A. Stadium High School <i>Exterior masonry repairs</i>	Brian Rich	3	15 m
-----------------------------------------------------------	------------	---	------

STADIUM HIGH SCHOOL EXTERIOR MASONRY RESTORATION PHASE 1 PROJECT

**STADIUM HIGH SCHOOL
MASONRY RESTORATION DEMONSTRATION**

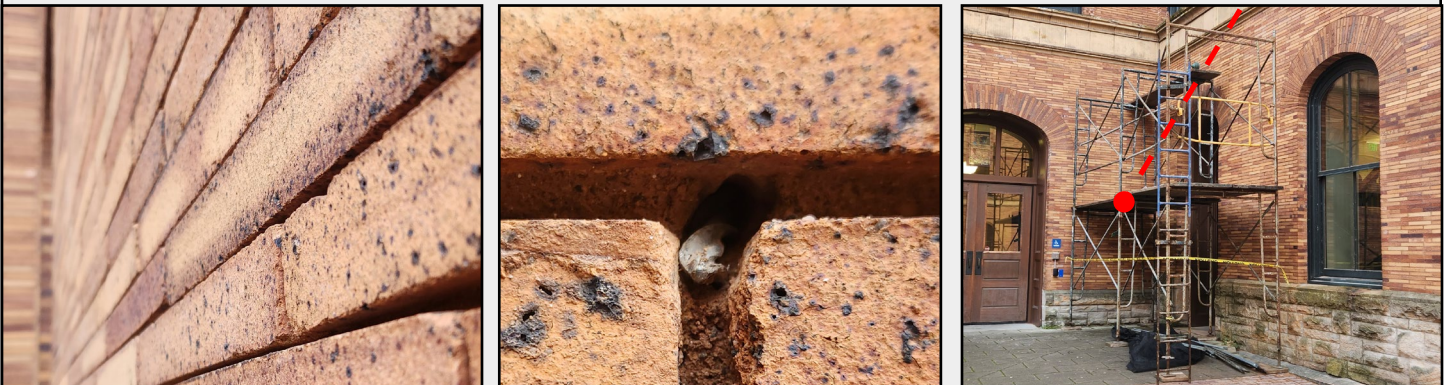
SITE VISIT #3**TIME:** 8:00 AM**DATE:** January 2, 2024**ATTENDEES:** Rick (FTM), Brian Rich, Anna Gold (RAP)**OBSERVATIONS**

Failed mortar patch at window sill unit is in process of being removed.

Decision to remove full terra cotta unit that has existing crack at its base.

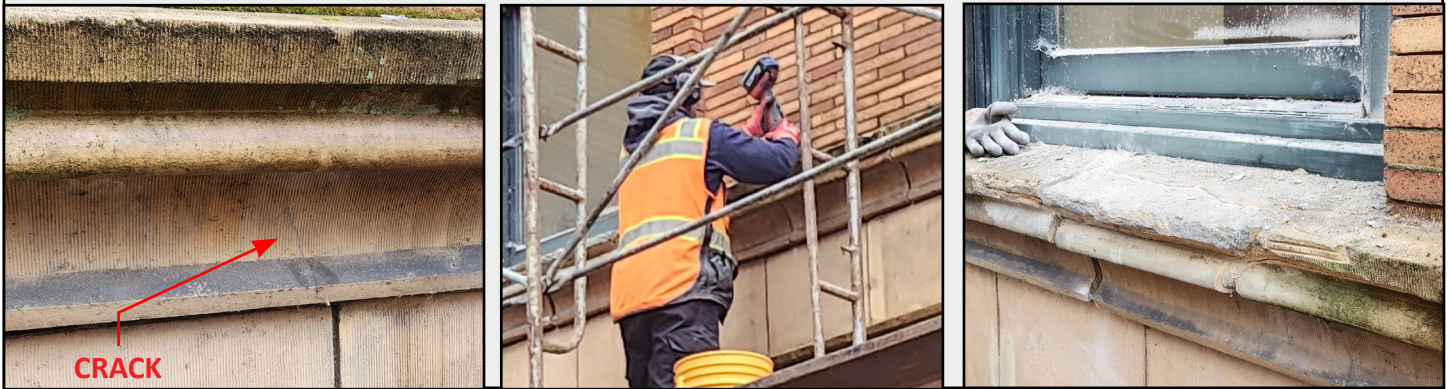
**SITE VISIT #4****TIME:** 1:30 PM**DATE:** January 3, 2025**ATTENDEES:** Rebecca (Parametrix), Brian Rich, Anna Gold (RAP)**OBSERVATIONS**

Brick masonry has not been saturated prior to repointing. Some mortar repointing at brick.

Some scaffolding cross-bracing not fully fastened into place.

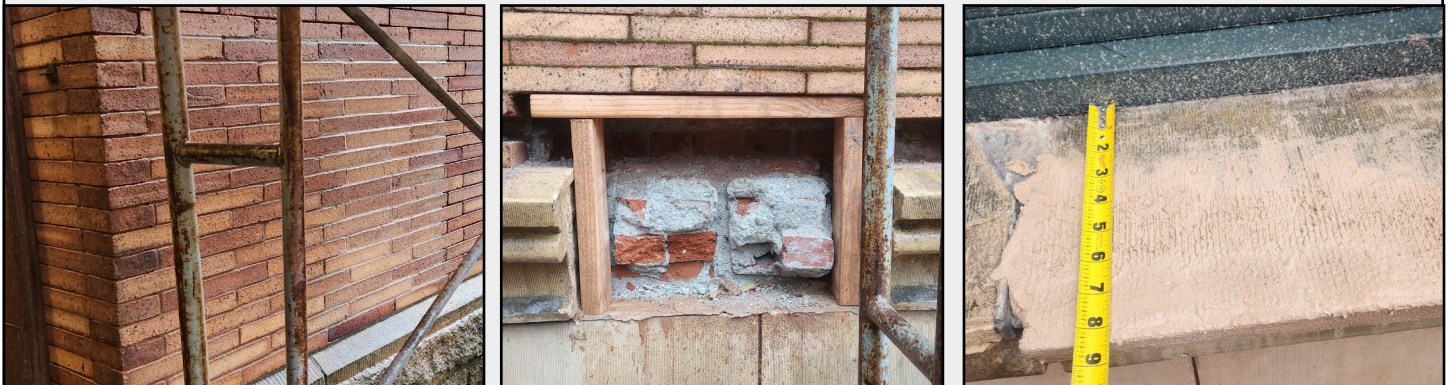
SITE VISIT #5**TIME:** 9:30 AM**DATE:** January 6, 2024**ATTENDEES:** Rick, Anthony (FTM), Anna Gold (RAP)**OBSERVATIONS**

Terra cotta patch being re-installed at window sill unit.
 Brick masonry has not been saturated prior to repointing.
 Striking mortar at Sample Area B using metal tool.

Not enough restoration mortar to equally divide Sample Area B. Spec Mix mortar to make up difference.

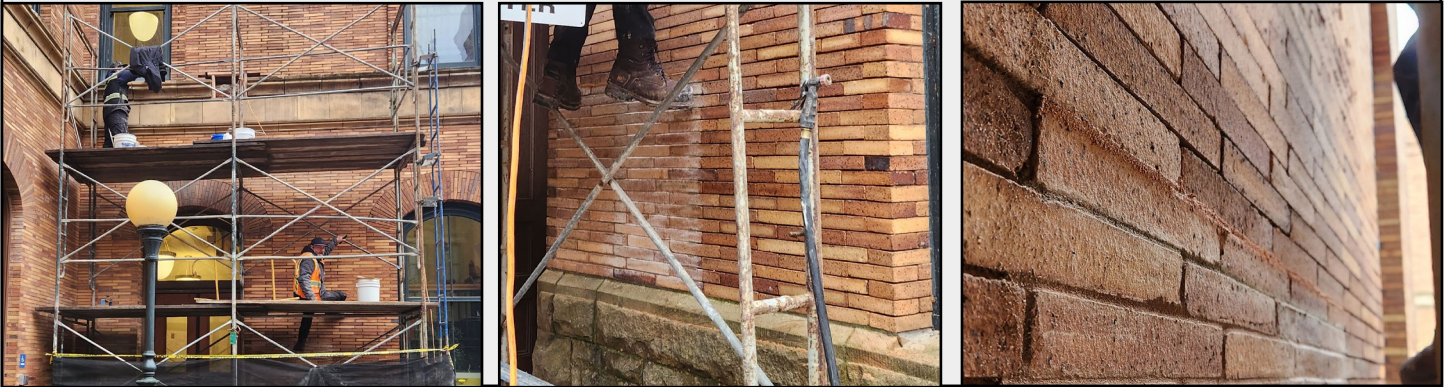
**SITE VISIT #6****TIME:** 1:30 PM**DATE:** January 7, 2025**ATTENDEES:** Rebecca (Parametrix), Brian Rich, Anna Gold (RAP)**OBSERVATIONS**

Mortar samples installed at stone Sample Area A.
 Site work has splashed onto paneling on door entry jambs. To be clean prior to completion of work.
 Terra cotta patch has been reinstalled at the window sill. The wash has been tooled to correspond with existing surface grooves.
 Some restoration mortar exhibiting salt crystallization at Sample Area A.

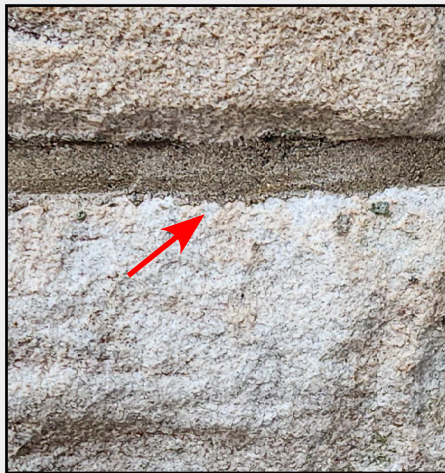
Although this is the recommended restoration mortar, further color matching and aggregate sizing needs to be explored.

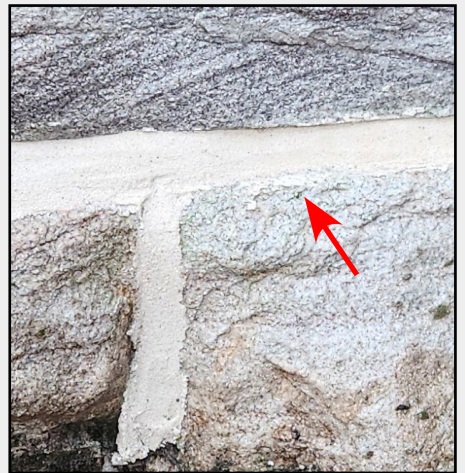
Cathedral Stone mortar uses a white sand aggregate, which does not match the historic stone mortar characteristics. Some mortar is visible on the face of the Wilkeson Sandstone.

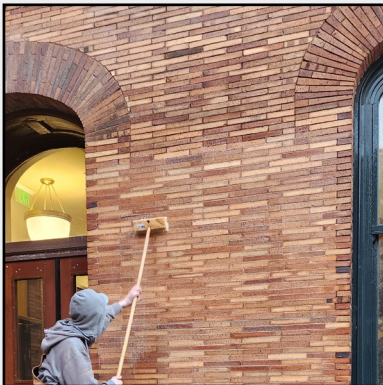
The historic mortar is visible in the recessed joint on the left, in comparison to the restoration mortar on the right. The excess mortar on the brick face has not been fully removed.

The excess mortar on the brick face has not been fully removed. Further development of a masonry cleaning protocol is recommended.

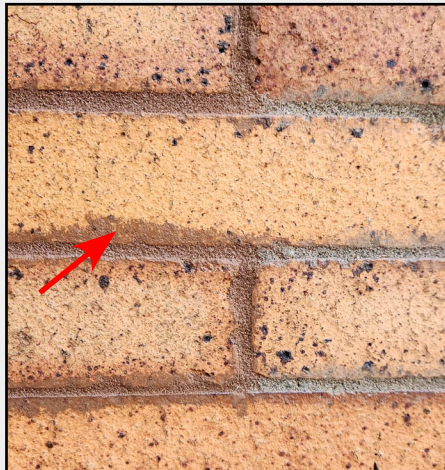
Excess mortar visible on the face of the brick at both the restoration mortar installed on the left and the dividing gray mortar (unknown product) on the right.

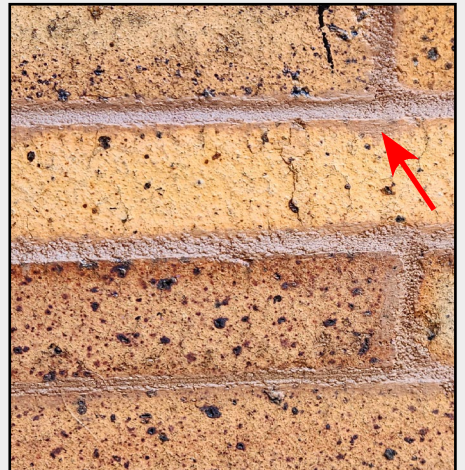
Some excess mortar on the face of the brick and textural differences the striking of the joints. The top horizontal row appears smoother than the bottom two rows.

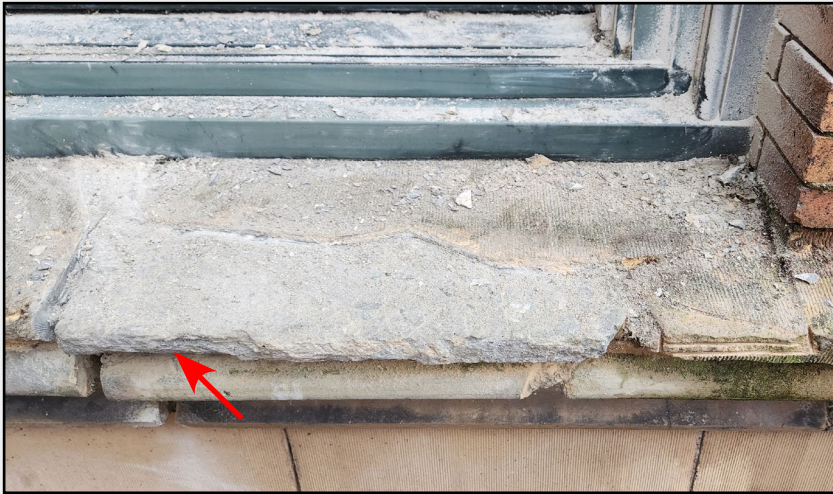
BEFORE This terra cotta window sill piece has been repaired in the past using a two-layer system. In this photo, the first layer of the failed patches at the surface have been removed, revealing an extensive area of gray-colored patching compound used previously to repair the unit.

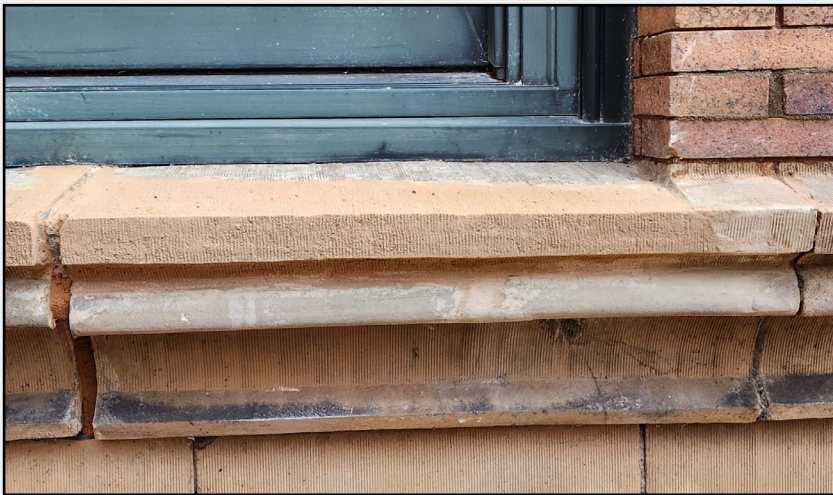
AFTER This is the second patch installed at the demonstration unit, the first was not able to properly cure due to rainy conditions. The patching compound has been both shaped and the surface raked to mimic the existing surface grooves.
Note: This level of workmanship is not anticipated for the temporary patching repairs for Summer of 2025.

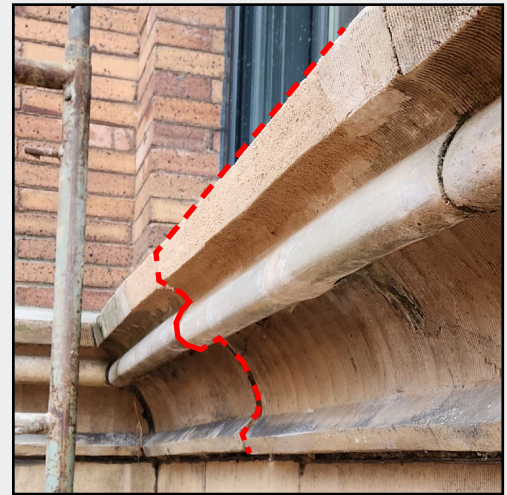
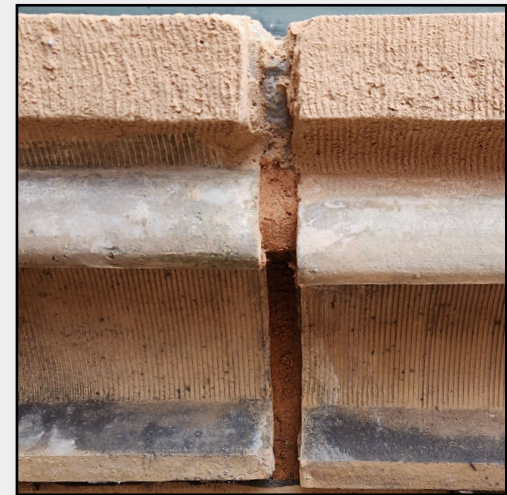
See (2) above images for shaped patch and restoration mortar mimicking the ornate profile of the belt course. Brick restoration mortar was installed at the joints, but further investigation of the historic terra cotta mortar is recommended.

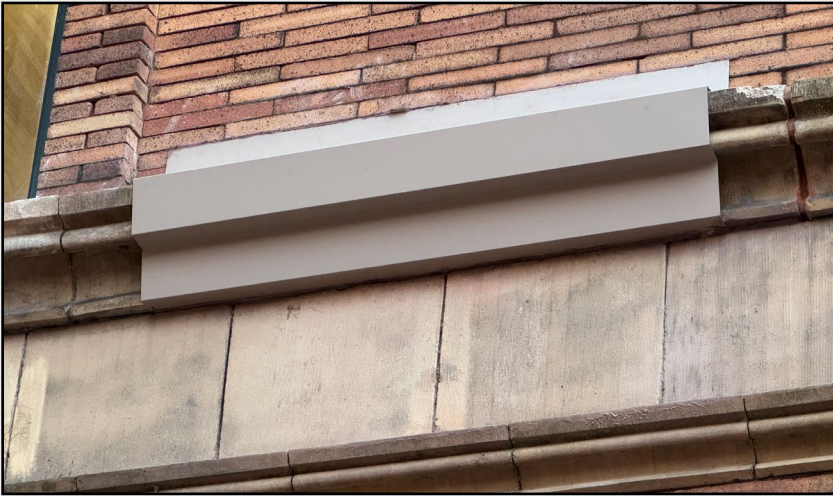
Until an appropriate replacement piece is installed, a piece of beige sheet metal is bent to replicate the surrounding masonry on the belt course. This temporary flashing is to prevent rainwater from being driven into the wall system

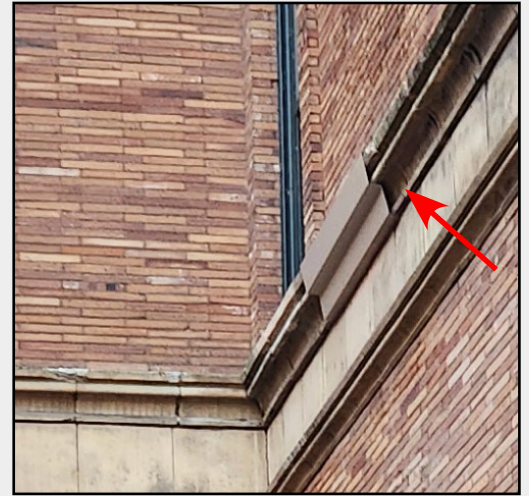
Due to the curved nature of the upper piece of terra cotta on the belt course, there is a small gap created at the sheet metal.

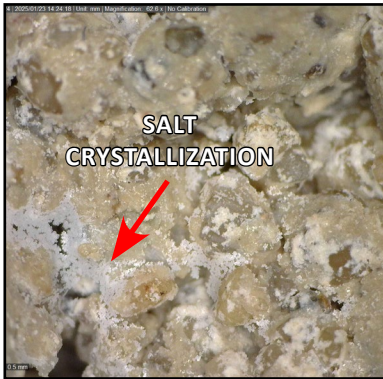
A2.1 - USHG (BASE)
Sample appears dry and not easily workable. All USHG stone mortars share this characteristic as well as visible salt crystallization.

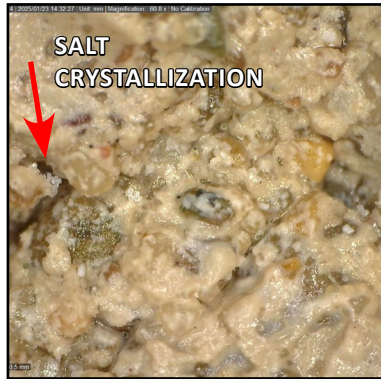
A2.2 - USHG (LIGHT)
Aggregate very difficult to see through mortar cream. The variety of aggregate colors is visible.

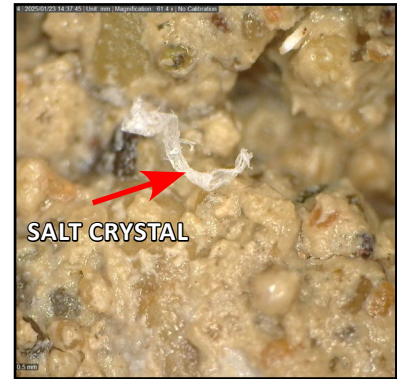
A2.3 - USHG (DARK)
Similar to the other USHG stone mortars, this sample has a very thick, chunky consistency.

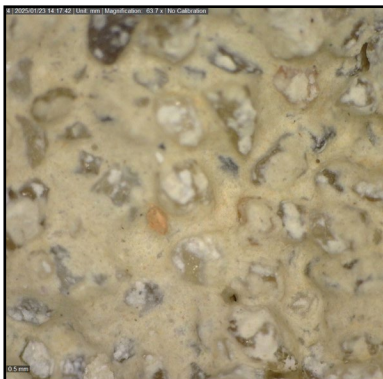
A1 - EDISON
Aggregate very difficult to see through mortar cream. Shrinkage cracks throughout.

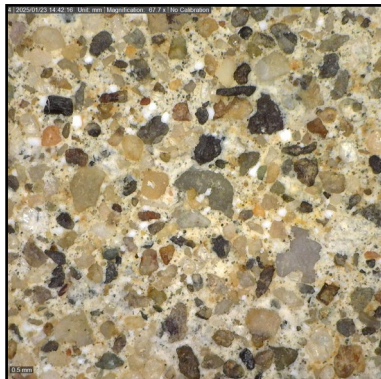
A3 - SPEC MIX*
Wide variety of aggregate sizing and colors. Color needs further adjustment, it is notably darker.
**Note: This sample was prepared on December 11, 2024*

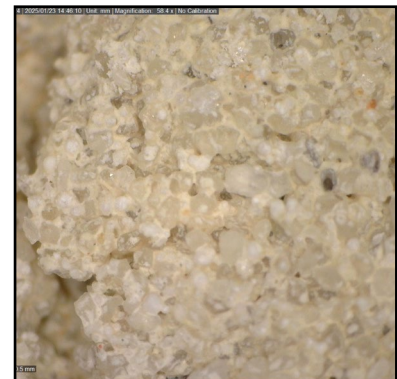
A4 - CATHEDRAL STONE
As the lightest-colored sample, the use of white sand in this mortar does not match the historic mortar's characteristics.

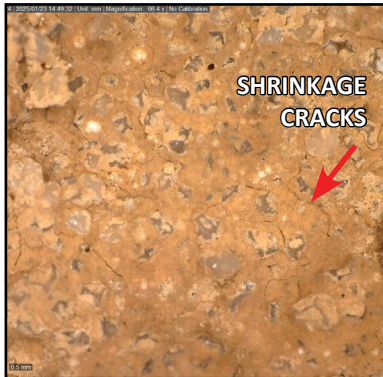
B1 - CATHEDRAL STONE
Aggregate very difficult to see through mortar cream. Shrinkage cracks throughout.

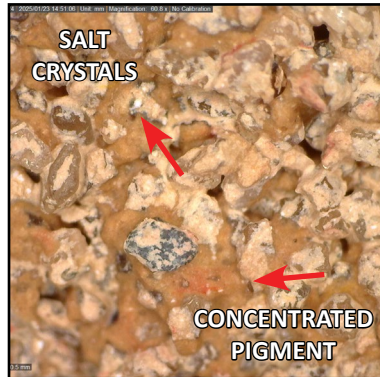
B2 - EDISON
Mortar cream visible on surface of aggregate. Salt grains present. Consistent aggregate sizes in a variety of colors. Spots of red concentrated pigment.

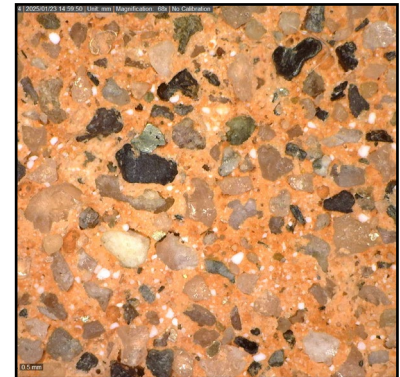
B4 - SPEC MIX*
Wide variety of aggregate sizing and colors. Mortar cream is consistently recessed from surface.
**Note: This sample was prepared on December 11, 2024*

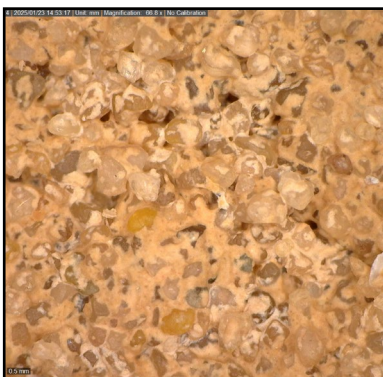
B3.1 - USHG (BASE)
Mortar cream visible on surface of aggregate. Consistent aggregate sizes in a variety of colors. Consistent aggregate sizes in a variety of light colors.

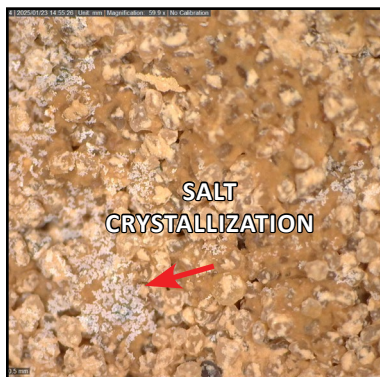
B3.2 - USHG (LIGHT)
Mortar cream visible on surface of aggregate. Salt crystals are forming in some areas.

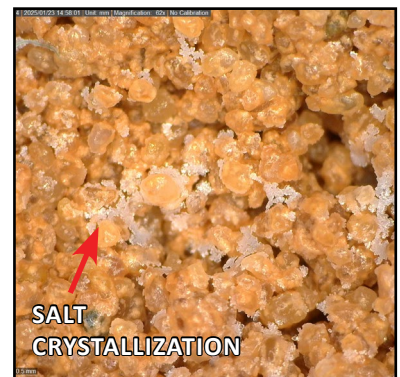
B3.3 - USHG (DARK)
Salt crystals visible in many areas of the sample. Translucent characteristics of the aggregate
