**Request for Proposals Specification No. PW24-0192F  
Facility Condition Assessment**

2023 Facility Condition Assessment

# Facility Detail Report

Greater Tacoma Convention Center  
Greater Tacoma Convention Center

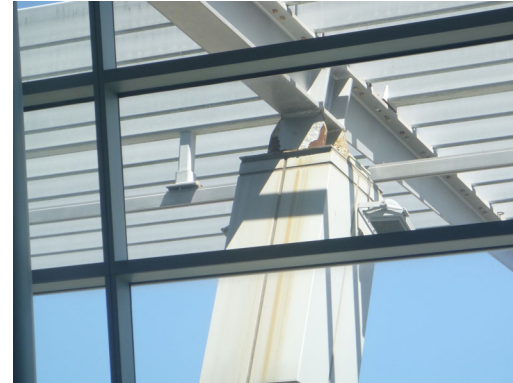
**Deficient Material:** Shade Device

Metal sun shade structure on east facade along Commerce Street, with corrosion occurring on top connection components. South shade system bars coated in dirt and moss.

Strip, prep, and recoat shade device structural components that are corroding with industrial exterior steel coating system.  
Clean south-facing system components.

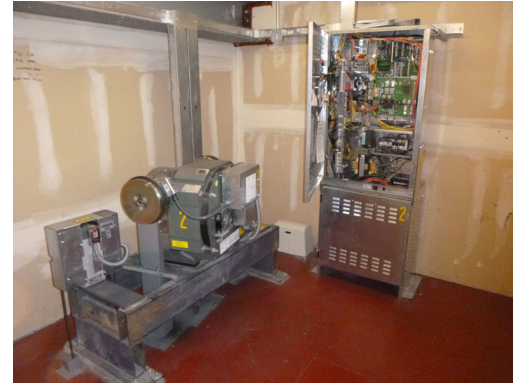
**Deficient Material:** Elevator Machine Room Cooling  
Poor cooling distribution at the passenger overhead traction machine room.

**Remedial Action:**  
Provide supplemental cooling for the second passenger elevator traction motor and controls.

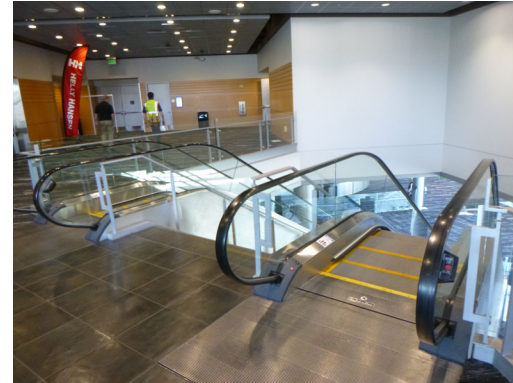
**Deficient Material:** Escalator

Repair floor 3/4 escalator.

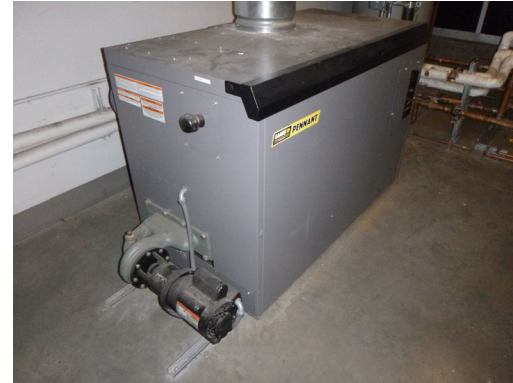
**Deficient Material:** Hot water heater

Budget to replace upon failure.

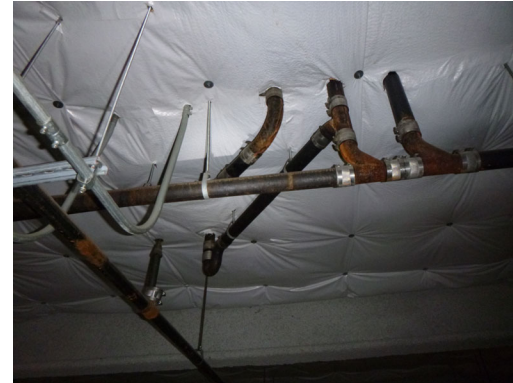
**Deficient Material:** Cast Iron waste piping

Rusted and corroding waste piping at east parking garage ceiling with several signs of recent leakage.

Clean, inspect, test, and repair or replace rusted and corroded waste piping at east parking garage. Inspect other waste piping throughout and repair as needed.

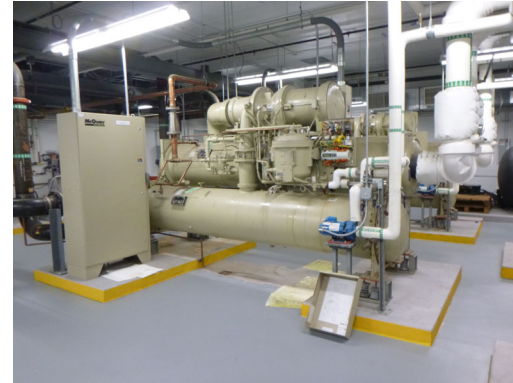
**Deficient Material:** Chiller

Chillers are original (2004); one has a refrigerant leak, both are aging.

Renew chillers, including leak repair.

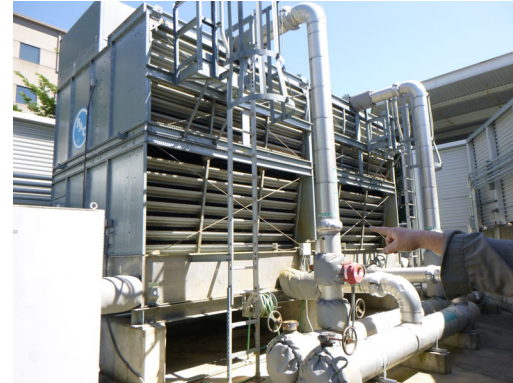
**Deficient Material:** Cooling tower

Original (2004) cooling towers aging with increasing problems; the fill is aging, brittle, and beginning to fail.

Fully service cooling towers including new fill and fan bearings to extend life 10 to 15 years prior to more severe failure.

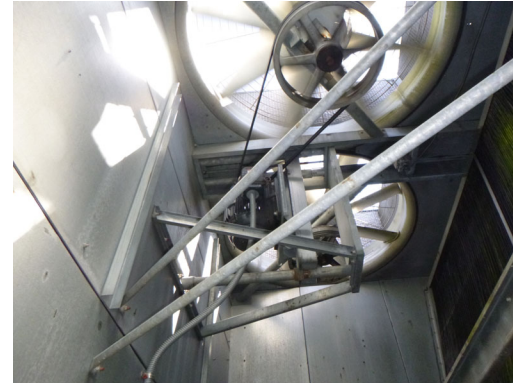
**Deficient Material:** Cooling tower fan

One cooling tower fan has failed, resulting in only 50% capacity available from this tower until fixed.

Repair or replace damaged cooling tower fan.

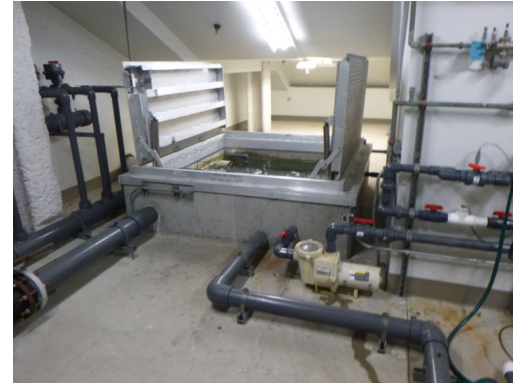
**Deficient Material:** Pump room humidity

Water feature pump room under the stairs has high humidity, despite apparent retrofit of a forced-air cooling unit. While forced-air cooling may work for comfort cooling, it appears insufficient for the high humidity produced by the water feature sump and support equipment.

Install industrial-grade dehumidification and/or increase ventilation to control humidity.

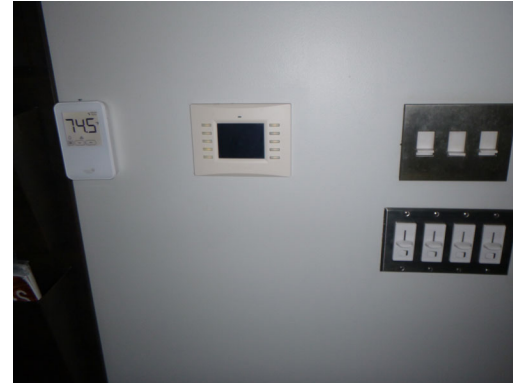
**Deficient Material:** Sales HVAC  
Poor HVAC service at lower level sales area.

**Remedial Action:**  
Upgrade to an engineered system to more fully support the tenant improvement which split the former open space into multiple smaller spaces and private offices.

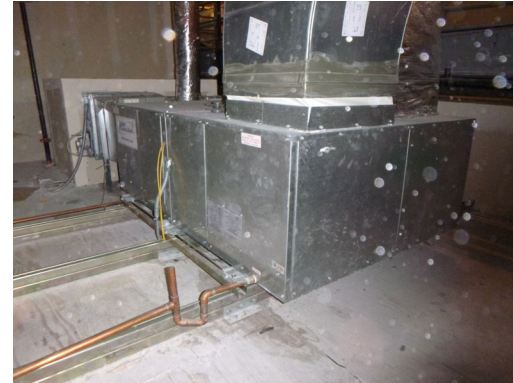
**Deficient Material:** Package units

Budget to replace upon failure.

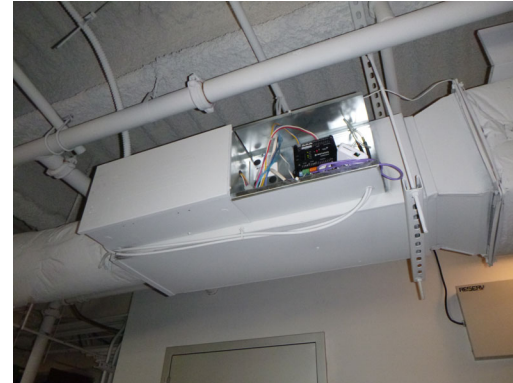
**Deficient Material:** VAV terminal units

Renew variable air volume units prior to or upon failure.

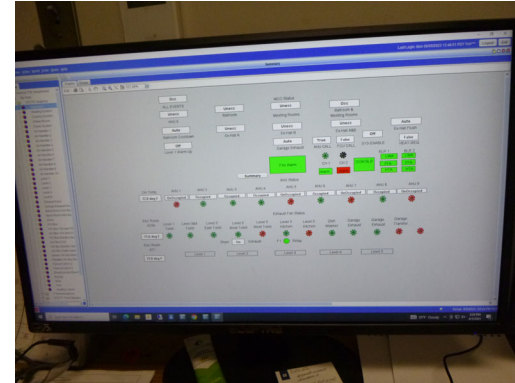
**Deficient Material:** Controls  
Somewhat aged controls.

**Remedial Action:**  
Budget to update hardware and software to keep up to date and optimize performance; coordinate with work supporting Clean Buildings compliance.

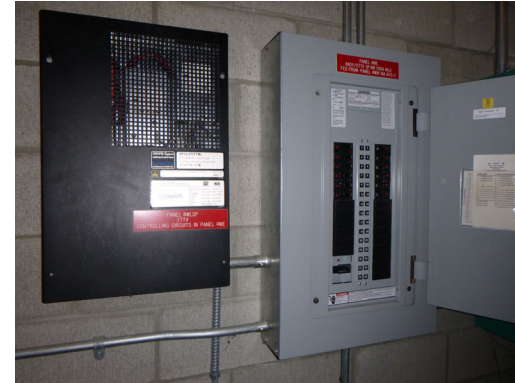
**Deficient Material:** Lighting controls  
Aging and failing lighting controls.

**Remedial Action:**  
Upgrade hardware and software to restore full functionality.

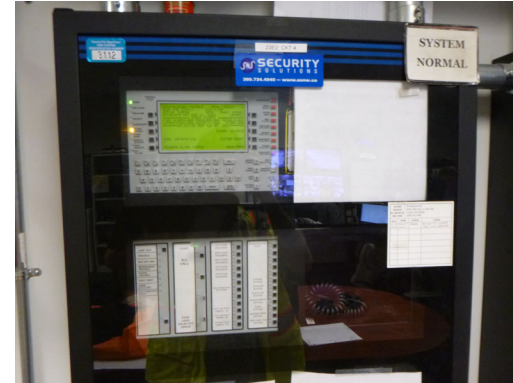
**Deficient Material:** Fire alarm

Aged and increasingly obsolete fire alarm system with failing specialty devices and minimal coverage at parking garages.

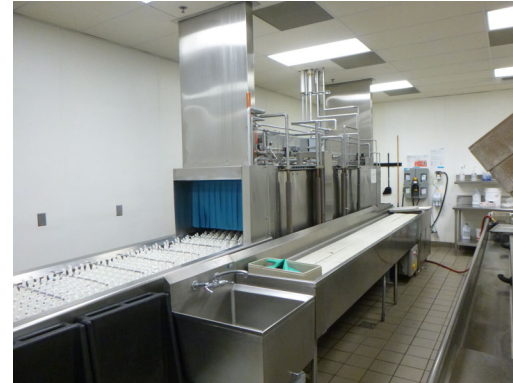
**Deficient Material:** Dishwasher
