Baseline Conditions Assessment

Schuster Slope Management Area
Tacoma, Washington

for
City of Tacoma

October 15, 2014

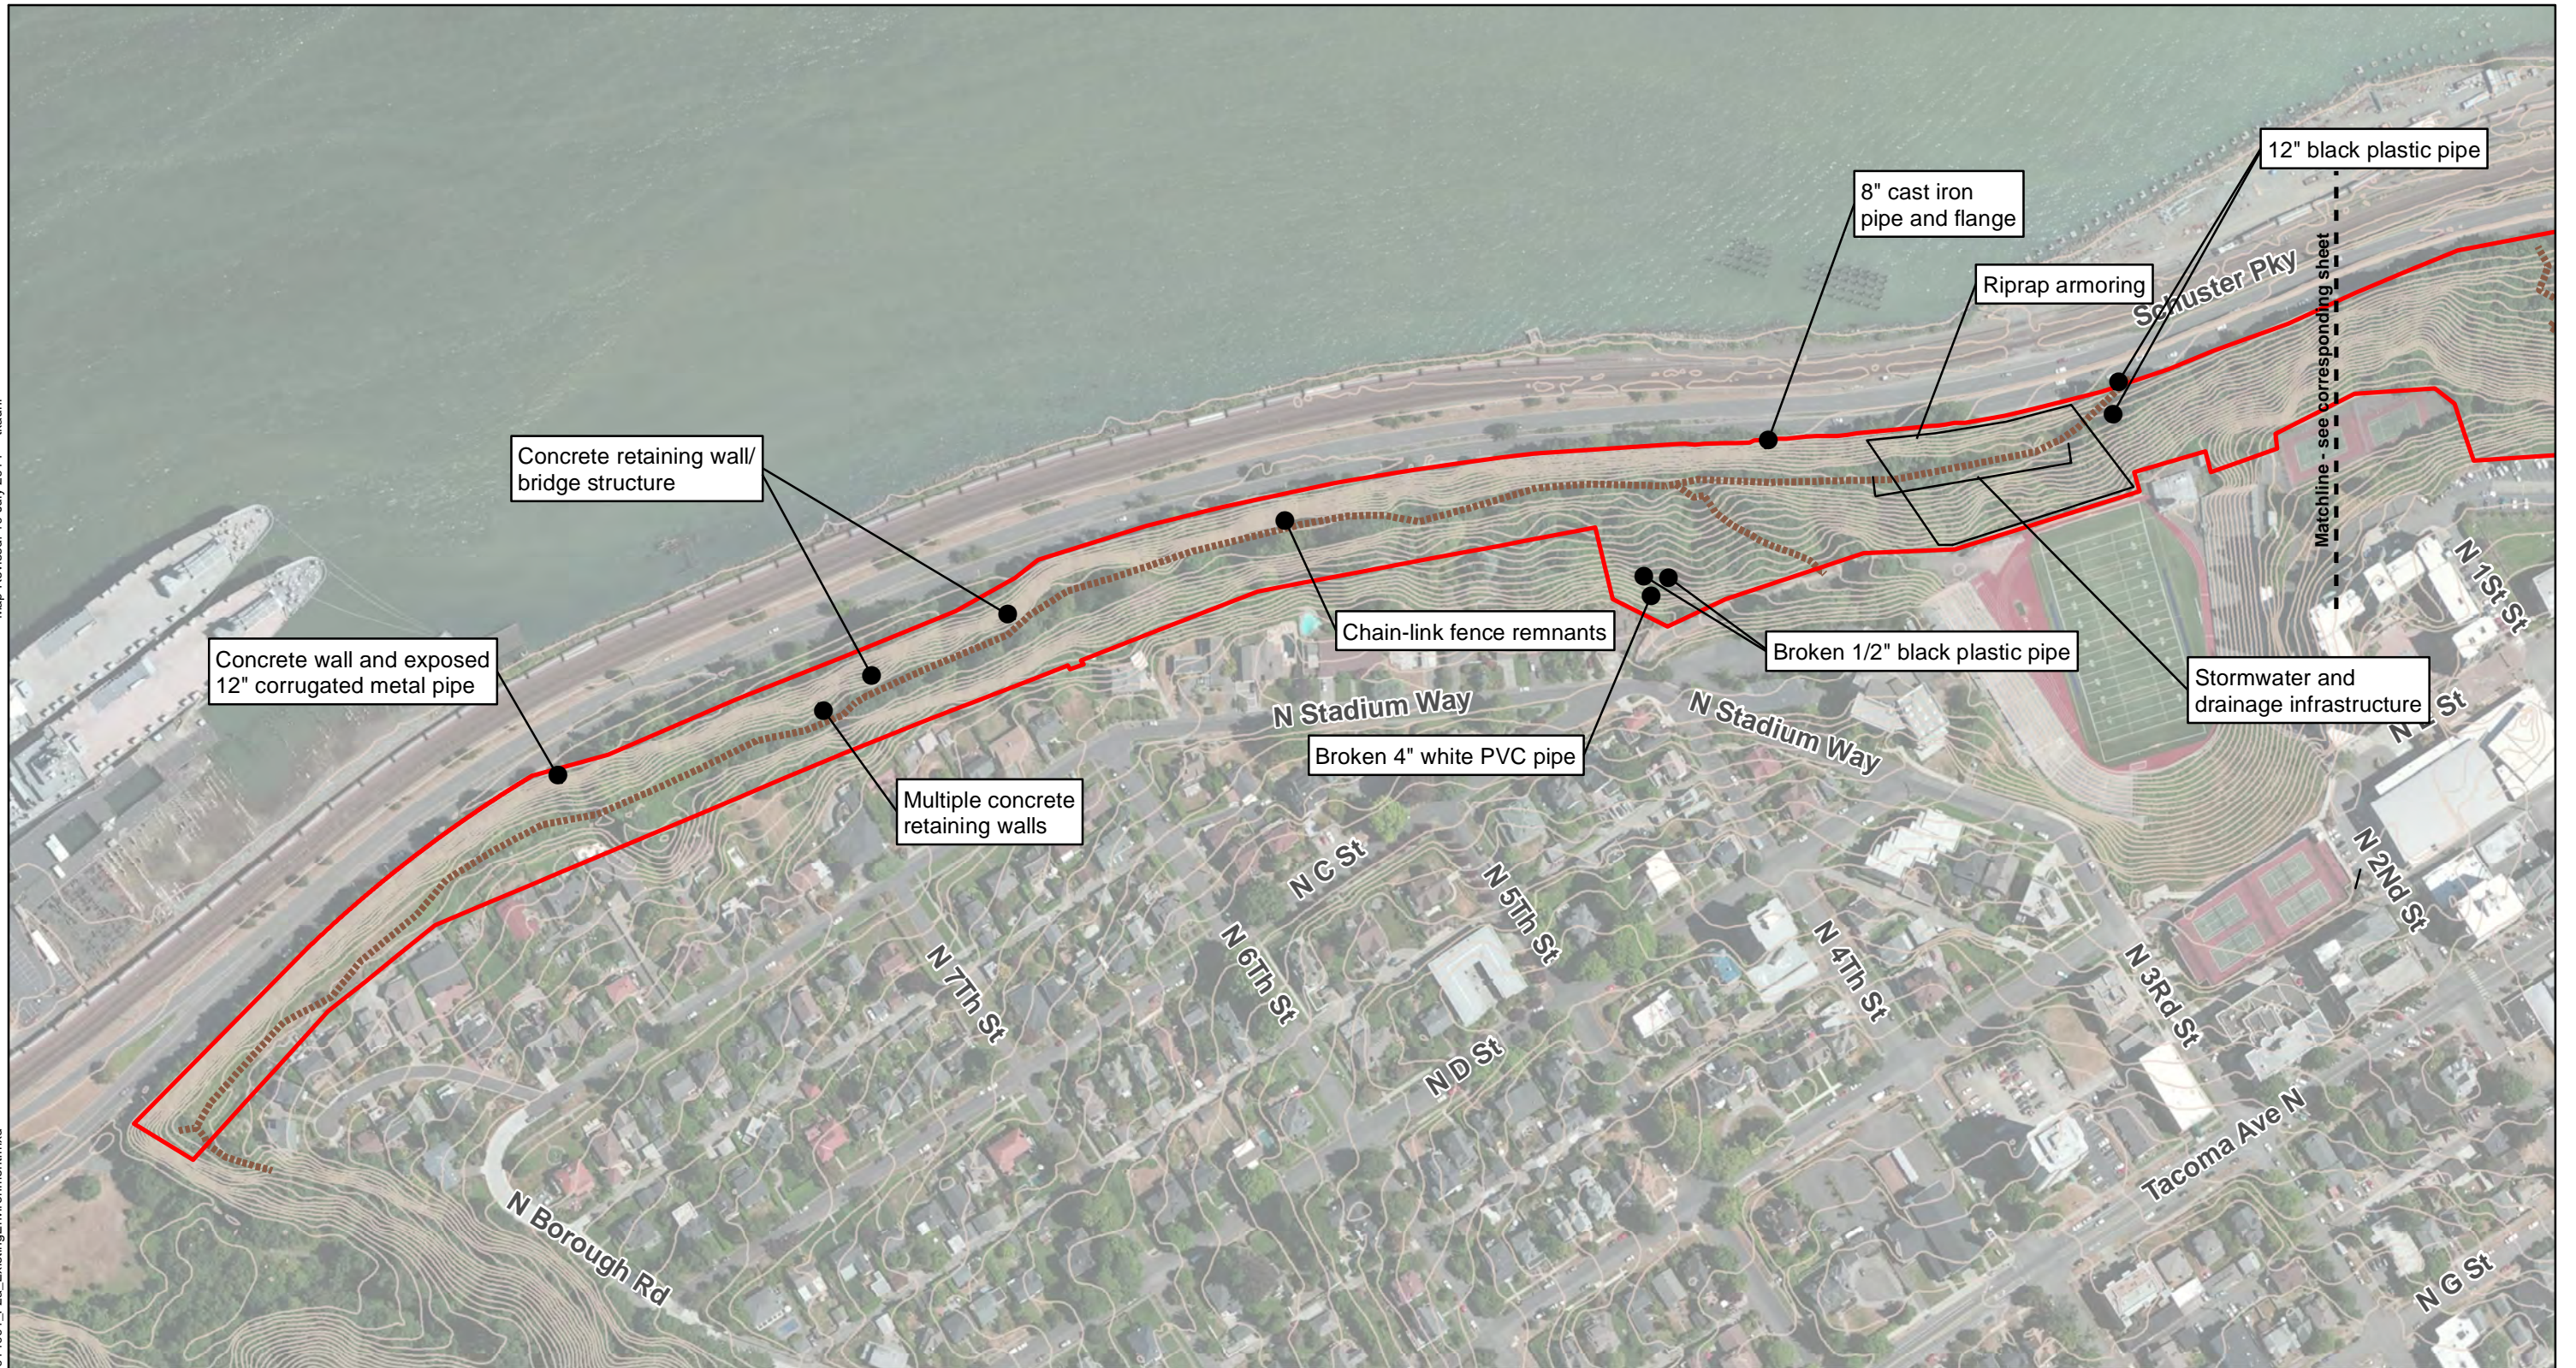
Figure 2a

General observations within the study area are shown on Figures 2a and 2b. We generally confirmed the location and alignment of the Bayside Trail system, which is in various states of disrepair as noted. We also observed a number of pipes (some intact; some broken), structures (for example, retaining walls and slope stabilization measures), and other miscellaneous features.

The GovME map (Appendix A) indicates stormwater is conveyed down the slope in stormwater pipes at three locations in the study area: One in the southern portion of the study area (north of the 6th Street alignment), one in the middle of the study area (adjacent to and north of Stadium High School), and one in the northern portion of the study area (8th Street alignment). GeoEngineers observed stormwater infrastructure at all three of the GovME-identified locations (Figures 2a and 2b). We observed an exposed 12-inch-diameter metal pipe in the southern portion of the study area (see the southern portion of Figure 2b). An approximately 20- to 30-foot-long portion of the pipe was observed exposed at grade. A slide scarp was observed north of and adjacent to the exposed section of pipe (Figure 3b), however it was difficult to tell if the slide scarp unearthed the pipe or if the pipe had been installed at grade. We observed stormwater drainage infrastructure (catch basins and manholes) in the middle of the study area (see the southern portion of Figure 2a). Water was observed flowing into a catch basin, and could be heard flowing in manholes. We observed an exposed 12-inch-diameter corrugated metal pipe in the northern portion of the study area (see the northern portion of Figure 2a). The pipe was exposed and a portion of the pipe was unsupported.

Two areas of minor soil erosion that, if left unchecked, may eventually affect recent Stadium Way improvements were observed at and south of the 4th Street bumpout. Minor soil erosion was noted at the base of the 4th Street bumpout. South of the bumpout (north of the 6th Avenue alignment), we noted a minor erosional feature beginning to be incised, likely by flowing surface water as a result of storm events.

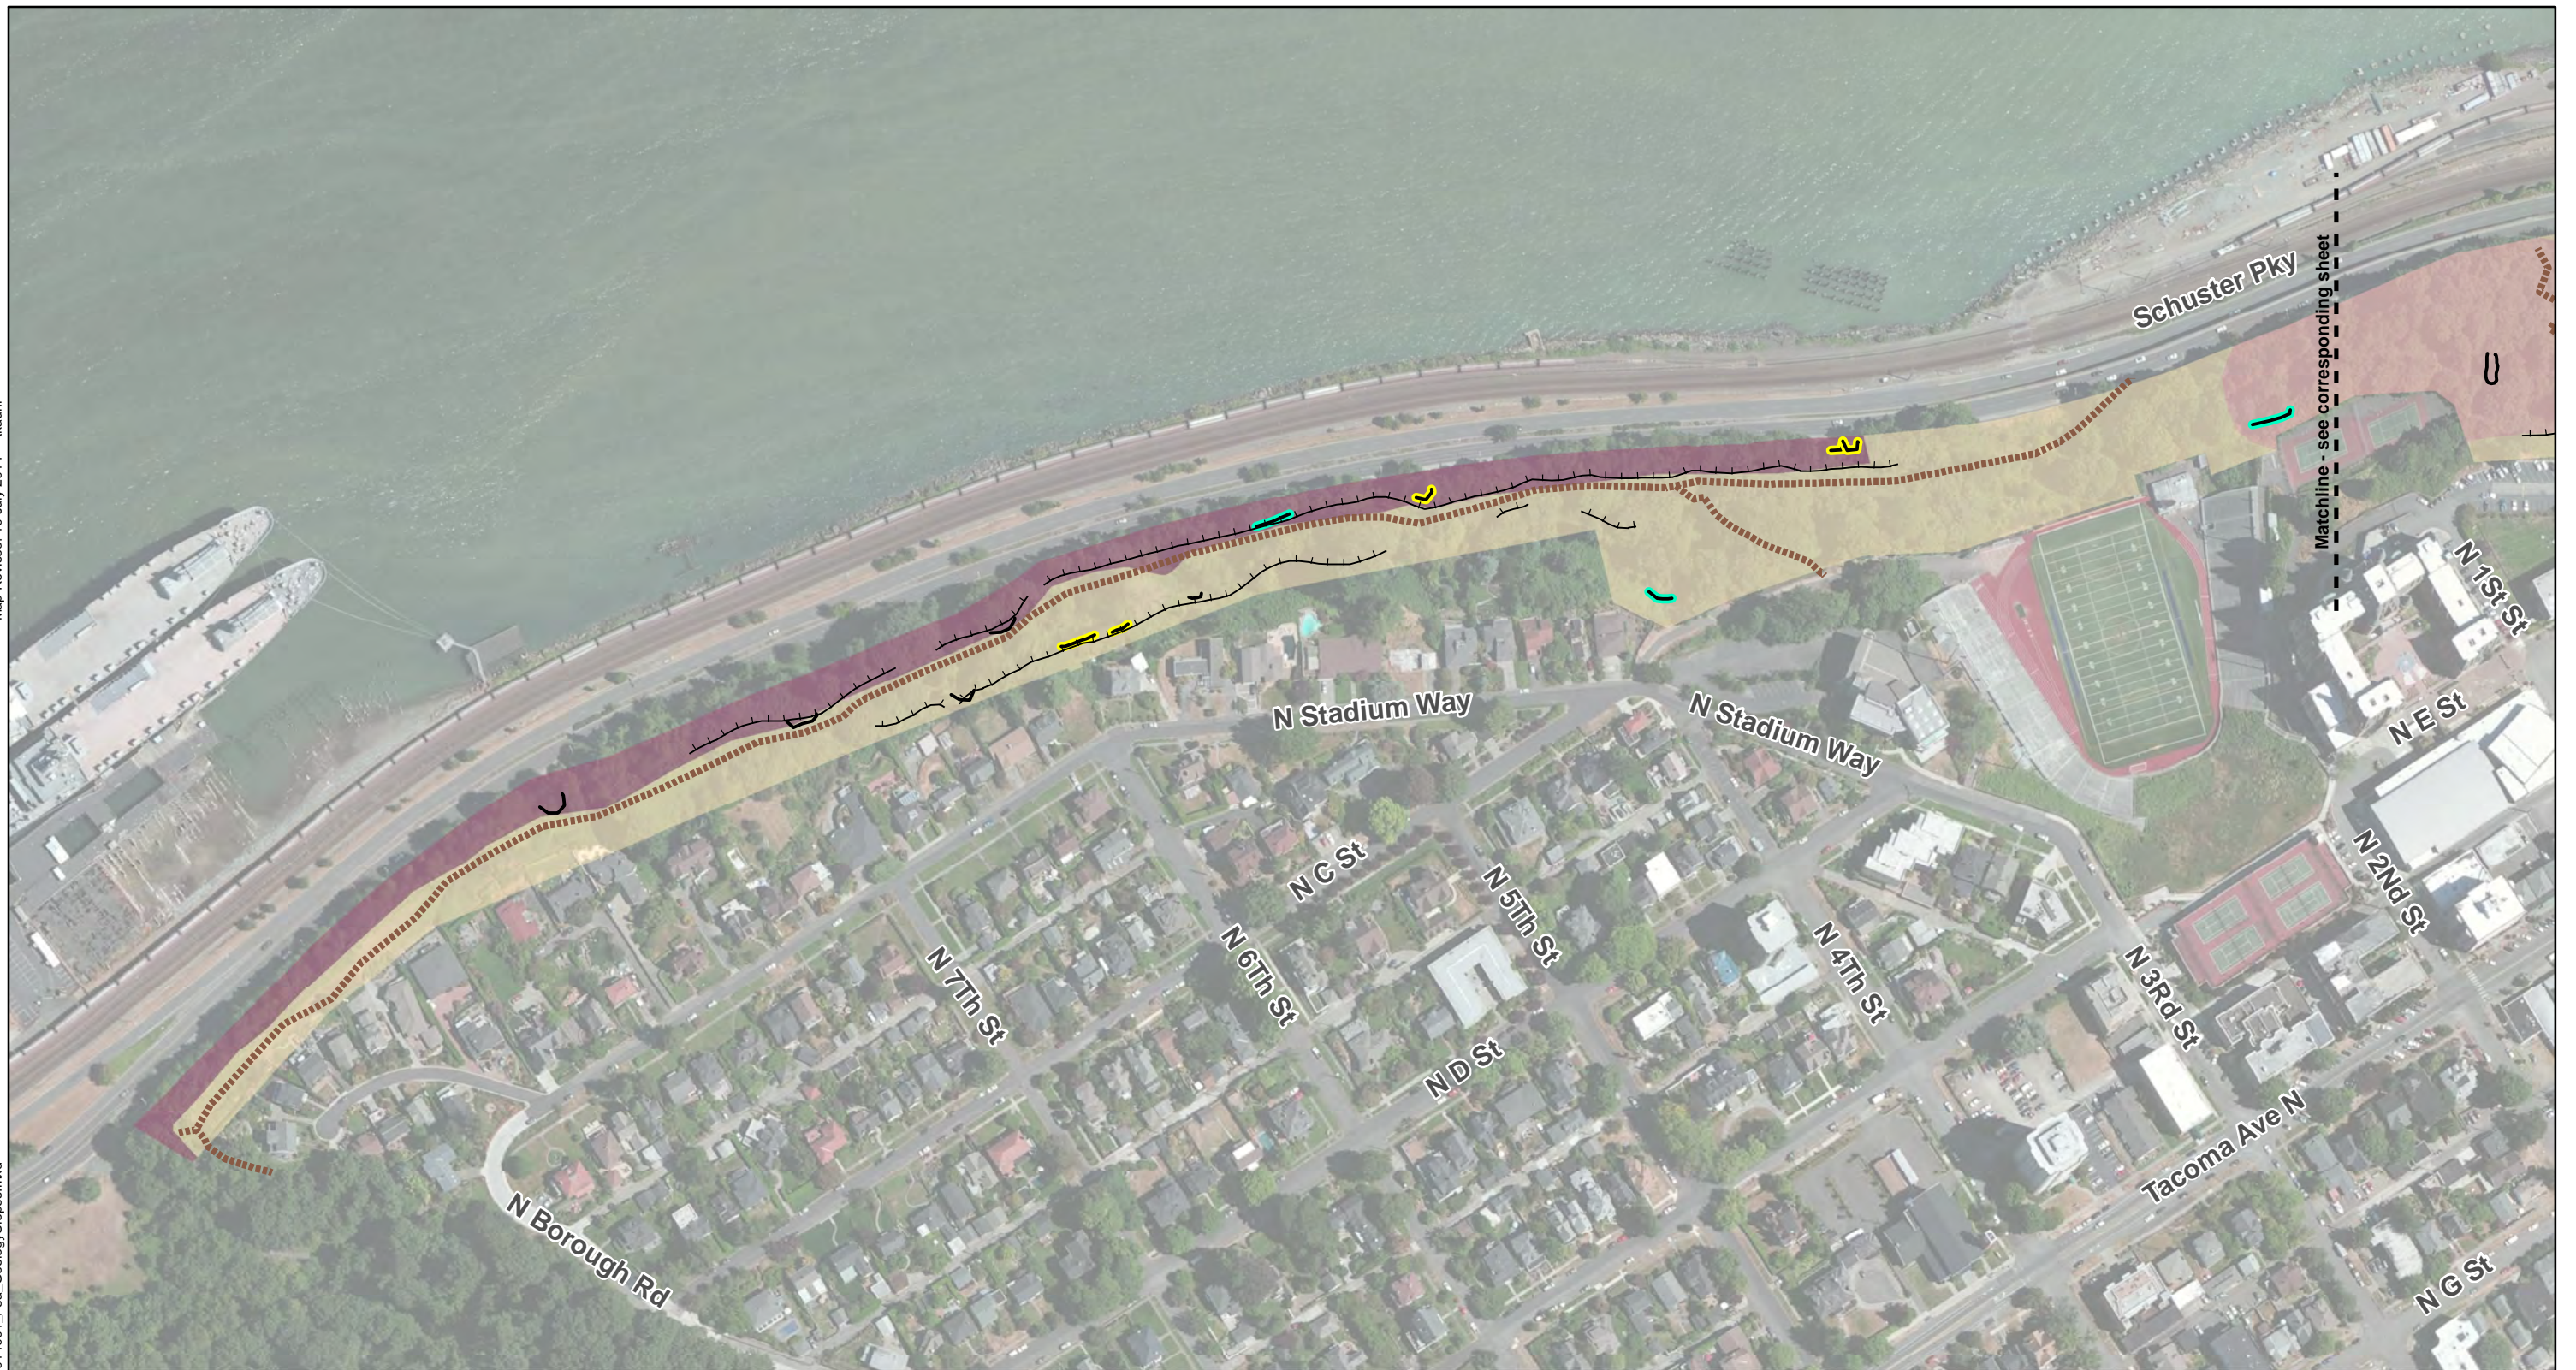
| | Figure 3a |

For the purposes of this report, we have divided the study area into the following four zones based on the geologic deposits interpreted, and other slope characteristics (Figures 3a and 3b):

- Zone A (Figure 3b) is an area of relatively high landslide susceptibility. The area appears to be actively creeping. Slopes are 70 to 80 percent. Trees are limited to clumps of maples, many of which are butt-bowed (i.e., bent, likely as a result of slope creep). Ground cover vegetation is limited which could be an indication of soil creep. Surficial soils consist of a loose blanket of cobbles, gravel, and sand.

- Zone B (Figures 3a and 3b) is an area of moderate landslide susceptibility. Trees include a mix of mature maple, cedar, Douglas fir; some are straight and some are butt-bowed. Ground cover vegetation is relatively well established throughout much of the area. Surficial soils consist of medium dense silt, sand and gravel.

- Zone C is an area of moderate landslide susceptibility and is similar to Zone B, however we noted that there was not as much ground cover vegetation as in Zone B, indicating that this may be an area of lesser slope stability compared to Zone B.

- Zone D is an area of moderate landslide susceptibility, and consists of the vertical and near-vertical slopes composed of the Kitsap formation. Certain exposures have little or no vegetation. Where vegetation does exist, it consists of maple and alder trees as well as ground cover. Soils consist of hard silts and very dense sands.

Figures 3a and 3b also show the tops of slide scarps (black lines) and bluffs (hachured black lines). For the purposes of this report, bluffs and slide scarps are defined as follows: Bluffs are long, continuous sections of relatively steep slope that may or may not have vegetation. Slide scarps are erosional slopes less than approximately 150 feet long in map view having minimal or no vegetation, likely resulting from relatively recent landslide activity. The tops of bluffs and slide scarps shown on Figures 3a and 3b fall into one of three categories based on a comparison of 2001 and 2014 observations:

- Bluff and/or slide scarp features mapped in 2001 that were also observed in 2014 are shown in black.
- Slide scarp features mapped in 2001 that were not observed in 2014 are highlighted yellow. It is likely that re-vegetation has occurred in the time between observations. There were no bluffs mapped in 2001 that were not observed in 2014.

- Bluff and/or slide scarp features observed in 2014 that were not mapped in 2001 are highlighted blue. It is likely these represent landslide activity that is more recent than 2001.

A number of slide scarps and bluffs exist within the study area (Figures 3a and 3b). Some portions of the study area also appear to consist of soils that are underlain by dense glacially consolidated soils. These soils can be stable at relatively steep angles with respect to deep-seated slope failures. However, shallow “skin” slides are common in sloping areas underlain by these materials. Deep seated rotational landslides are generally less common in these materials. The entire study area was mapped as a moderate to high landslide risk in our 2001 report. This condition does not appear to have changed in the intervening 13 years. Future landsliding at the study area should be expected.

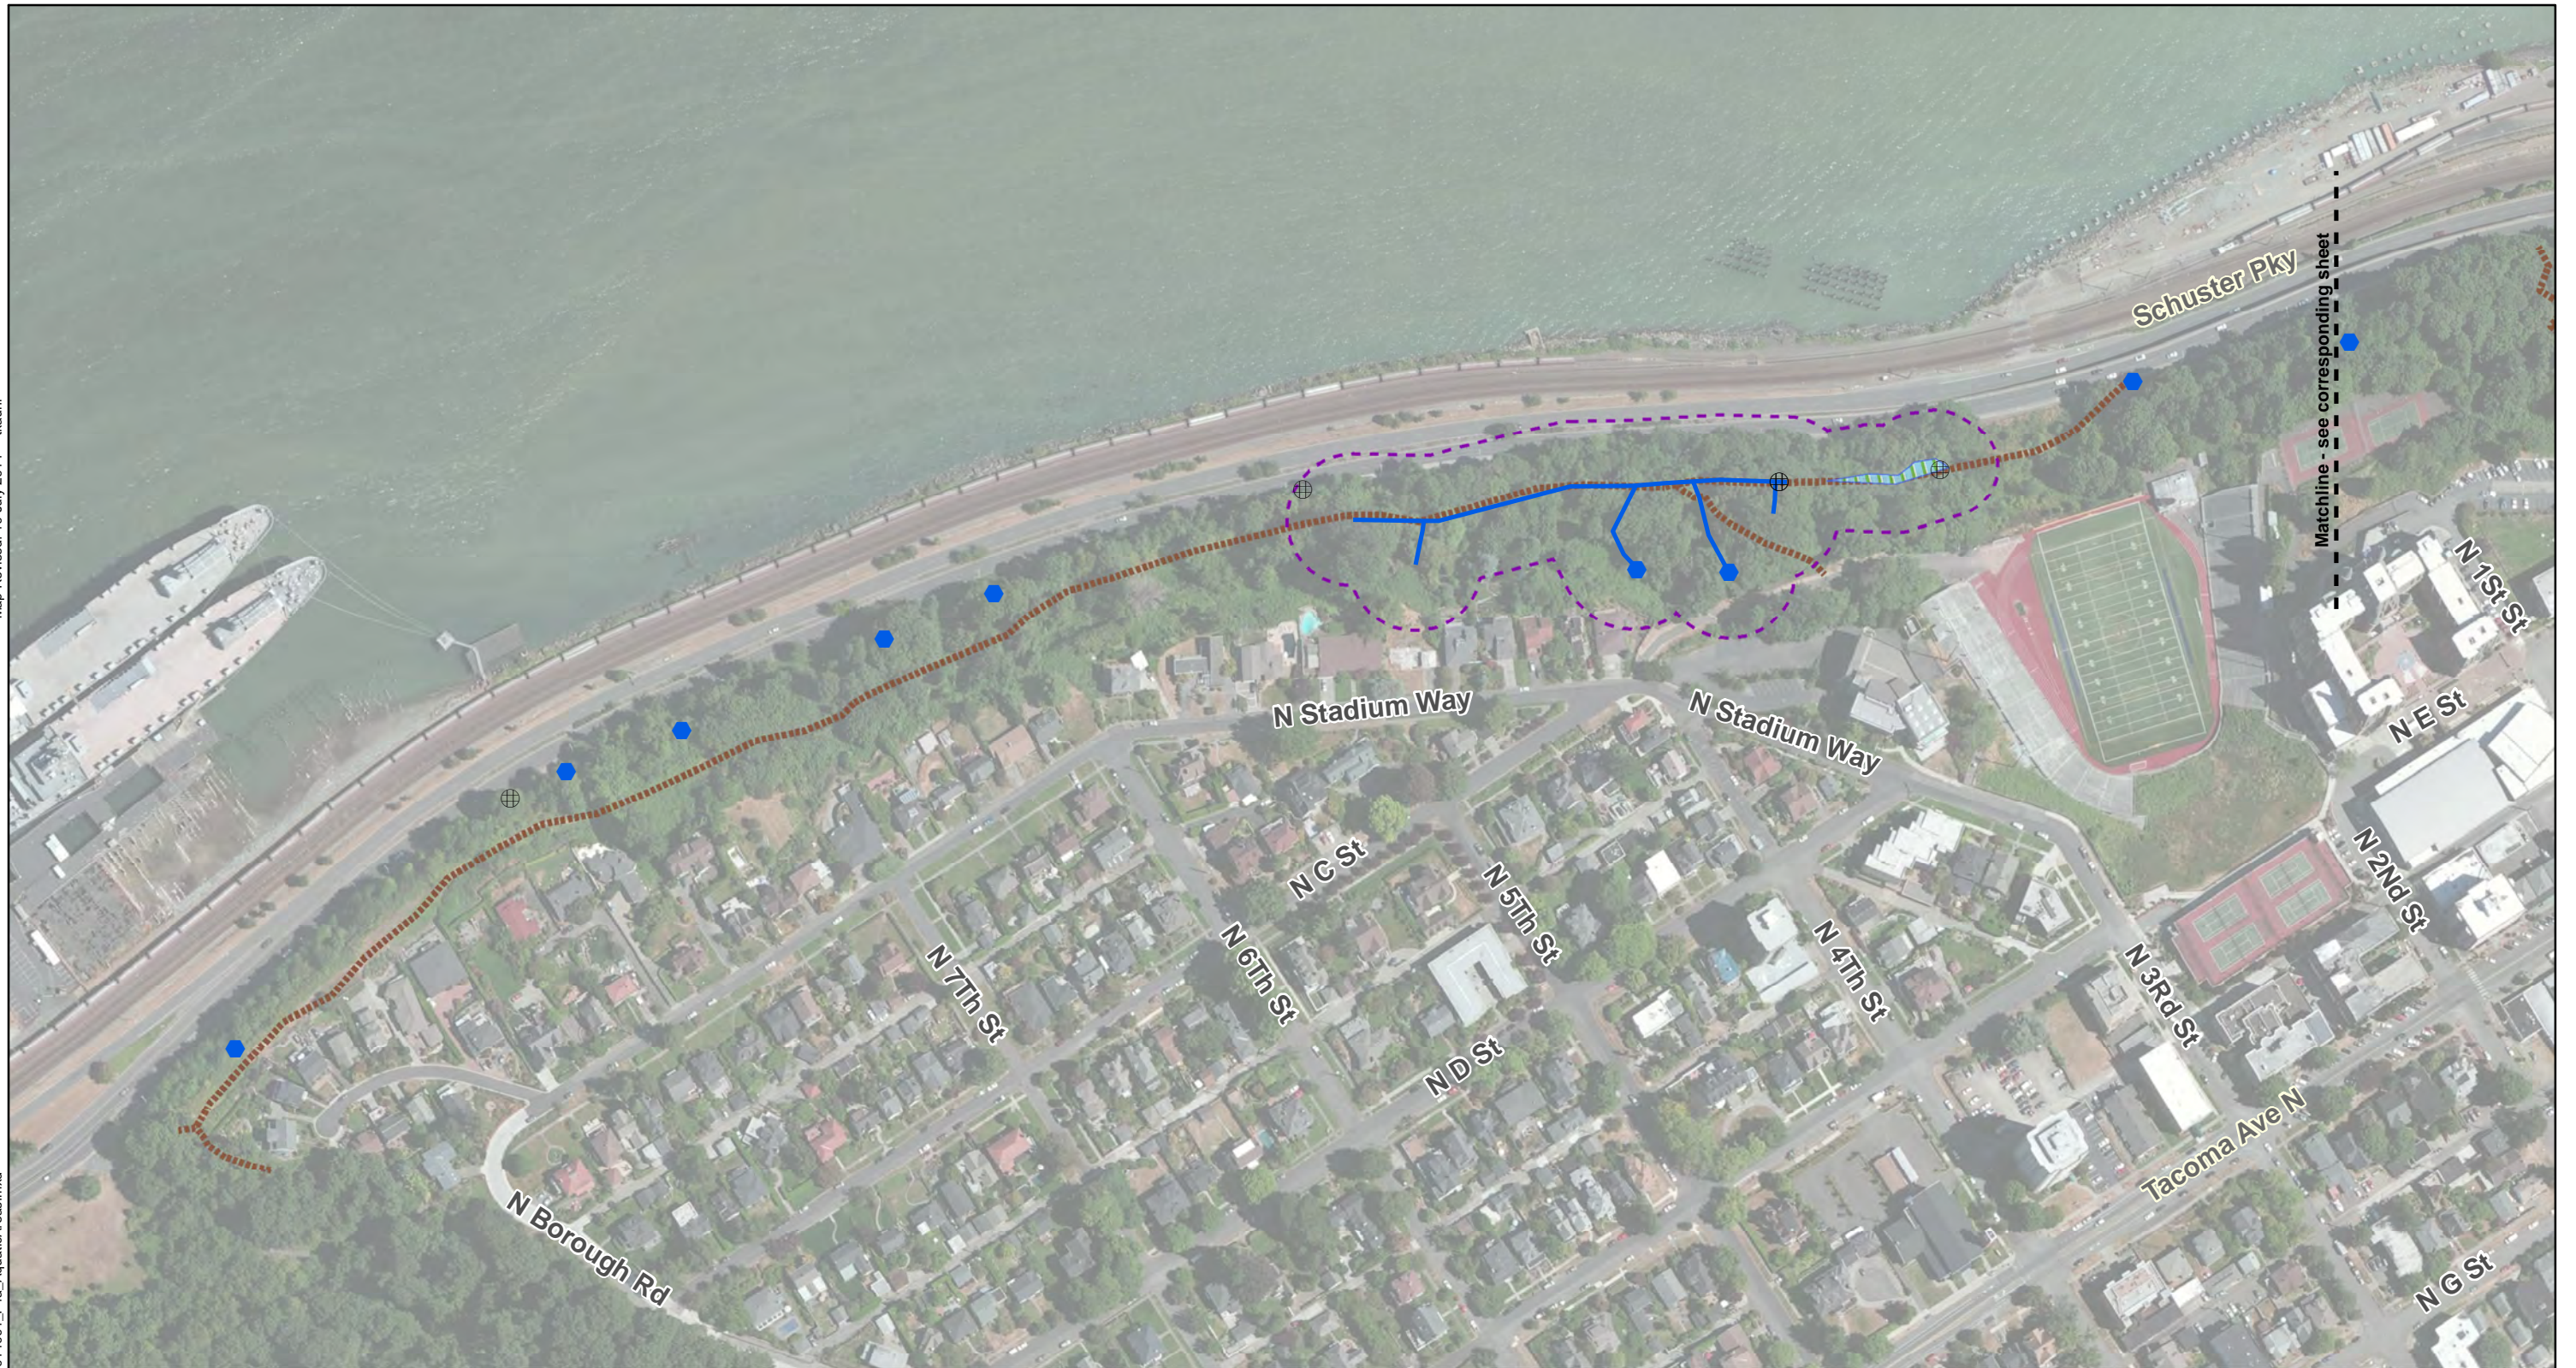
| | Figure 4a |

We mapped springs/seeps, surface water channels and wetlands throughout the study area (Figures 4a and 4b). This mapping effort was general in nature and did not include jurisdictional wetland boundary determinations (wetlands) or Ordinary High Water Mark identification (surface water channels); rather, the focus of this effort was to identify the general location and extent of these features for the purpose of developing a slope management plan.

The locations of springs/seeps were observed to be generally located where previously observed by GeoEngineers (2001), Dames & Moore (1971a, 1971b, 1972), and the City of Tacoma. However, the current study likely represents the most comprehensive mapping effort for aquatic critical areas within the study area.

Channels that we observed with flowing surface water would likely be considered by the City for regulatory purposes as Type Np or Ns streams, which are distinguished based on perennial or seasonal water flow. Our study did not attempt to identify seasonality of flow in these channels. As a conservative estimate, we have assumed a riparian buffer width of 100 feet would apply to mapped surface water channels, which corresponds to City of Tacoma regulations applicable to perennial non-fish-bearing streams (Type Np).

A number of springs/seeps and surface water drainage channels have been identified in the study area (Figures 4a and 4b). These features have resulted in, and may continue to cause, erosion of the slope and existing abandoned trail infrastructure. Extensive wetland areas are also present primarily in the southern half of the project area. Estimated wetland and surface water buffers are shown for planning purposes.

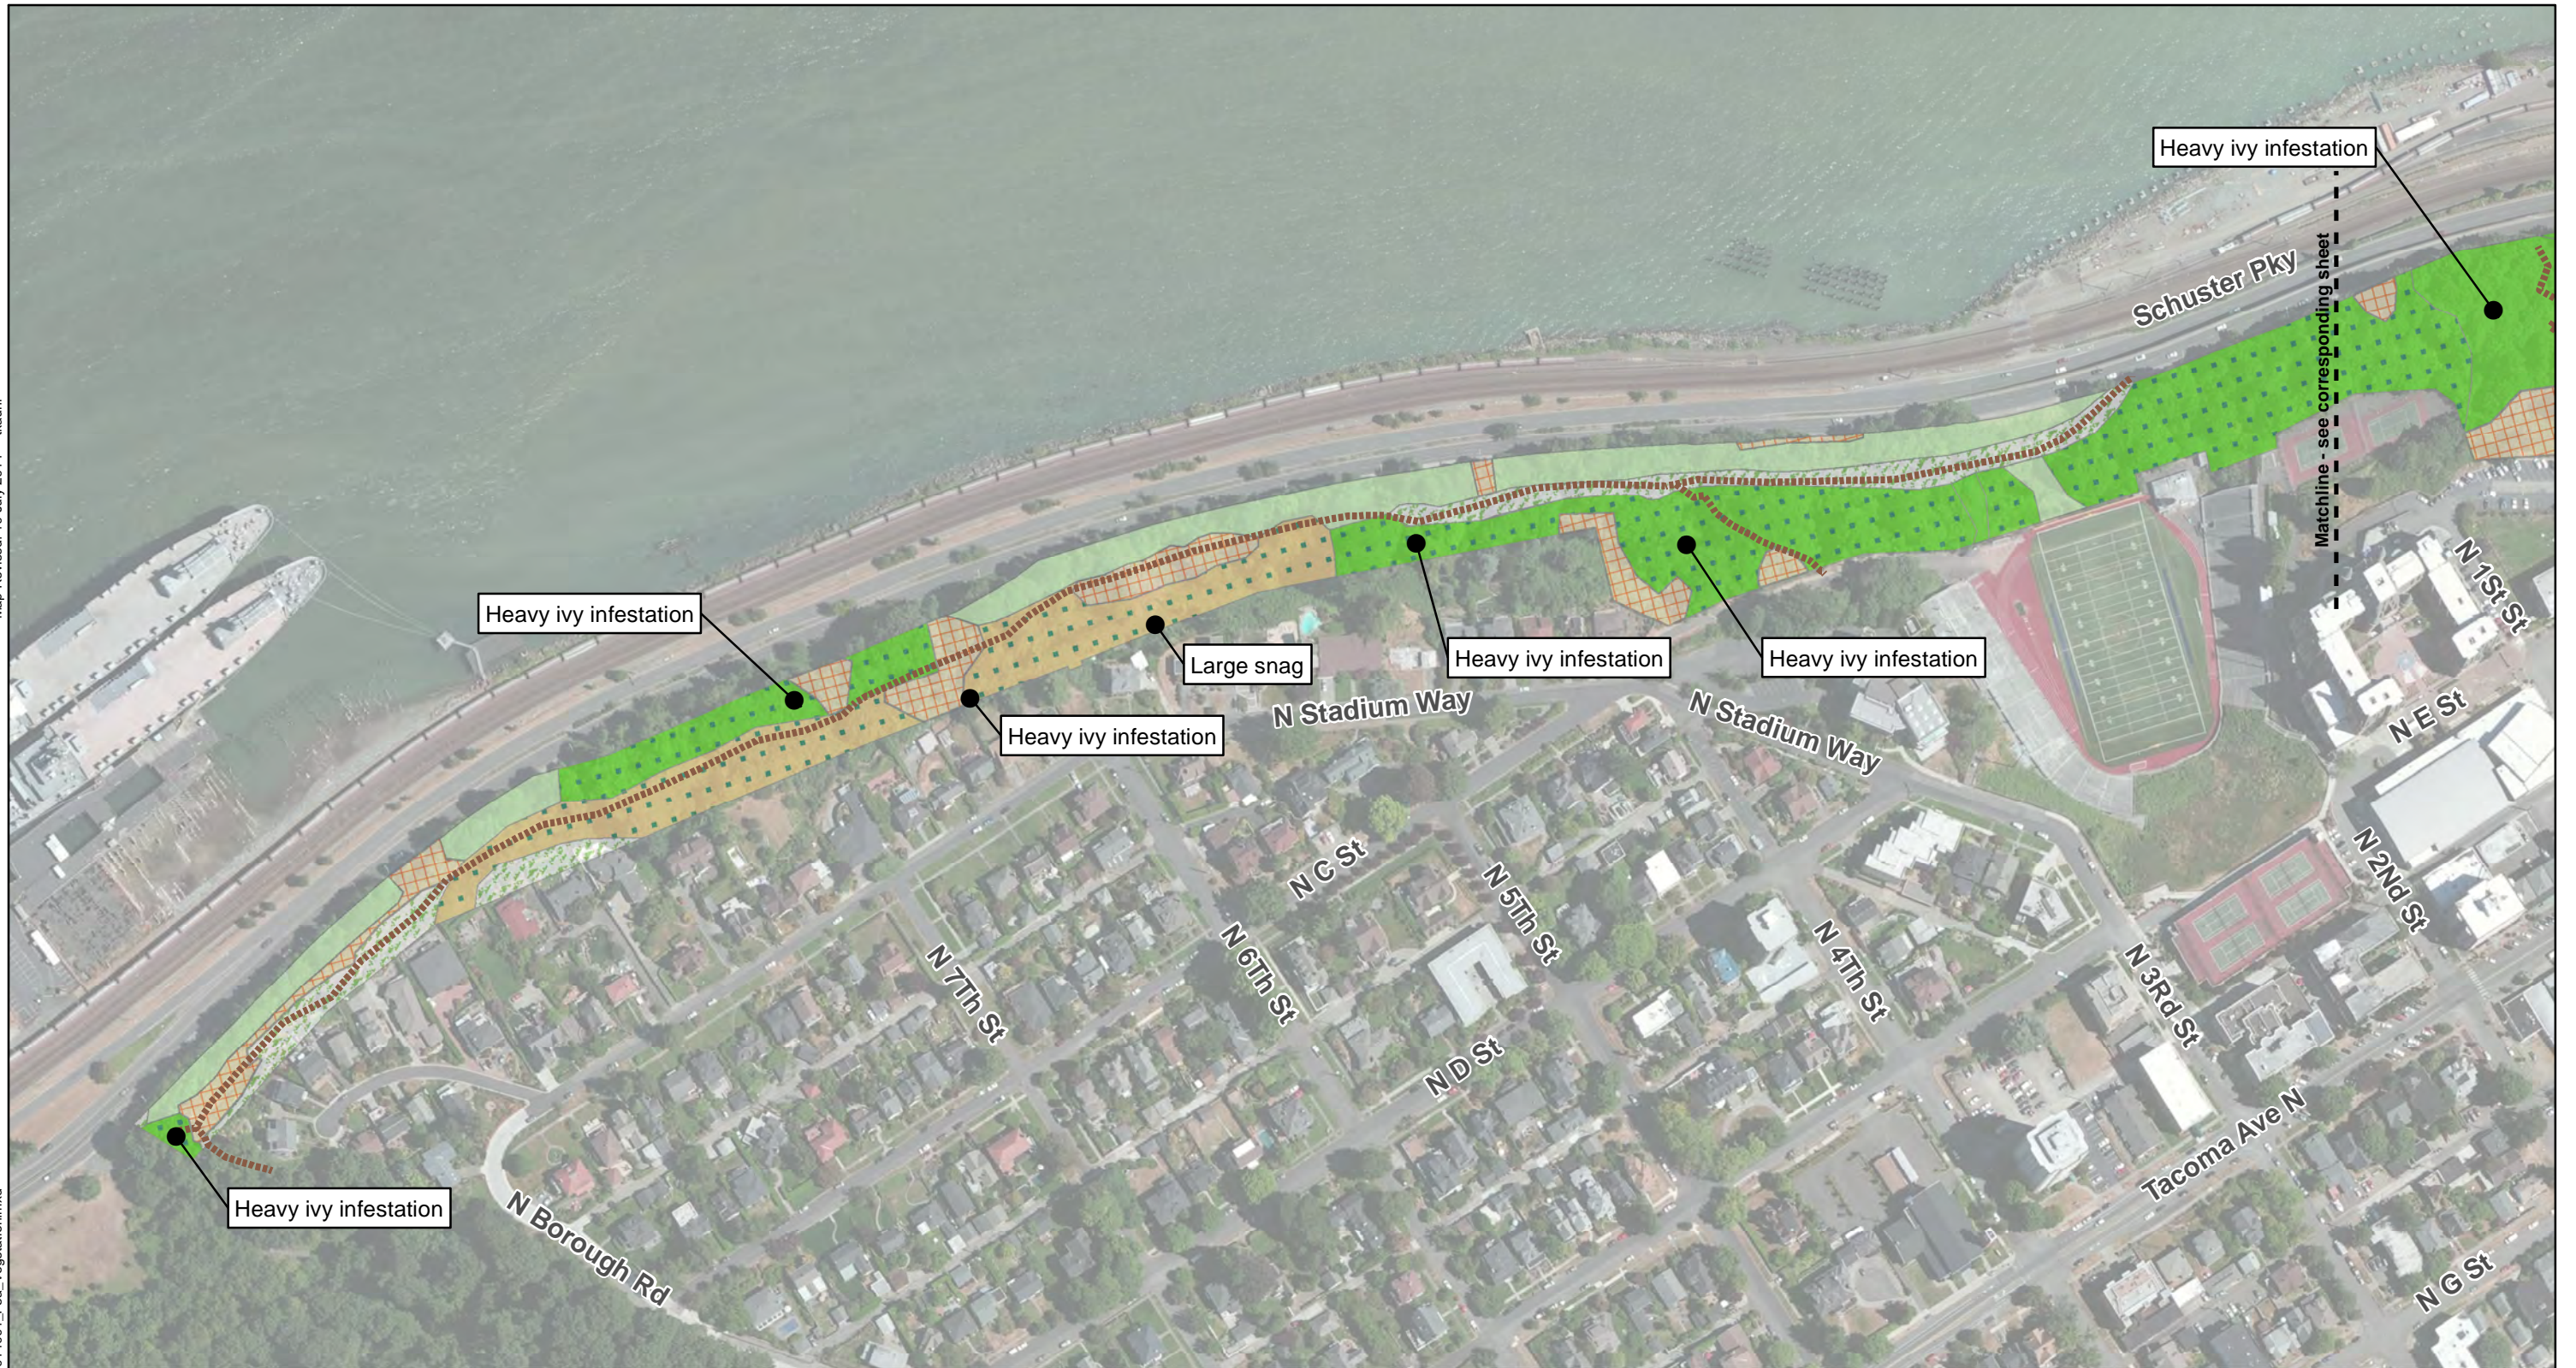
Figure 5a

We mapped general vegetation communities throughout the study area (Figures 5a and 5b). The focus of the vegetation mapping was to classify vegetation conditions with regard to implications for slope stability and vegetation management that may be relevant for the slope management plan. In general, our classification scheme and the extent and distribution of vegetation communities is consistent with the mapping presented in the 2001 GeoEngineers report, but was updated in places based on the most recent field reconnaissance. Furthermore, we classified vegetation into the following community types which differ somewhat from the previous effort:

Vegetation mapping provides a baseline condition upon which future desired conditions can be planned. Much of the slope already contains a mature forested overstory, although areas of younger stands, shrub communities and grass/landscaped areas are also present. Invasive species are present throughout much of the study area. Areas dominated by invasive species represent opportunities for clearing of problematic vegetation and replacing it with native communities. These areas occur particularly at or near the top of the slope where Himalayan blackberry dominates. Many of the forested areas also contain extensive areas of English ivy, but eradication of this invasive species would require a program spanning most of the slope and should be accompanied by a comprehensive invasive species management and landscaping program.
