# Schuster Slope Activities and Monitoring Report 2020/2021

**Prepared by City of Tacoma**

**Passive Open Space Program**

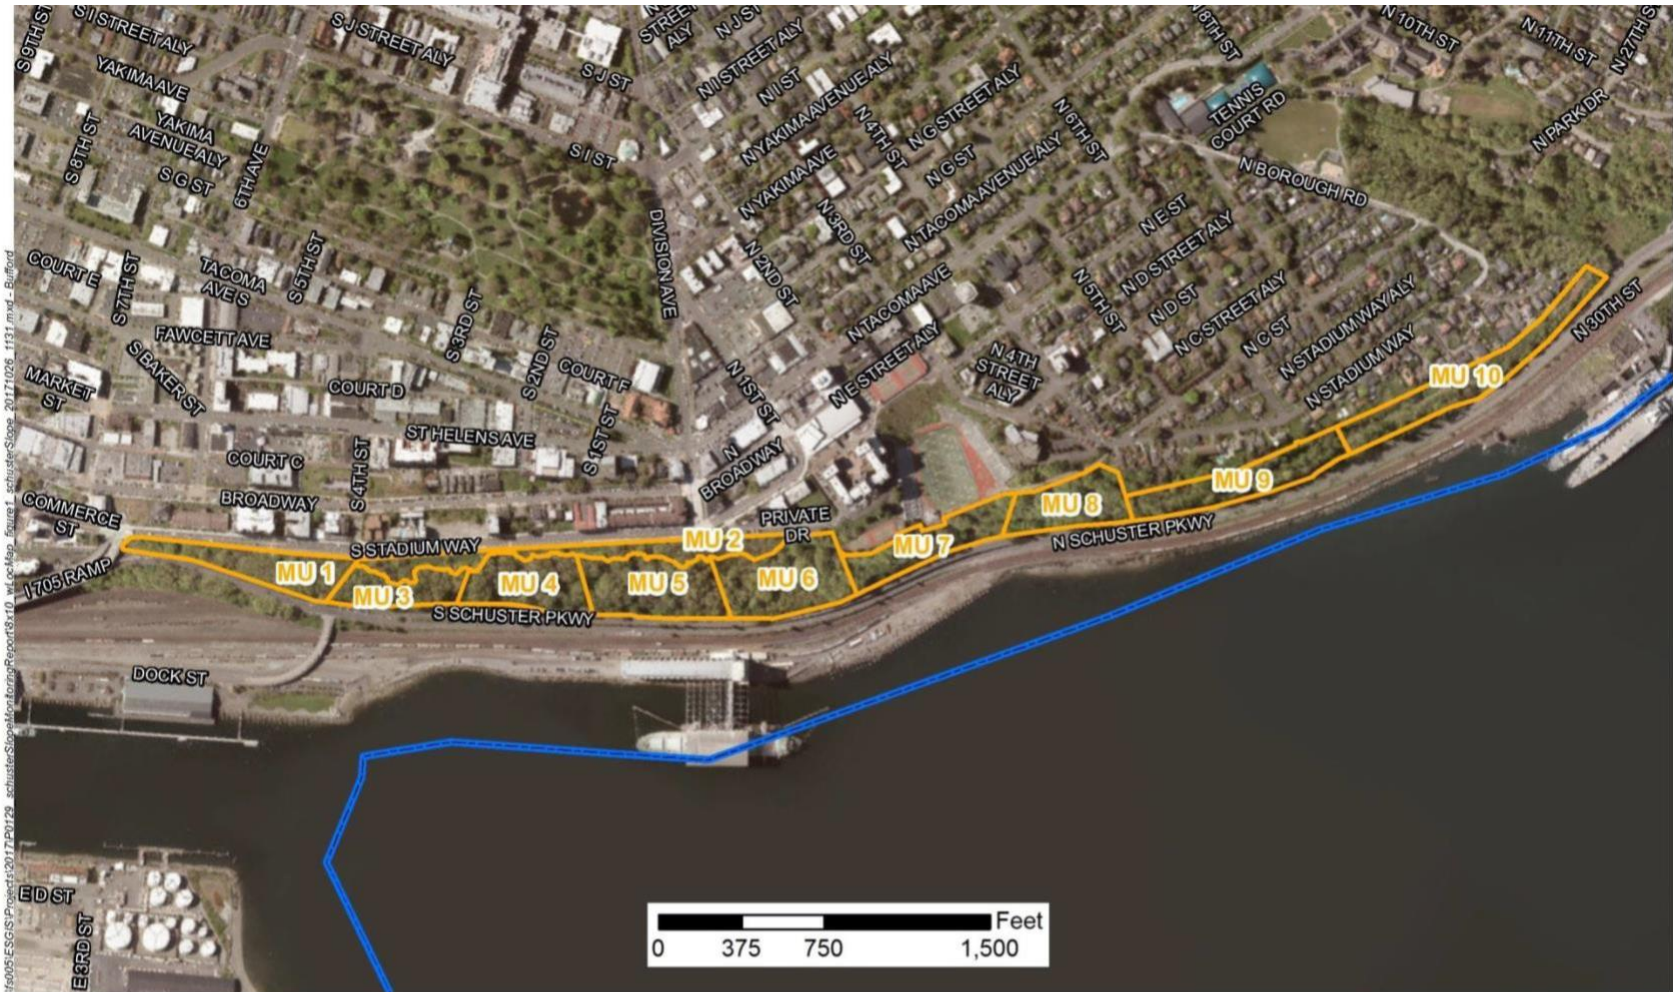
Figure 1. Schuster Slope Management Units

Schuster Slope is made up of 10 management units (Figure 1), totaling 31.2 acres. The LMP indicates Schuster Slope is divided into nine management units, however these were redistributed by the City of Tacoma to create more homogeneous units to better accommodate future work. Management Unit 1 remains unchanged from the LMP. Management Unit 2 has been altered from the LMP. Where it once spanned the slope from top to bottom adjacent to Management Unit 1 (MU1), it is now stretched across the top of the slope directly above MUs 3-6 (Figure 1).

Management Unit 2 is located north of MU1, and makes up approximately the upper one-third of the slope, with MUs 3-6 comprising the lower two-thirds of the slope (Figure 1). Management Unit 2 is 2.8 acres in size and made up of four TPs (Figure 3). Restoration began on Management Unit 2 (MU2) during 2016/2017, however the majority of efforts occurred during 2017/2018. Infill planting also took place in MU2 during 2018/2019. Monitoring began in MU2 during the summer of 2019 and will continue for five consecutive growing seasons.

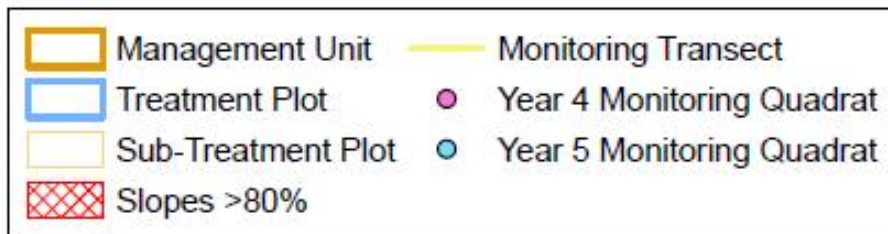
Figure 3. Schuster Slope Management Unit 2 Monitoring Locations

Management Unit 2, located at the top of the slope, is divided into four TPs (Figure 3). In general, MU2 is dominated by bigleaf maple (*A. macrophyllum*) trees, many of which were previously coppiced. Monocultures of Himalayan blackberry (*R. armeniacus*) and English ivy (*H. helix*) dominated the understory before restoration. Slopes are typically between 40%-80%. Soils tend to be made up mostly of sandy silt with some gravel.

The number of transects within each TP was based upon the LMP requirements of one 50 ft transect per quarter acre. One 50 ft transect was established for MU1 TPs 2, 3, 4, and 5, and MU2 TP2. Three transects were identified for MU1 TP6, MU2 TPs 3 and 4, and four transects for MU2 TP1. Two 9 ft radius quadrats were established along each of the transects for MU2 (Figure 3). The quadrats for MU1 had a 4.5 ft radius (Figure 2).

Many encampments occurred under the sidewalk "bump-outs" at the top of MU2 as these provide cover from rain. These areas were fenced off resulting in fewer encampments, but not eliminating them completely, as campers sometimes cut the fence and/or the lock on the gate. At any given time, there are typically encampments in MU1 TP5 (Figure 2), and MU2 TP1 and the bottom of TP4 (Figure 3). There is quite a bit of transient activity across MU1 TPs 2 and 3, and MU2 TP4 is used to access another common encampment area located below MU2. Encampment clean-up costs for Schuster Slope during 2020/2021 totaled \$34,503.88, costing almost three times more than the previous year. Management Unit 2 TP1-T2 had an encampment physically present across most of the monitoring area that destroyed the nearly 100% vegetation cover that existed there. Although other plots did not have camps directly in them, these areas were likely impacted by transient activity.
