CUSHMAN AND ADAMS SUBSTATIONS PROJECT

Background and Existing
Conditions Report

FEBRUARY 2024

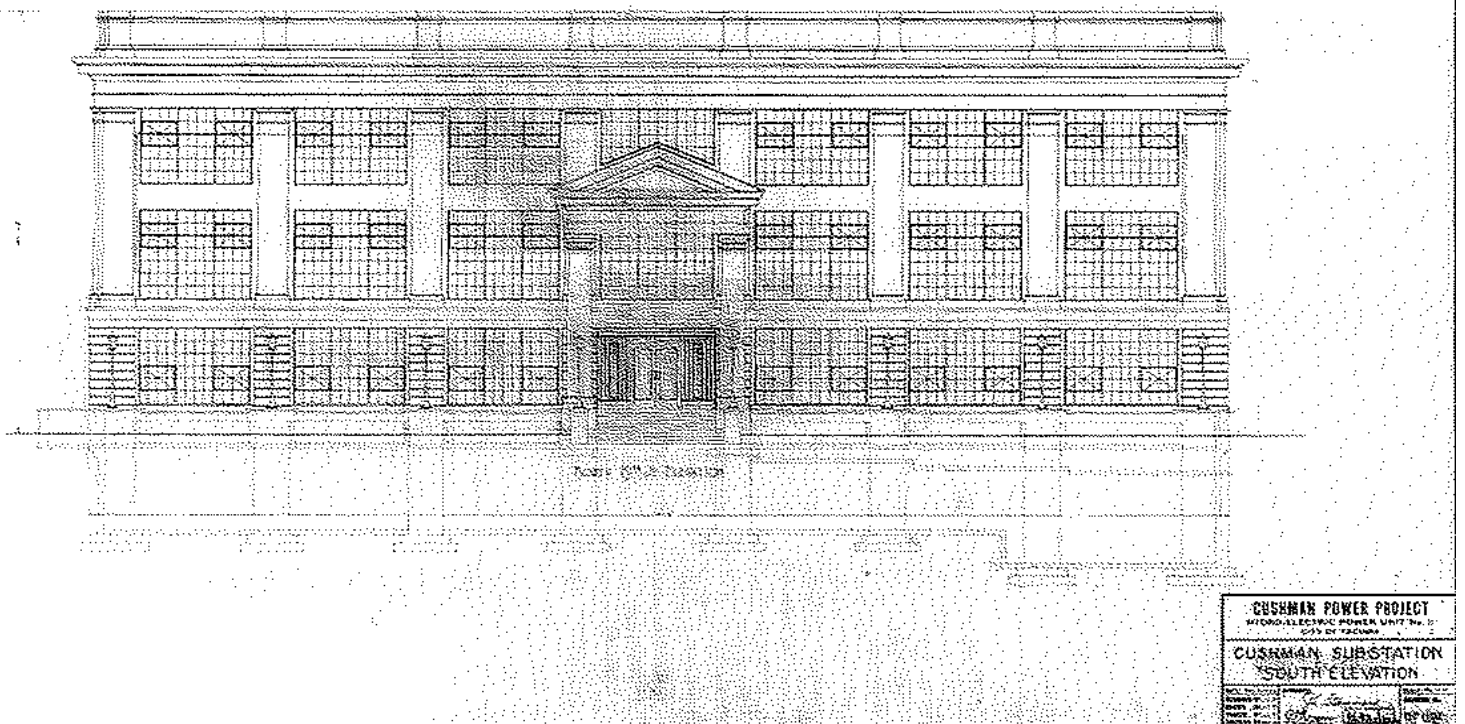
Design drawings, Cushman Substation, South Elevation, December 1924.
 Source: Tacoma Public Utilities.

The Cushman Substation building is rectangular in plan and three stories tall on basement. The building is constructed of board-formed poured concrete, including the foundation, walls, and exterior cladding. Seven bays wide by four bays deep, the building has a shallow-pitched gable roof with a concrete parapet. The roof also features a shed-roof penthouse in the northwest corner that denotes the location of the interior elevator shaft. Below the parapet, a projecting concrete cornice articulates the top of a full entablature, supported by engaged pilasters. Designed in the Tuscan order, the simplified Doric pilasters that define the second and third floors sit atop a pedestal (the first floor) comprising a raked dado and unadorned plinth.

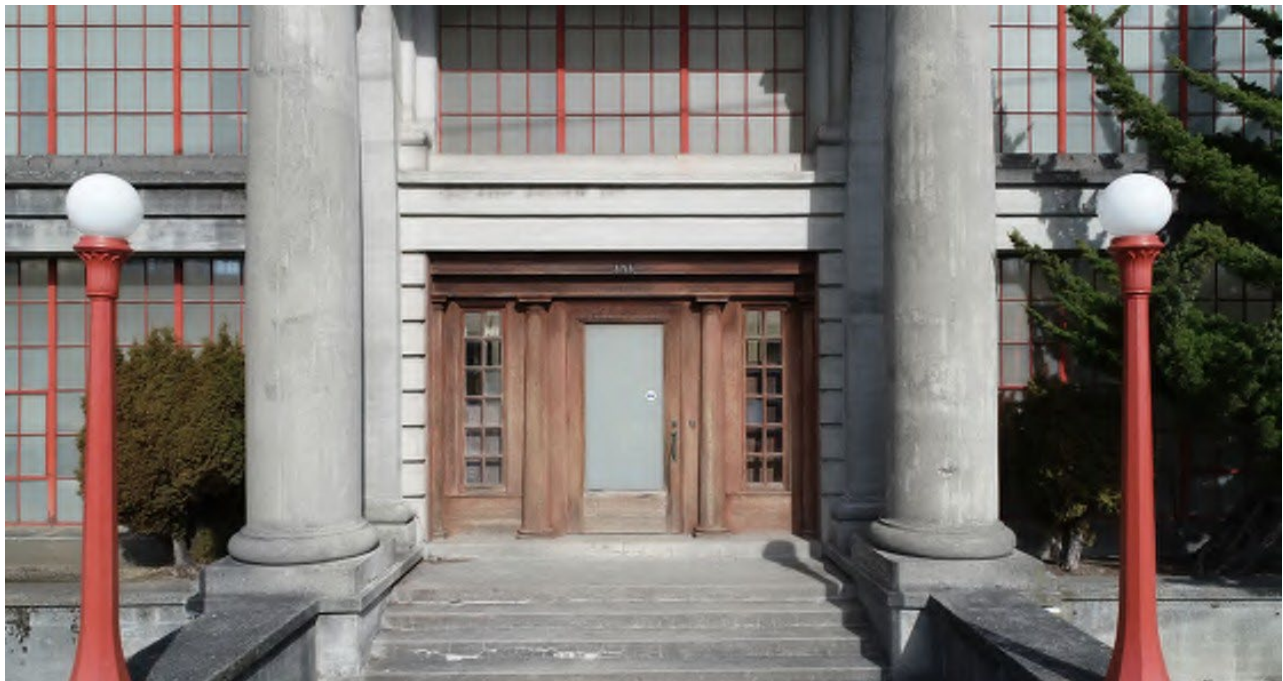
South facing elevation of the Cushman Substation.

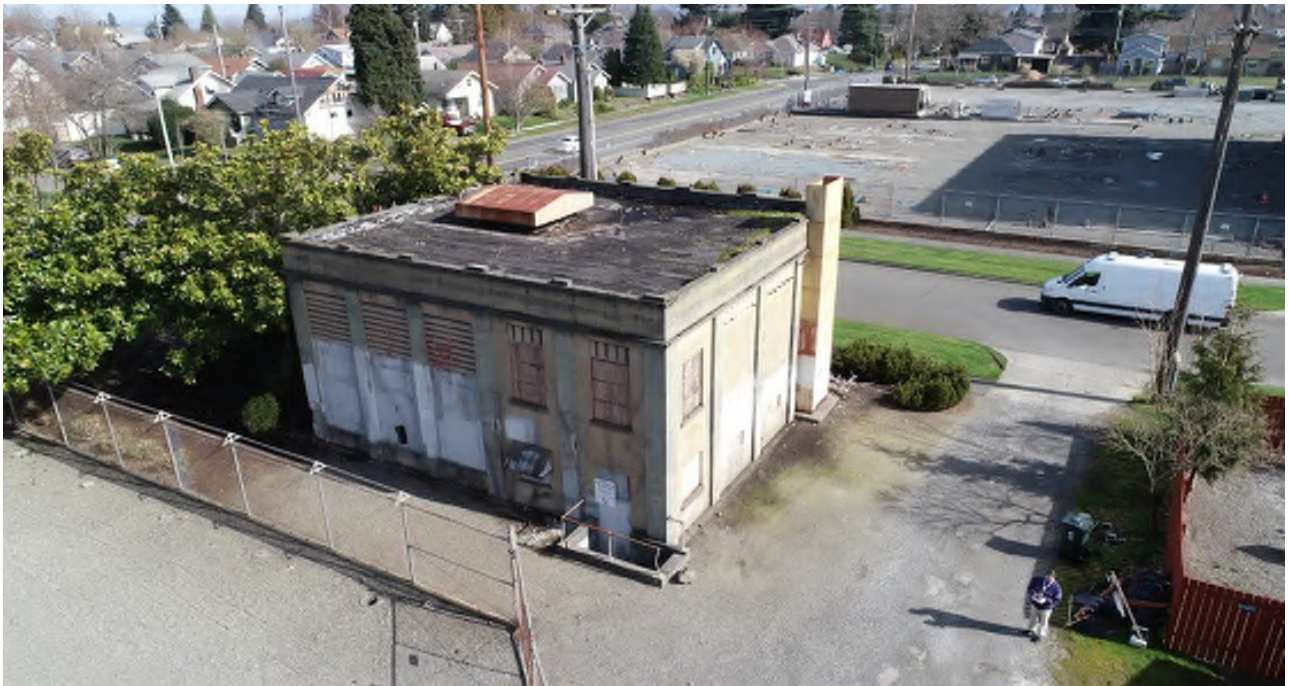
Adams Substation West and South elevations.

The Adams Street Substation is rectangular in plan, a tall single-story building in height, with a daylight basement and fronts on the Adams Street property line near the southeast corner of the property. Like the Cushman Substation, the building is constructed of reinforced board-formed concrete, which was mixed on-site and poured in place. The building’s façade is broken into five bays on the east and west sides, and four bays on the north and south, by pilasters that rise from grade up to the cornice line of the building. A shallow cornice extends around all four sides of the building, presenting a finished appearance on all sides. Above the cornice is a parapet wall with an articulated cap reflecting the pilaster located below. A shallow shed roof sloping to the west is hidden behind the parapet wall. The building is finished to the same level of finish and form on all four sides.
