# Preliminary Evaluation of Building Conditions

## Cushman & Adams Street Substations

January 14, 2025

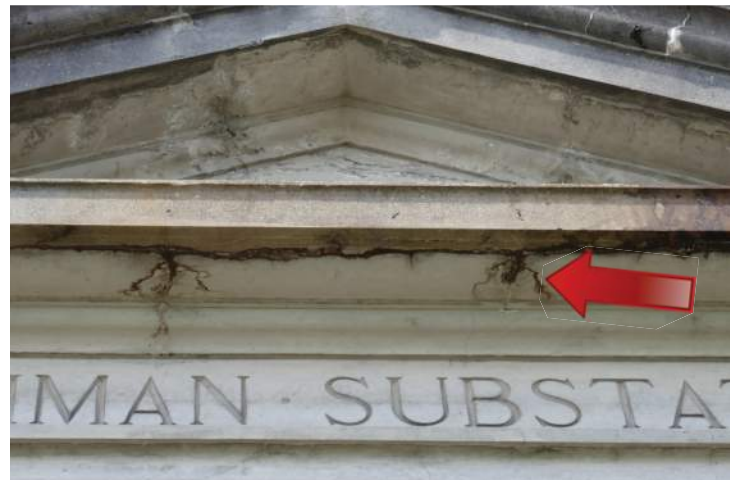
The pediment above the main entrance on the south elevation shows some water damage that resulted in cracking and spalling of the concrete. Image by Richaven Architecture and Preservation. 220620 CoT CAS EL-S P1000651.JPG

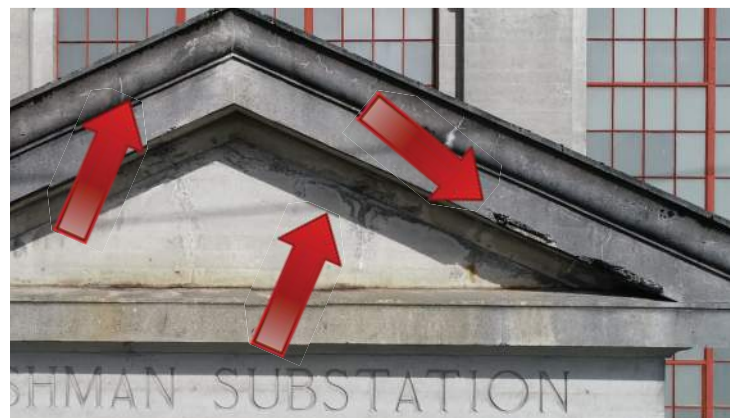
Pediment above the main entrance on the south elevation shows severe spalling, efflorescence, and atmospheric soiling. Image by Richaven Architecture and Preservation. 200224 CoT CAS EL-S DJI\_00221.PNG

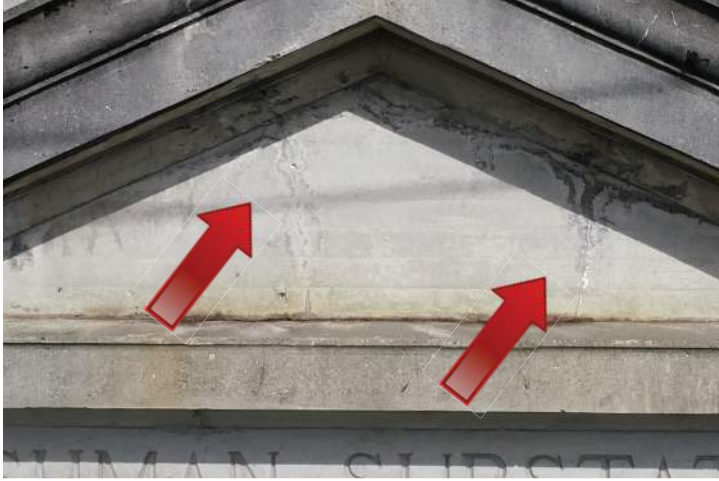
Spalling and efflorescence on the frieze. Image by Richaven Architecture and Preservation.  
200224 CoT CAS EL-S DJI\_00221.PNG

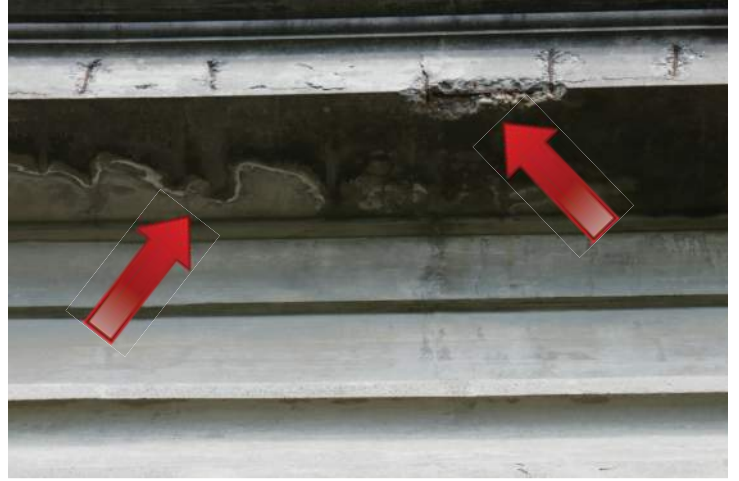
Section of the cornice on the west elevation shows spalling and reinforcing steel exposed due to water infiltration. Image by Richaven Architecture and Preservation.  
220620 CoT CAS EL-W P1000649.JPG

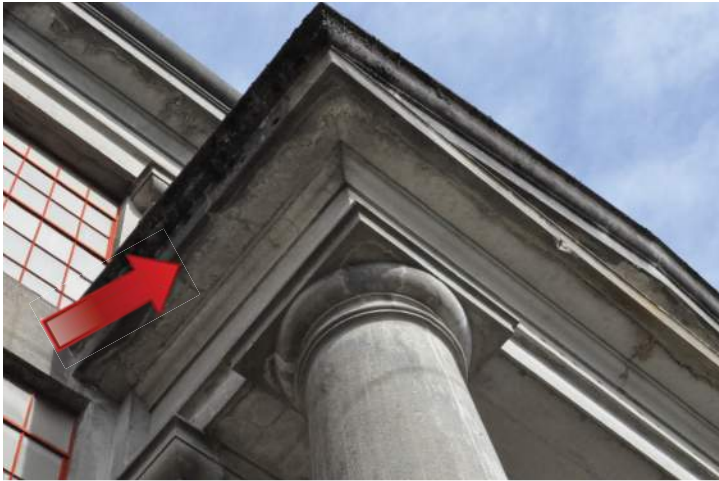
Efflorescence was observed under the pediment and entablature on the main entrance. Image by Richaven Architecture and Preservation. 200224 CoT CAS EL-S DSC\_0016.JPG

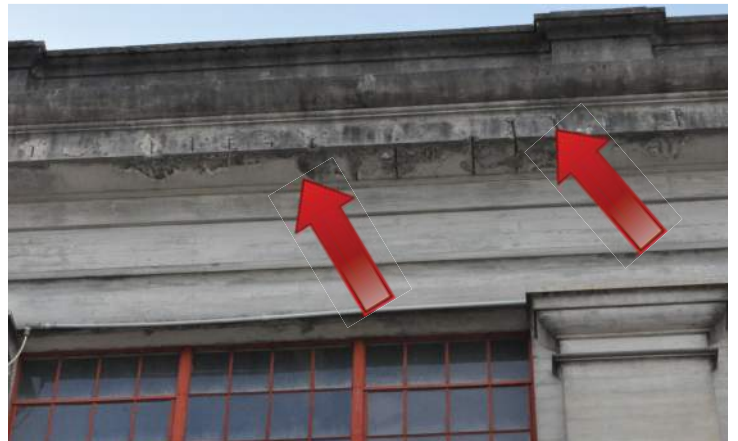
Spalling, efflorescence and atmospheric soiling under the cornice and capitals. Image by Richaven Architecture and Preservation. 200224 CoT CAS EL-N DSC\_0163.JPG

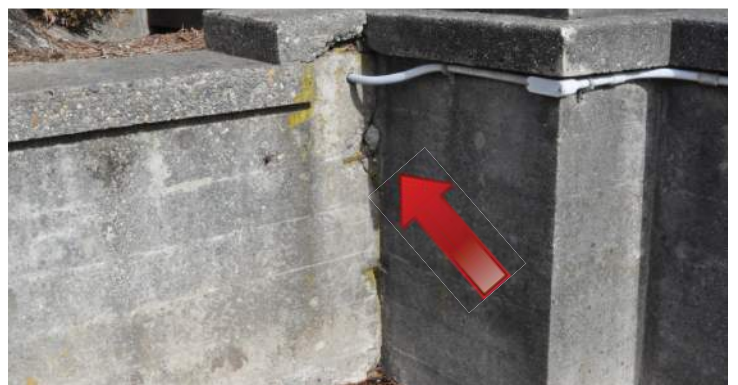
The foundation on the right side of the stairway has severe spalling, cracking, and organic soiling. Image by Richaven Architecture and Preservation. 200224 CoT CAS EL-S DSC\_0014

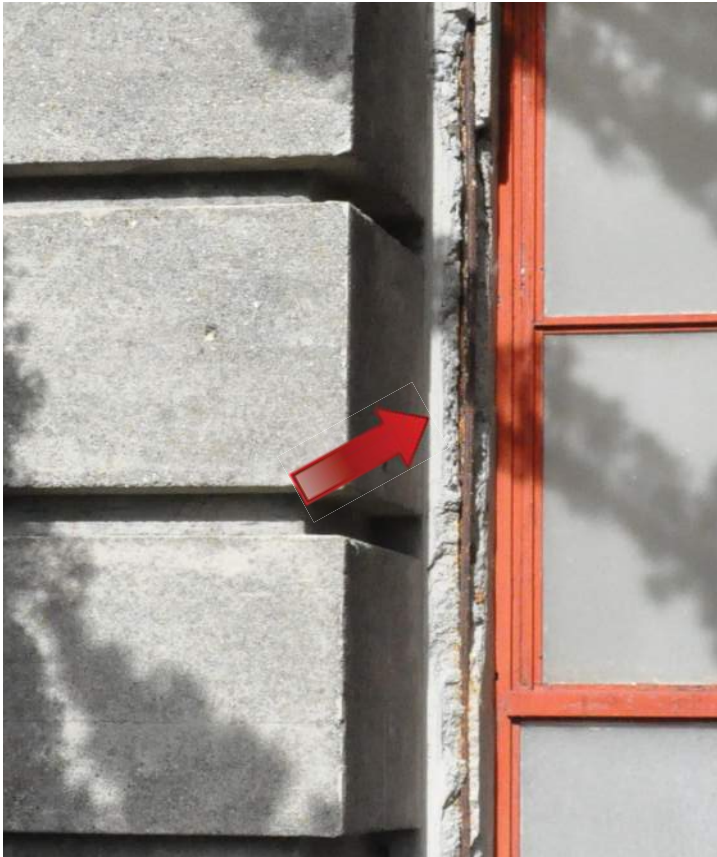
Spalling around a window frame on the west elevation and reinforcing steel bar exposed due to carbonation-induced corrosion. Often occurs in areas with a shallow concrete cover Image by Richaven Architecture and Preservation. 200224 CoT CAS EL-W DSC\_0026.JPG

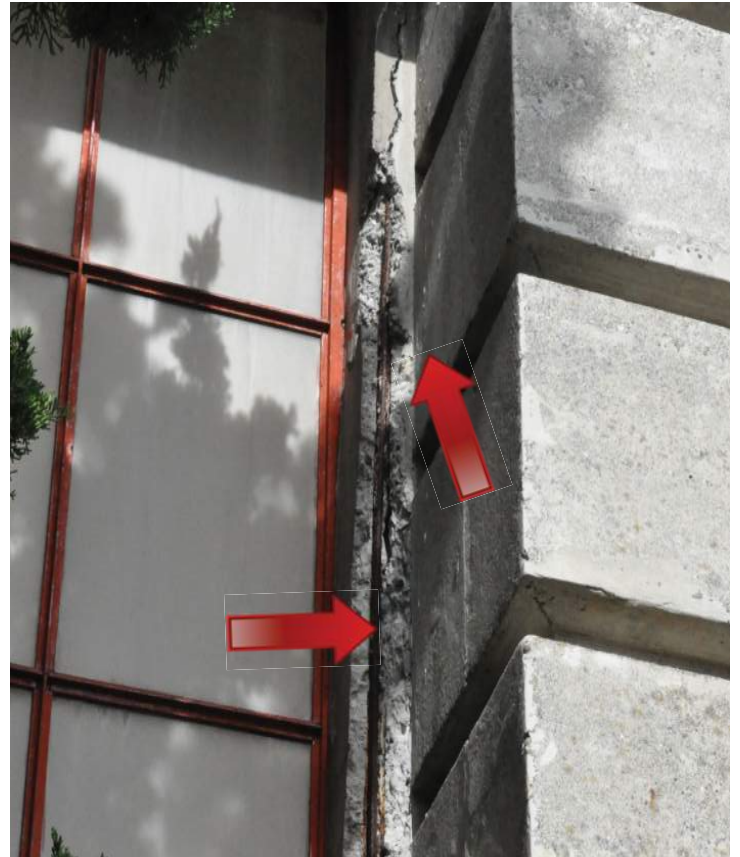
Exposed reinforcing steel and failed concrete around one of the ground-level window bays on the west elevation. There is some amount of corrosion visible. Image by Richaven Architecture and Preservation. 200224 CoT CAS EL-W DSC\_0028.JPG

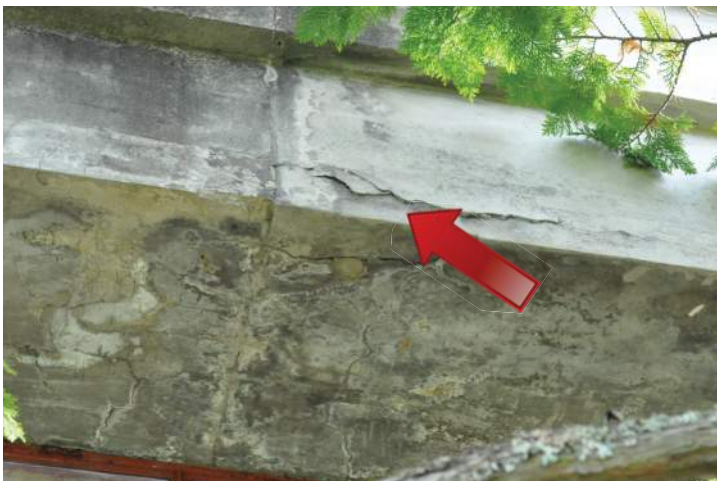
Cracking and delamination present above a window on the west elevation. Image by Richaven Architecture and Preservation. 200224 CoT CAS EL-W DSC\_0035.JPG

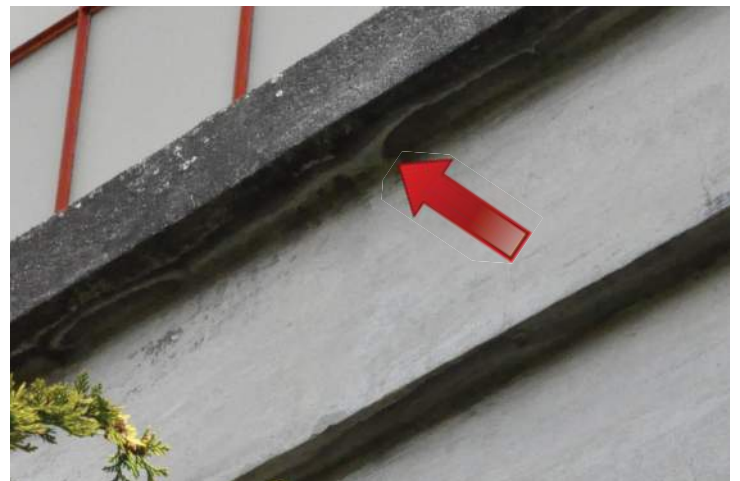
Efflorescence under a window ledge on the west elevation. Moisture infiltration will result in spalling. Image by Richaven Architecture and Preservation. 200224 CoT CAS EL-W DSC\_0034

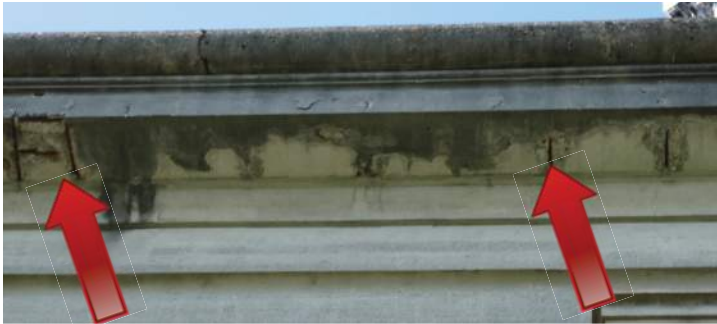
Exposed reinforcing steel and spalling under the cornice on the west elevation. Image by Richaven Architecture and Preservation. 220620 CoT CAS EL-W P1000666.JPG

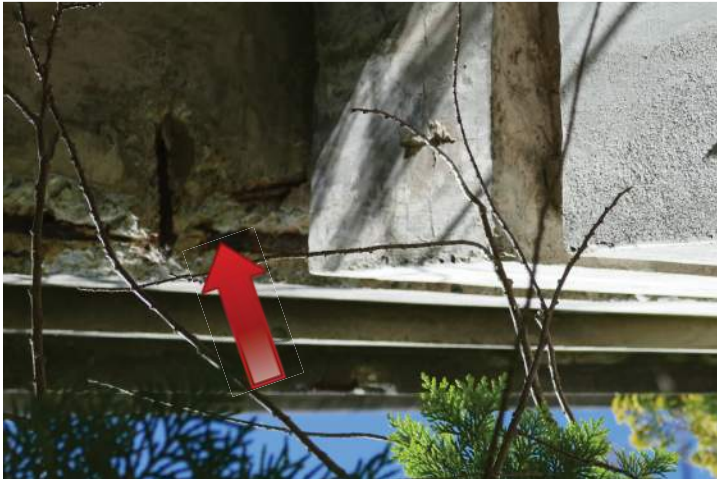
Looking up at the failed concrete at the upper left corner at a ground-level window bay, west elevation. The image below shows concrete debris that has separated from the substrate. Image by RichavenArchitectureandPreservation.220620CoTCASEL-WP1000663.JPG

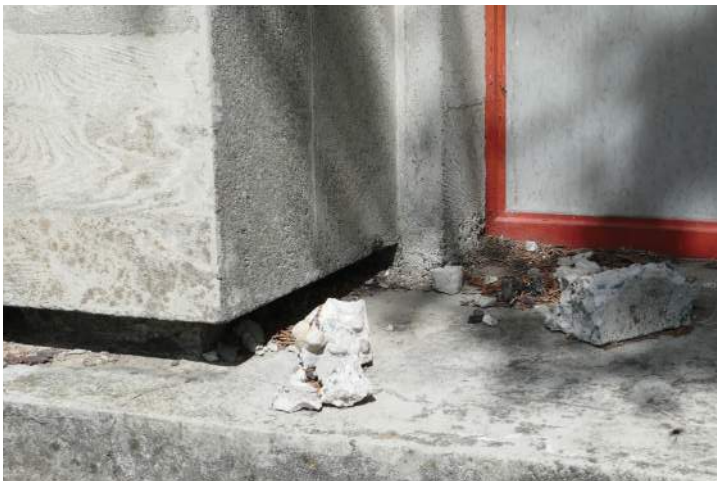
Failed concrete at one of the ground level window bays on the west elevation. Image by Richaven Architecture and Preservation. 220620 CoT CAS EL-W P1000660.JPG

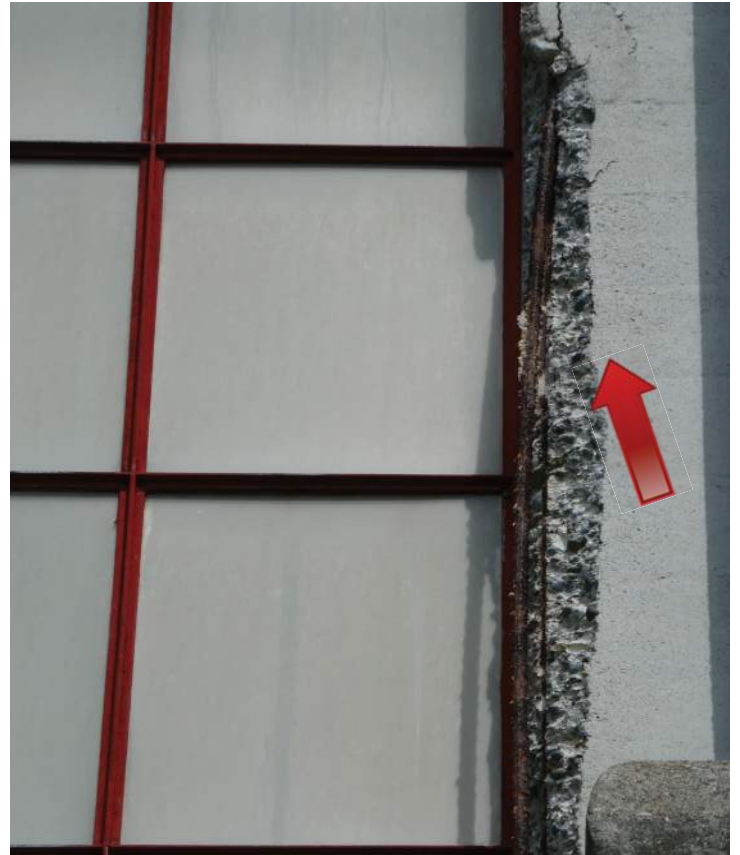
Severe spalling and separation from the substrate around a window on the west elevation. Image by Richaven Architecture and Preservation. 220620 CoT CAS EL-W P1000647.JPG

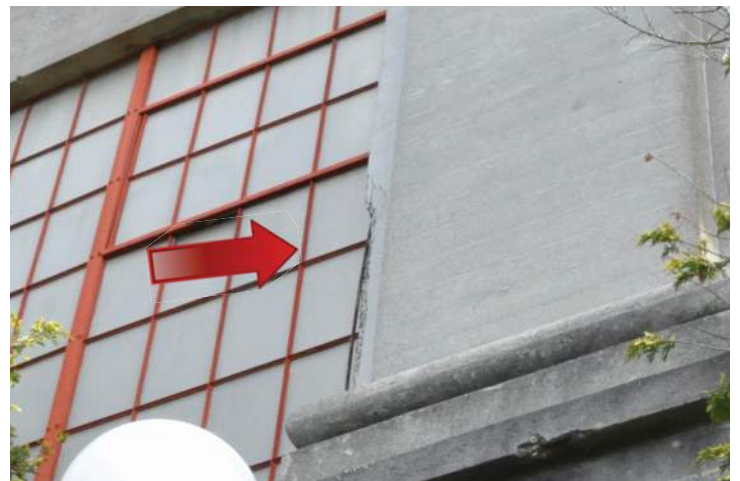
Severe separation from the substrate on the left edge of a pilaster on the west elevation. Image by Richaven Architecture and Preservation. 200224 CoT CAS EL-W DSC\_0036.JPG

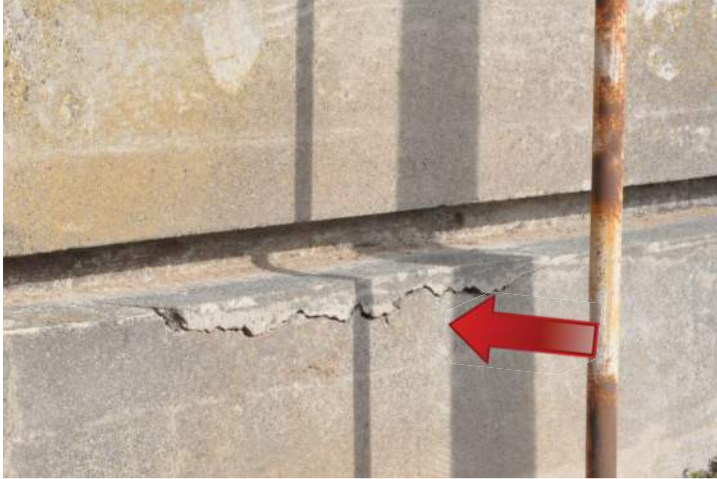
Cracks on the foundation, on the east corner of the south elevation. Image by Richaven Architecture and Preservation. 200224 CoT CAS EL-S DSC\_0004.JPG

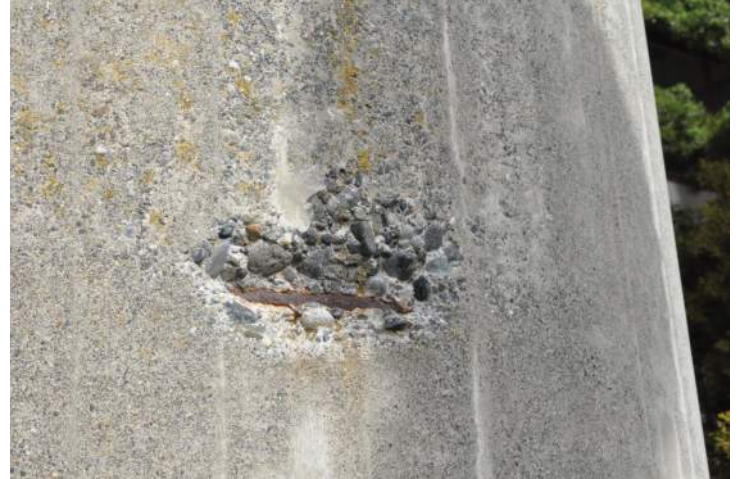
Reinforcing steel and aggregates being exposed on a wall corner on the west elevation. Spalling is present in all elevations on the building. Image by Richaven Architecture and Preservation. 200224 CoT CAS EL-S DSC\_0013.JPG

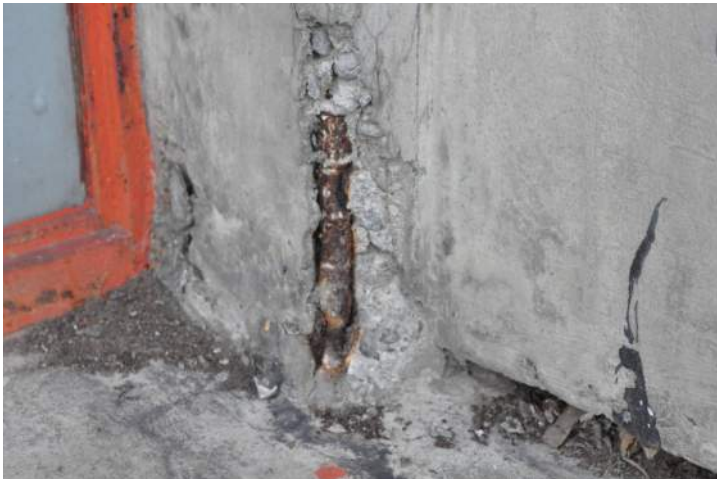
**Reinforcing Steel Components:** On all elevations of the building, some corrosion is visible where reinforcing steel components are exposed.

Exposed reinforcing steel with corrosion. Image by Richaven Architecture and Preservation. 200224 CoT CAS EL-N DSC\_0174.JPG

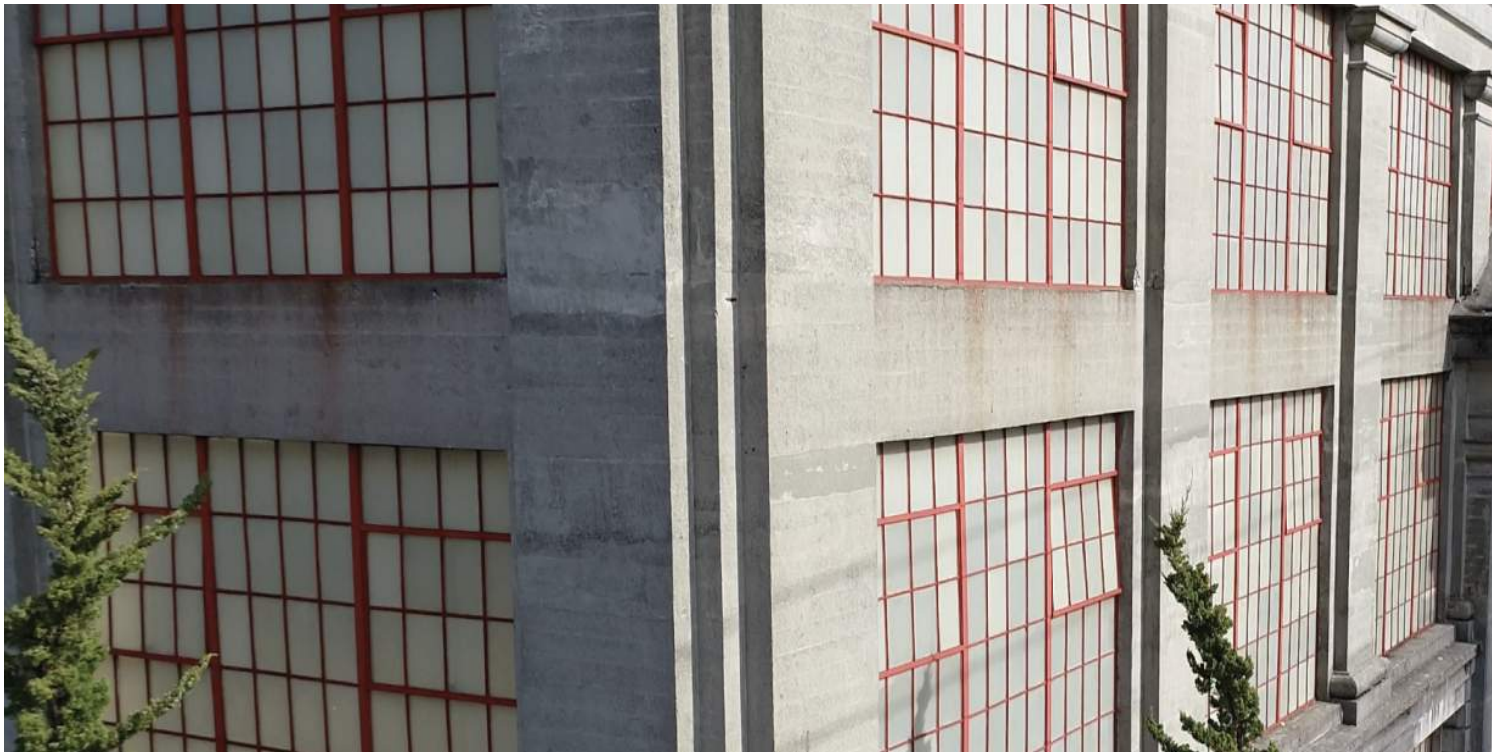
Bleeding marks of rust and paint have stained the concrete surfaces on all elevations of the building. 200224 CoT CAS EL-S-W  
200224 CoT CAS EL-S-W DJI\_00281.PNG

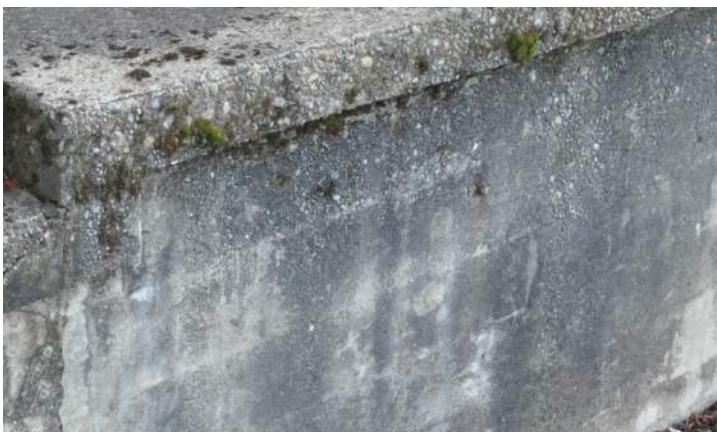
Organic soiling (algae and plants) and atmospheric soiling were observed on concrete at the West elevation of the building. Image by Richaven Architecture and Preservation. 200224 CoT CAS EL-W DSC\_0047.JPG

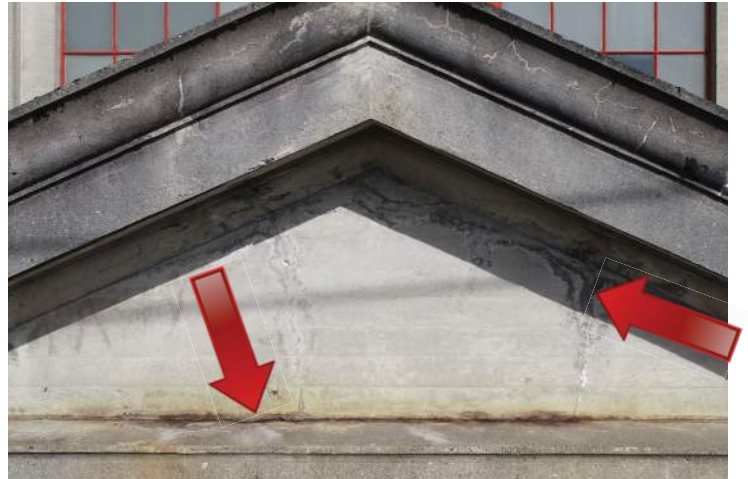
The pediment above the main entrance on the south elevation shows the build-up of atmospheric soiling that has adhered to the concrete and visible stains due to corrosion of the reinforcing steel. Efflorescence is also observed. Image by Richaven Architecture and Preservation. 200224 CoT CAS EL-S DJI\_0023.JPG

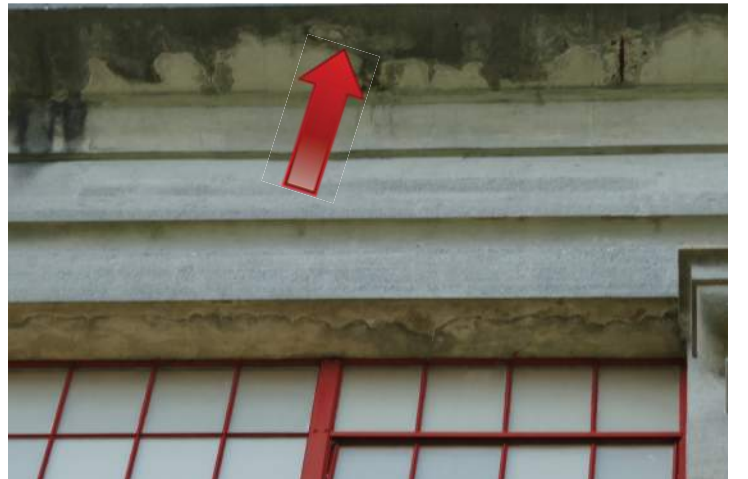
Build-up of airborne pollutants that have adhered and stained the concrete under the cornice on the south elevation. Efflorescence is also observed. Image by Richaven Architecture and Preservation. 220620 CoT CAS EL-W P1000666.JPG

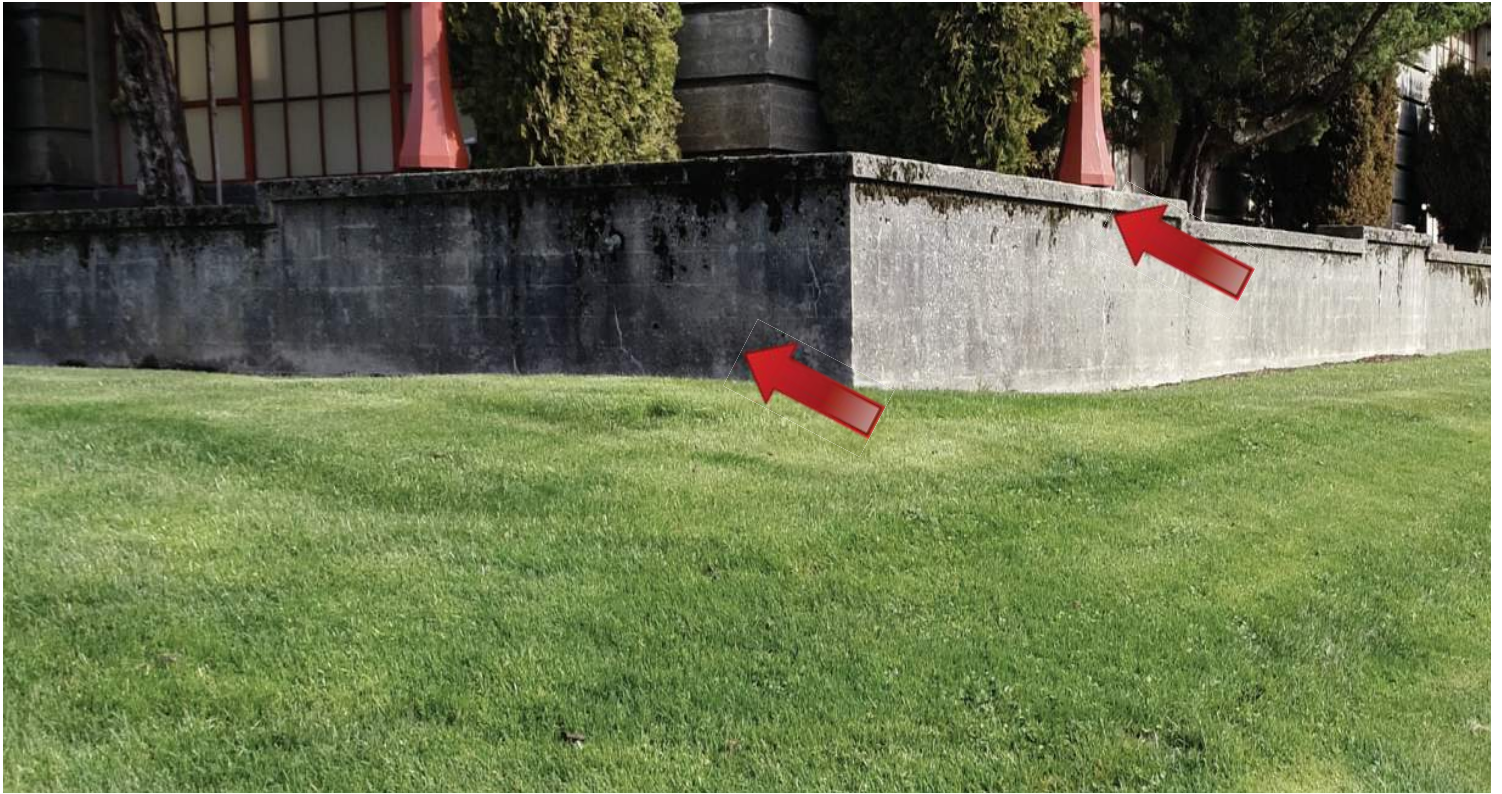
A substantial amount of organic soiling (algae) and atmospheric soiling was observed on walls on the west and south elevations. Image by Richaven Architecture and Preservation. 200224 CoT CAS EL-S-W 200224 CoT CAS EL-S-W DJI\_0028.PNG

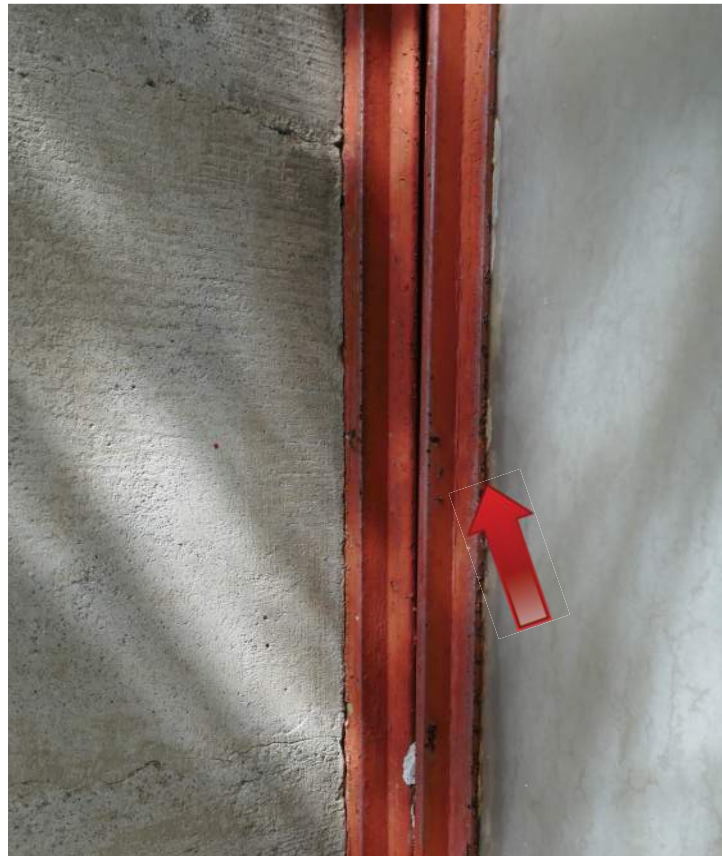
Detail of the cast-in-place steel window frame exhibits delamination, corrosion, and missing glazing compound. Image by Richaven Architecture and Preservation. 220620 CoT CAS EL-W P1000664.JPG

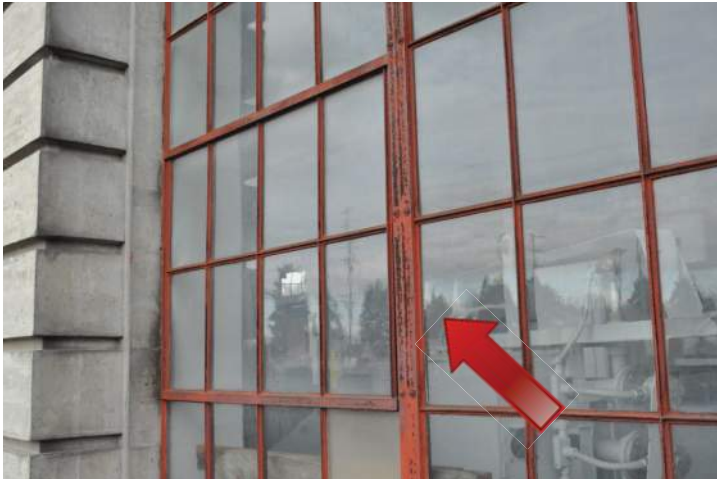
Steel with signs of corrosion. Image by Richaven Architecture and Preservation. 200224 CoT CAS EL-N DSC\_0175.JPG

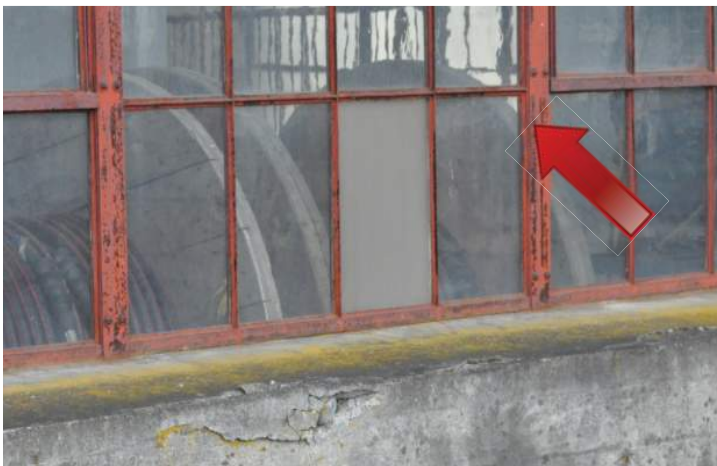
Mullions and muntins on all elevations exhibit corrosion and coating failure. Image by Otak. 200224 CoT CAS EL-N DSC\_0184.JPG

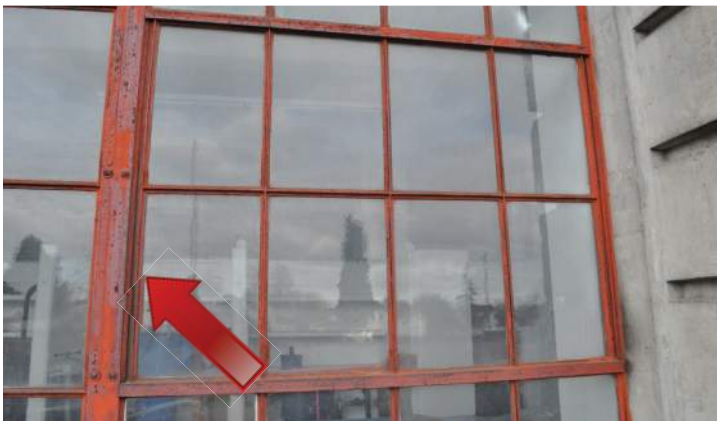
Operable sash-center-pivot exhibits corrosion and coating failure. Image by Richaven Architecture and Preservation. 200224 CoT CAS EL-N DSC\_0176.JPG

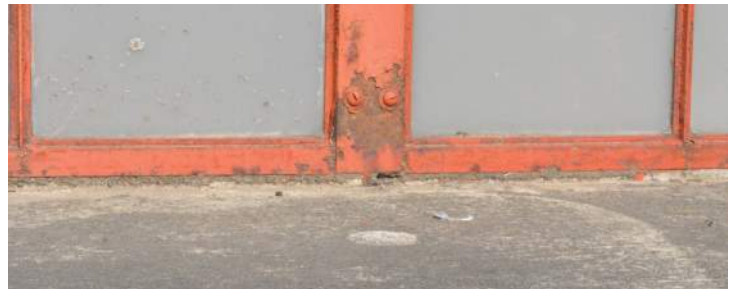
Most of the steel window frames on all elevations exhibit corrosion. Image by Richaven Architecture and Preservation. 200224 CoT CAS EL-W DSC\_0020.JPG

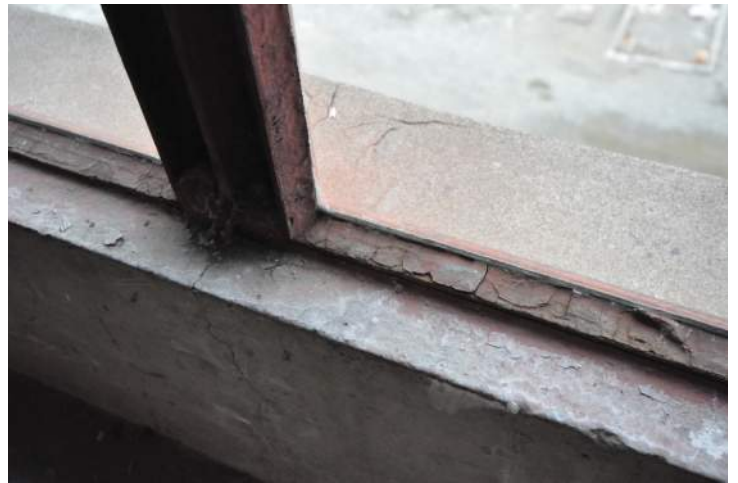
The cast-in-place steel windows exhibit extensive corrosion around the frame and loss of glazing compound. Image by Otak. 200224 CoT CAS EL-INT DSC\_0092.JPG

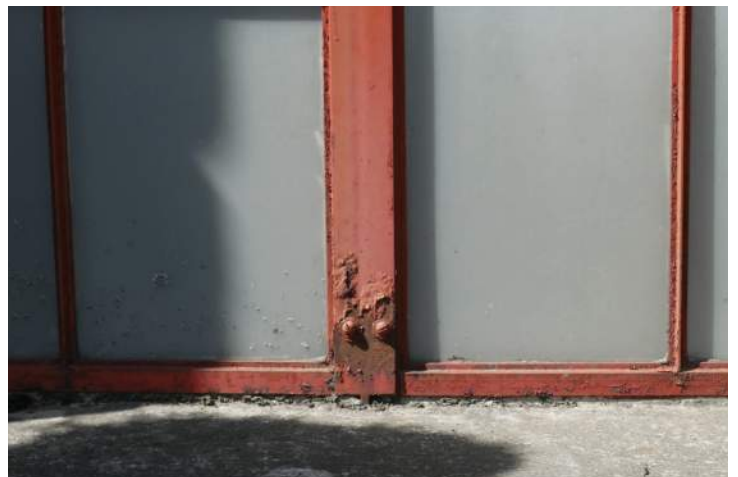
Visible corrosion around the fasteners of a window on the west elevation. Image by Richaven Architecture and Preservation. CoT CAS EL-W P1000654

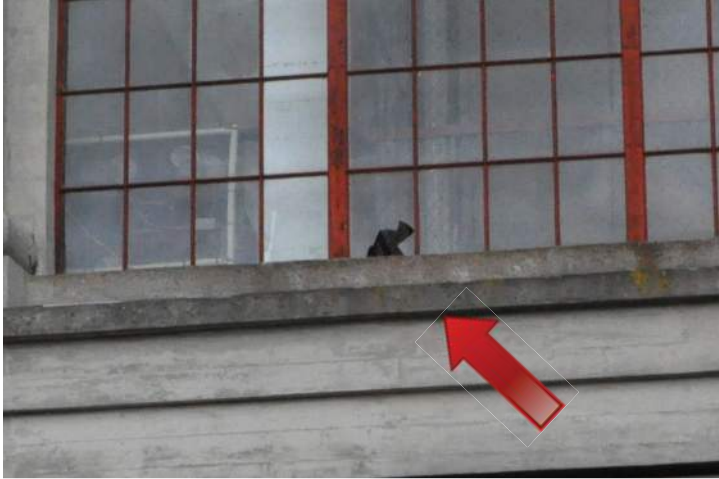
Broken glass pane on window bay above rolling gate on the north elevation. Image by Richaven Architecture and Preservation 200224 CoT CAS EL-N DSC\_0189.JPG

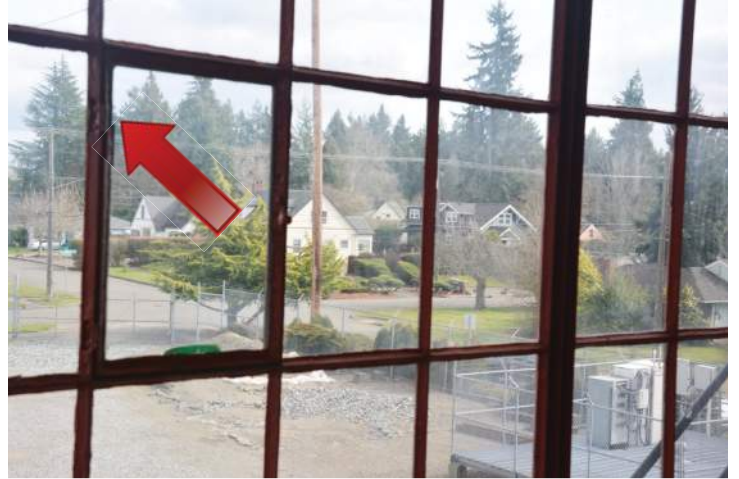
Badly corroded steel window frames and loss of glazing compound. Image by Otak. 200224 CoT CAS EL-INT DSC\_10099.jpg

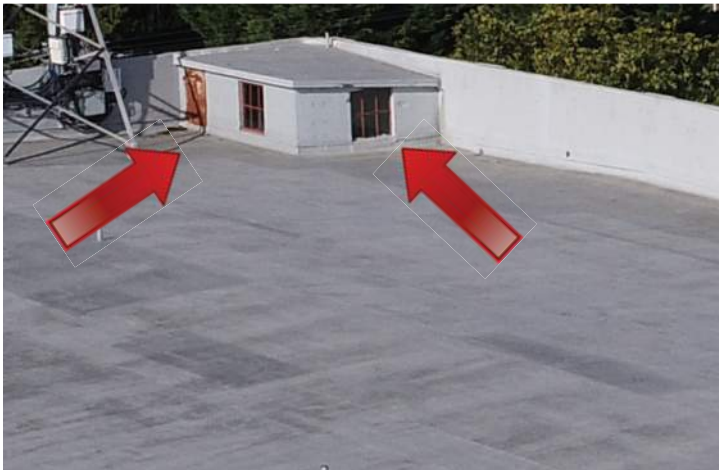
The door for roof access is badly corroded, and windows are starting to deteriorate. 200224 CoT CAS EL-S DJI\_0037

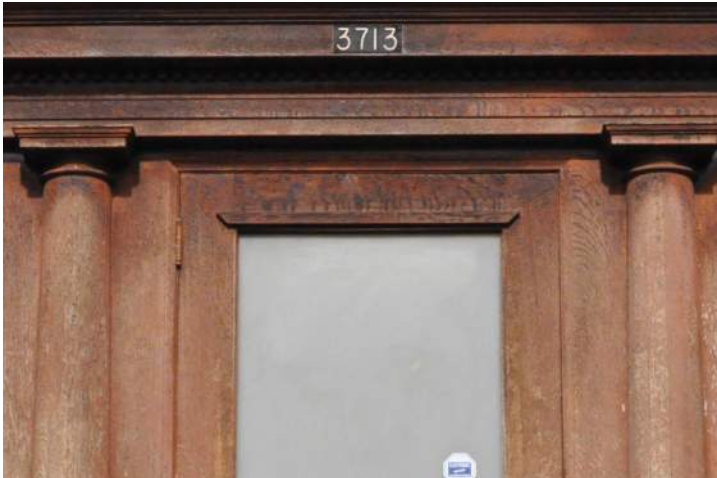
The wood in the primary entrance exhibits intensive UV radiation damage. The varnish finish in the wood shows fading and discoloration. Some areas are severely rotted, and others have atmospheric soiling.

Door frame with a significant amount of fading and discoloration. Image by Richaven Architecture and Preservation. 200224 CoT CAS EL-S DSC\_0011.JPG

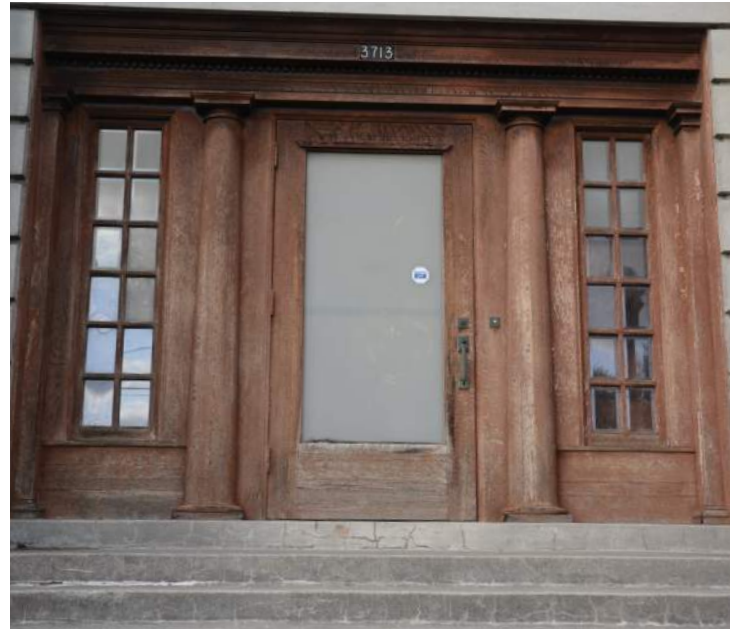
Wood columns with a significant amount of discoloration. Image by Richaven Architecture and Preservation. 200224 CoT CAS EL-S DSC\_1063.JPG

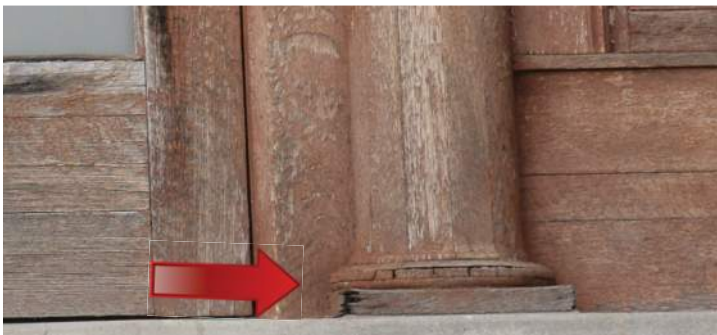
Some areas in the wood are severely rotted. Image by Richaven Architecture and Preservation. 200224 CoT CAS EL-S DSC\_1063.JPG

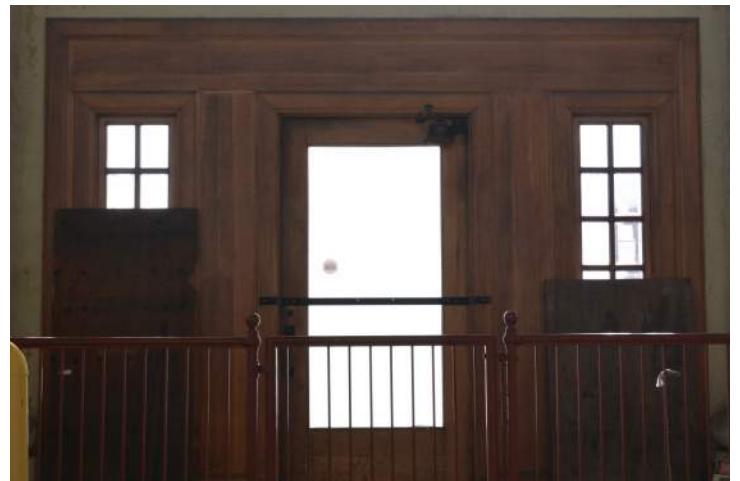
Interior wood frame with discoloration. Image by Otak. 200224 CoT CAS INT DSC\_0975.jpg

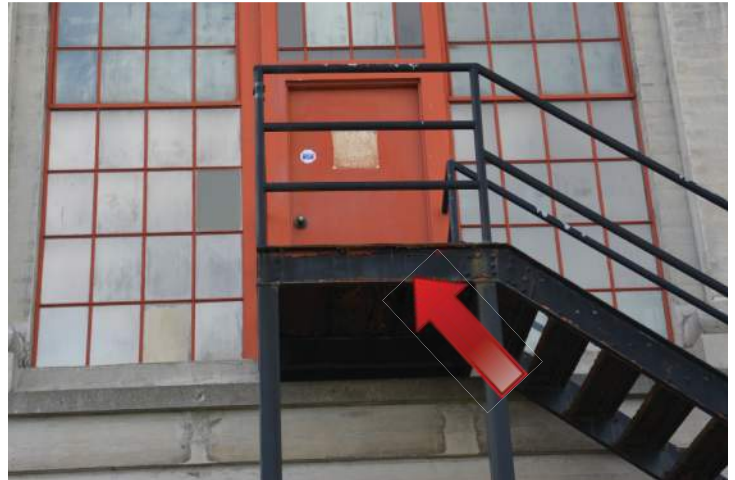
In general, corrosion was observed on all exterior metal structures. The paint on the surfaces is peeling off, accelerating the rate at which the metal corrodes.

Door and stairwell on the second floor of the east elevation. Image by Otak. 200224 CoT CAS EL-E DSC\_1039.JPG

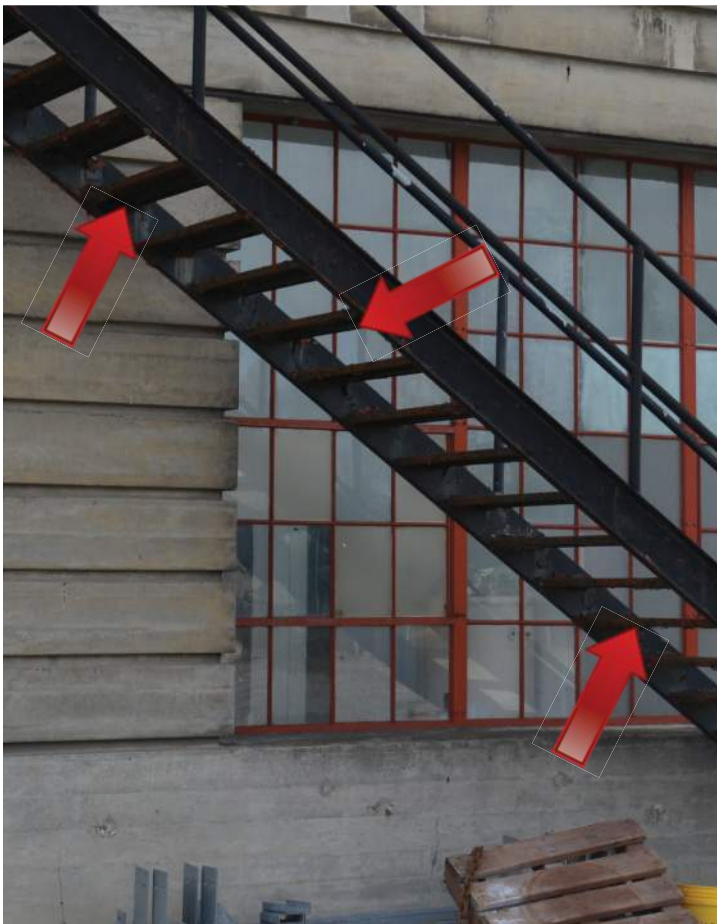
Richaven observed a substantial amount of corrosion on the steps and railings of the stairwell structure. Image by Otak. 200224 CoT CAS EL-E DSC\_1045.JPG

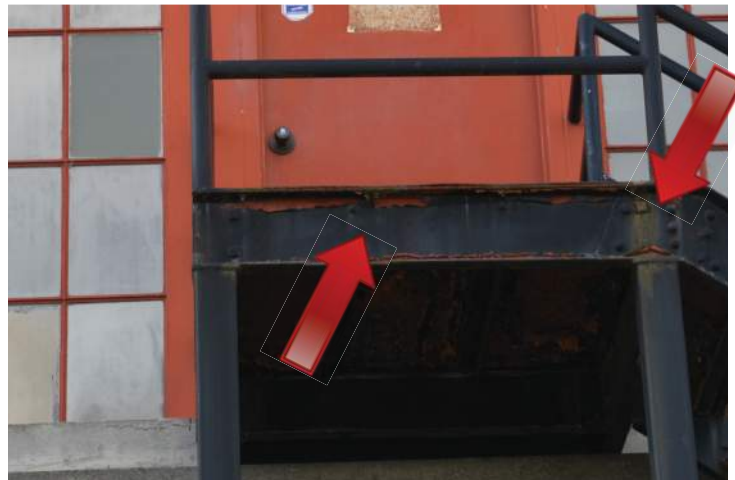
There is visible paint failure on the structure and signs of corrosion. Image by Otak. 200224 CoT CAS EL-E DSC\_1039.JPG

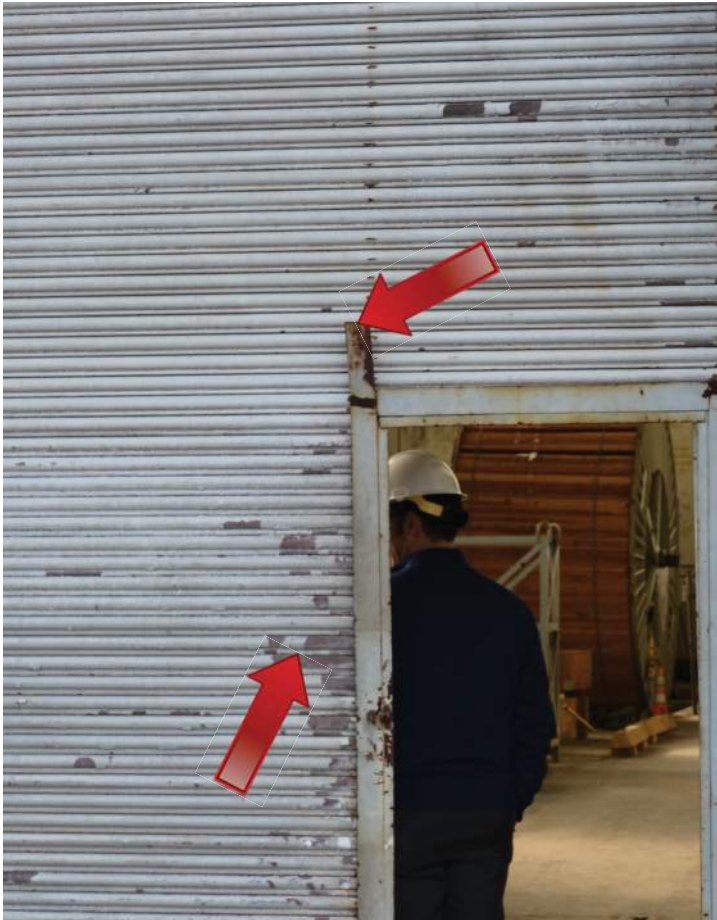
Richaven observed paint failure on the surface of the roll-up door on the north elevation, and corrosion around the steel frame door insert. Image by Otak. 200224 CoT CAS EL-E DSC\_1056.JPG

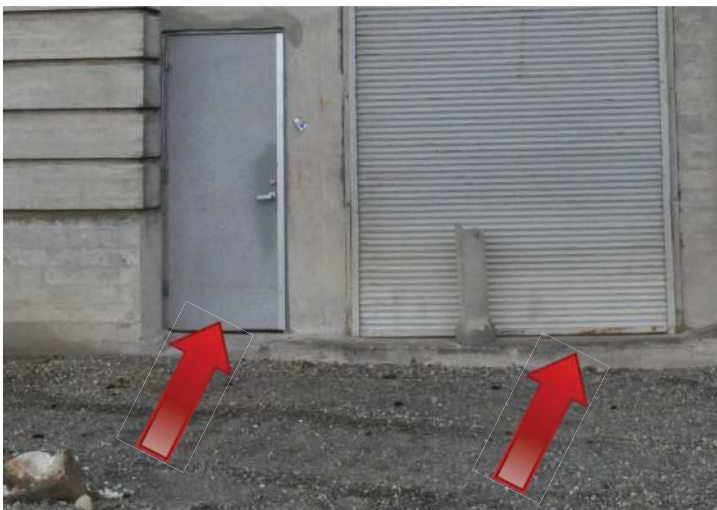
Doors on the north elevation are beginning to deteriorate. Image by Richaven Architecture and Preservation. 200224 CoT CAS EL-S DSC\_0189.JPG

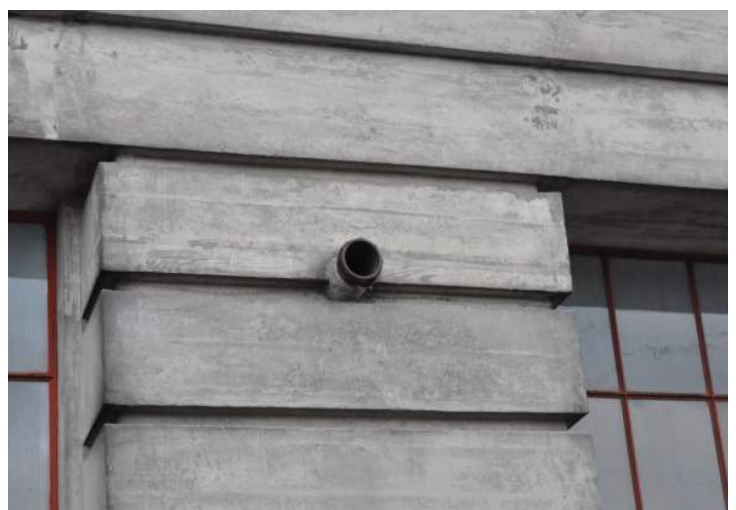
The tube embedded in the concrete appears not to be adequately sealed. It will allow water infiltration into the wall. 200224 CoT CAS EL-N DSC\_0183.JPG

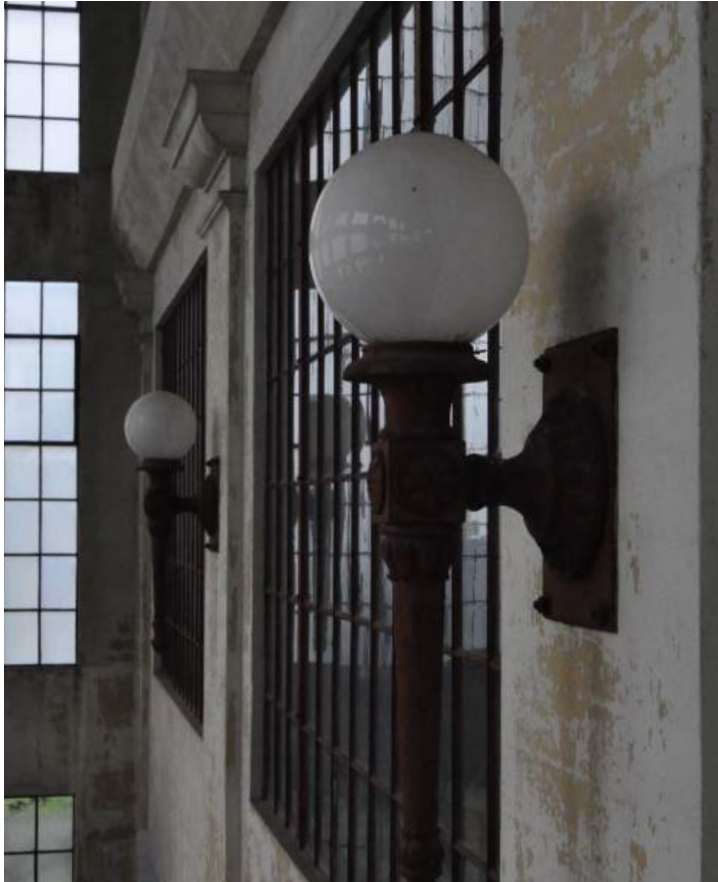
Visible paint failure in large areas in interior walls. Image by Otak. 200224 CoT CAS EL-INT DSC\_0083.JPG

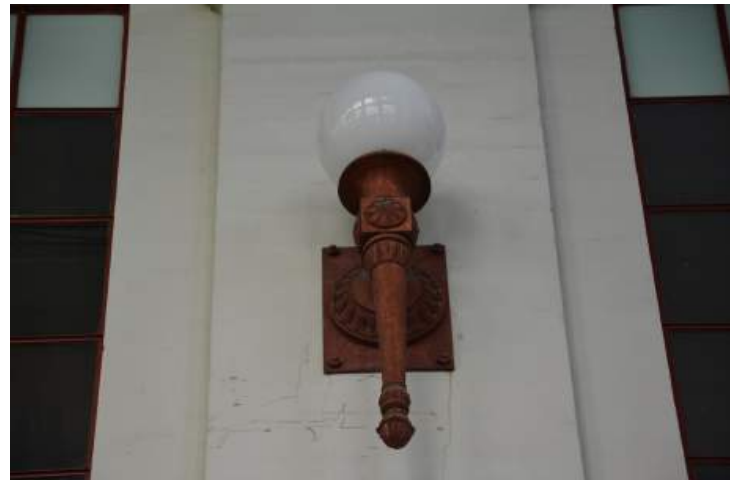
Cast iron decorative light fixture exhibiting corrosion. Image by Otak. 200224 CoT CAS INT DSC\_0970.JPG

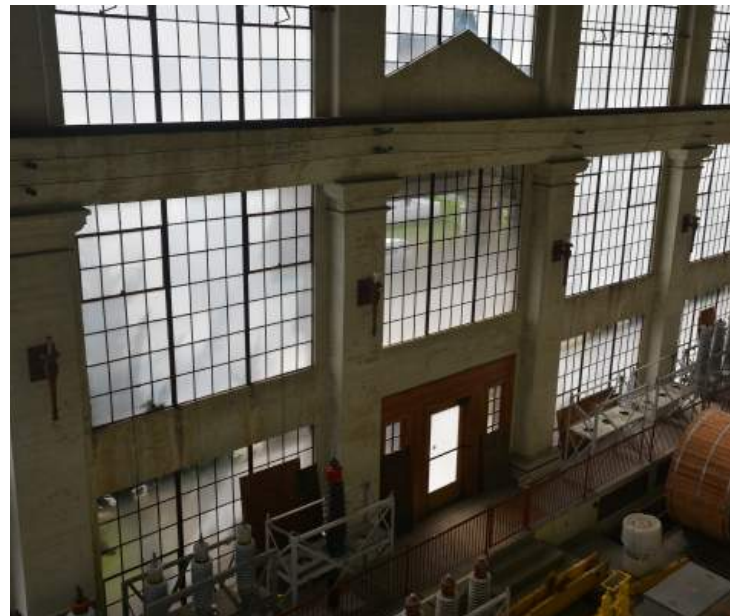
Glass globes are missing on the light fixtures above the main entrance. Image by Otak. 200224 CoT CAS EL-INT DSC\_0999.JPG
