# Preliminary Evaluation of Building Conditions

## Cushman & Adams Street Substations

January 14, 2025

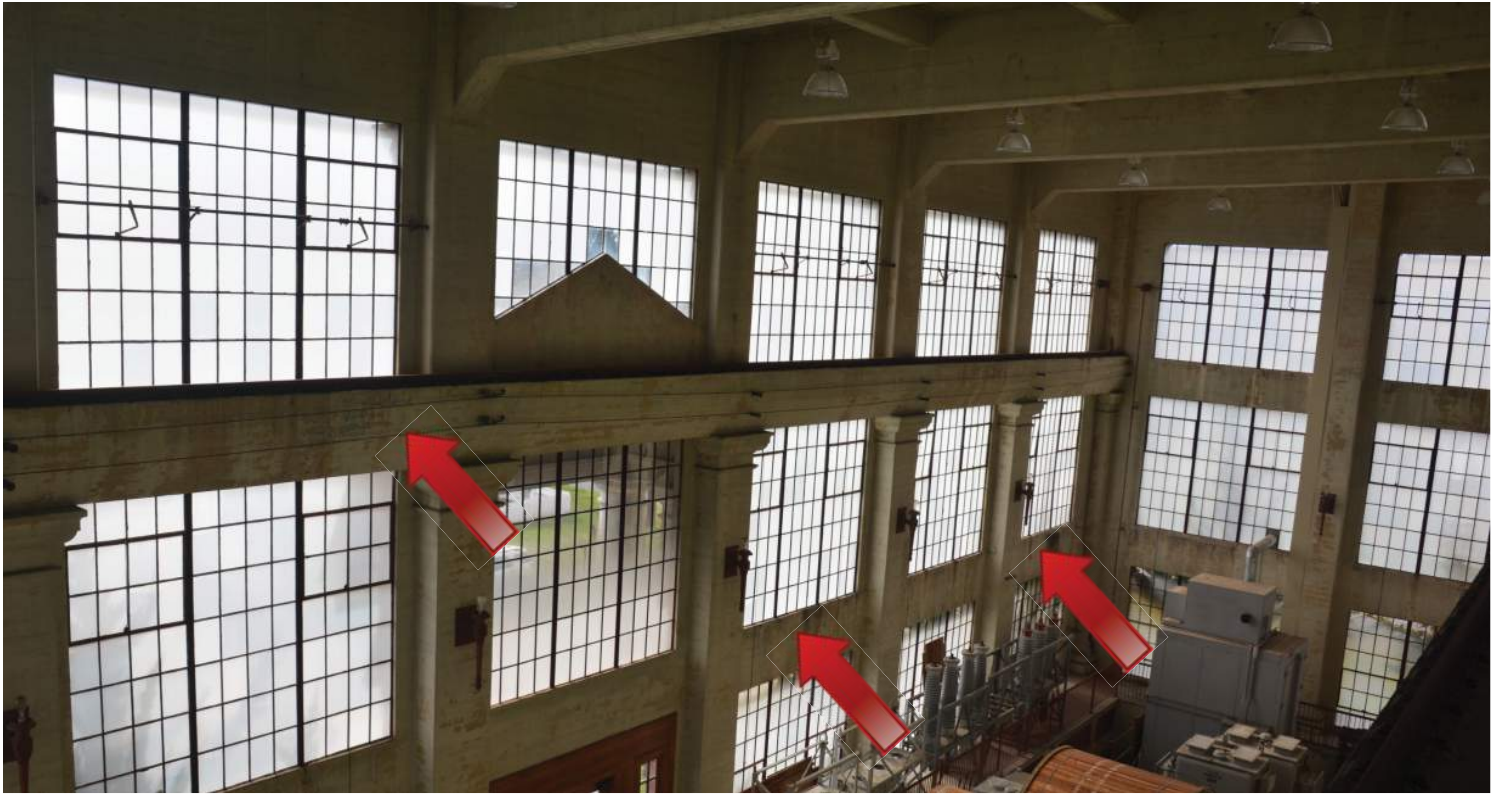
The dark areas under the windows appear to be organic growth (algae), indicating water infiltration. There is also a substantial amount of paint failure on the walls. Image by Otak. 200224 CoT CAS EL-INT DSC\_0998.jpg

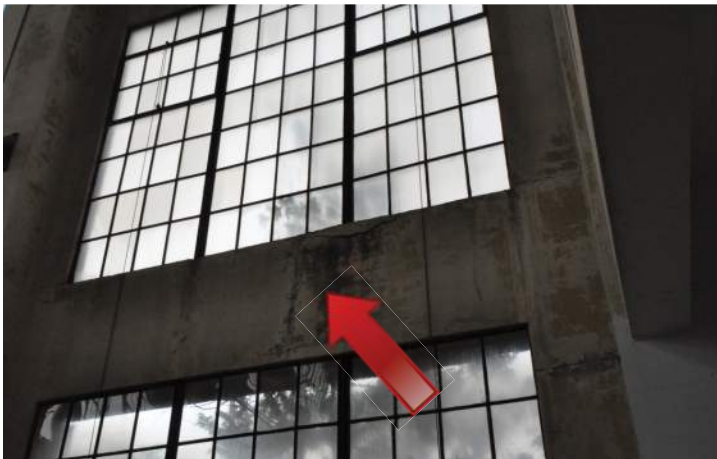
Soiling under the window appears to be mold and signs of water infiltration. Image by Otak. 200224 CoT CAS EL-INT DSC\_0070.JPG

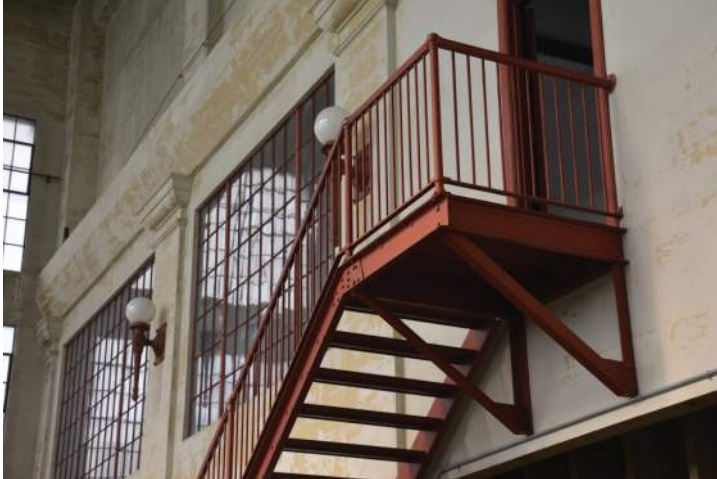
The stairwell railings are in fair condition. No corrosion was observed. Image by Otak. 200224 CoT CAS INT DSC\_0977.JPG

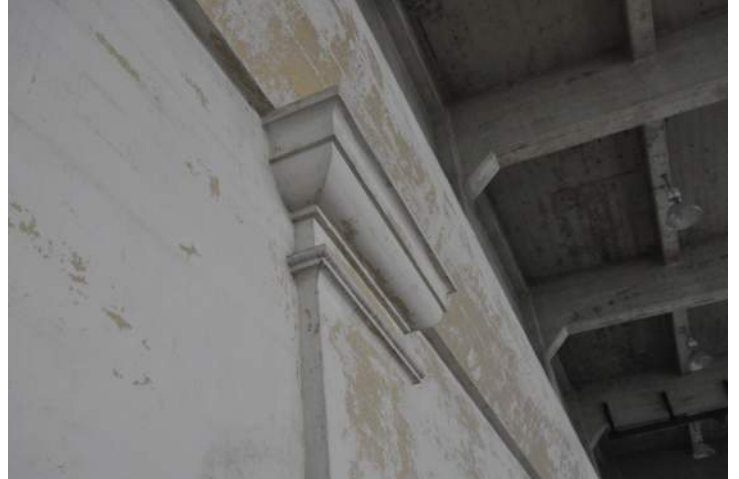
Visible paint failure, flaking, and peeling. Image by Otak. 200224 CoT CAS EL-INT DSC\_0082.JPG.

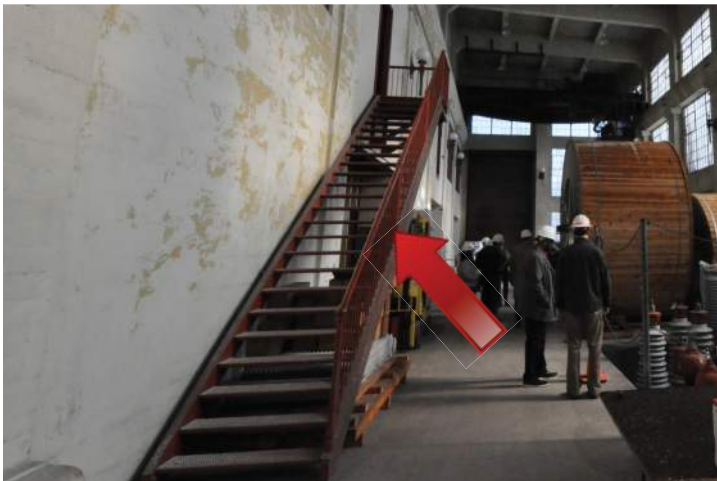
Dust / dirt soiling was observed on the stairwell. Image by Otak. 200224 CoT CAS EL-INT DSC\_0065.JPG

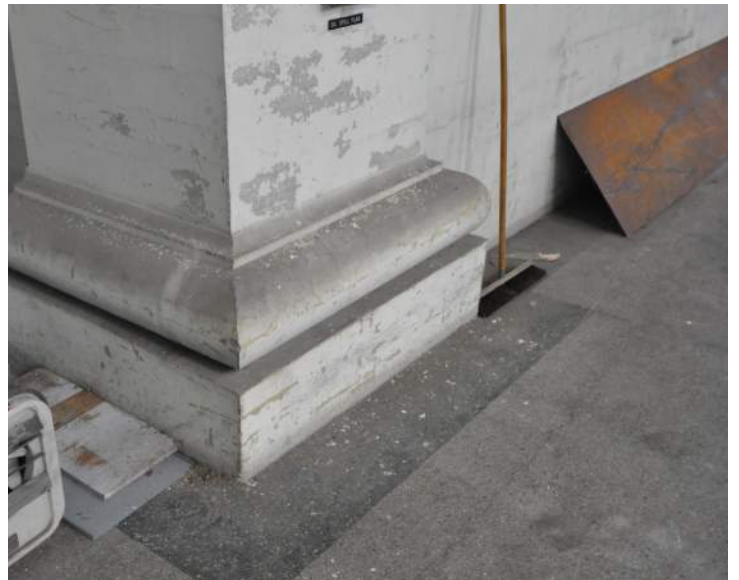
Paint failure and dust / dirt soiling on the base of the pilaster. Image by Otak. 200224 CoT CAS EL-INT DSC\_0078.JPG

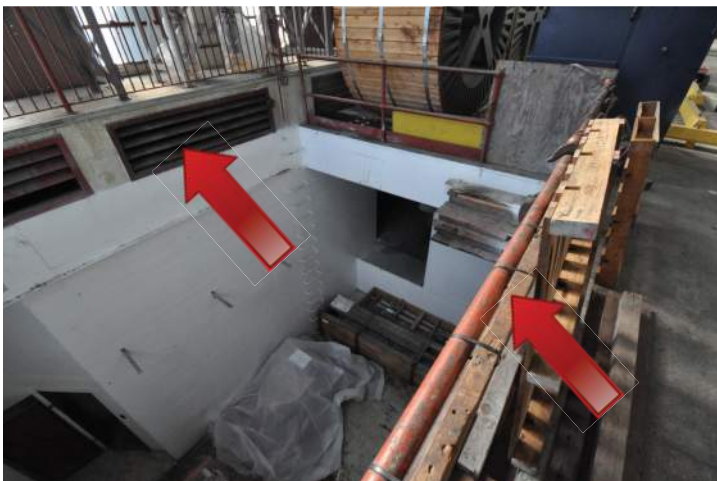
Visible soiling, corrosion, and paint failure over the vents and railings. Image by Otak. 200224 CoT CAS EL-INT DSC\_0051.JPG

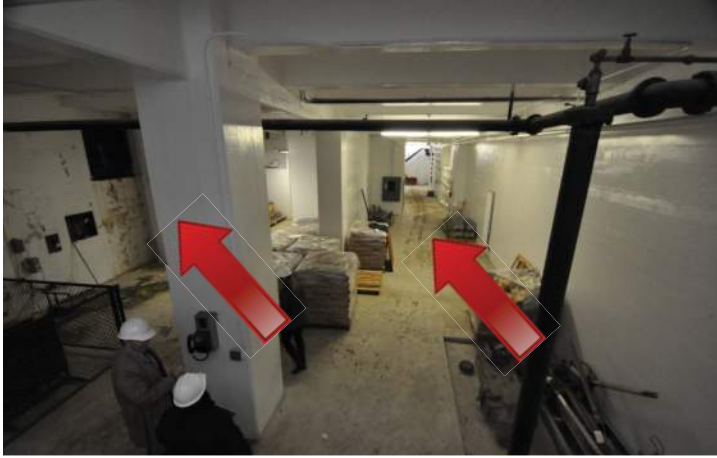
Paint failure on walls and soiling on the floor in the basement. Image by Otak. 200224 CoT CAS EL-INT DSC\_0124.JPG

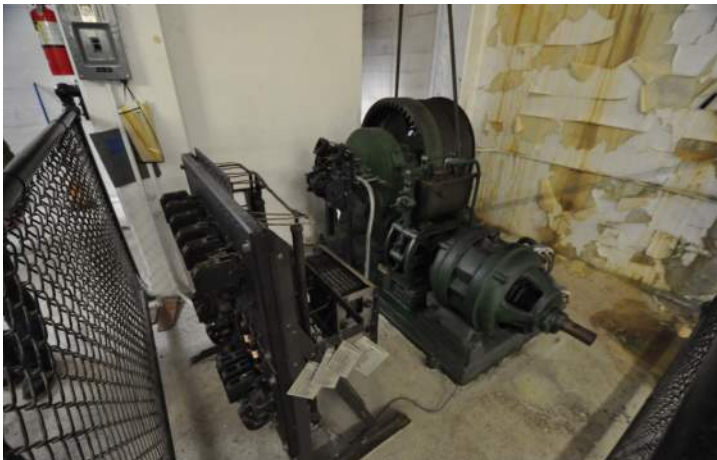
Paint failure, peeling, and soiling on walls. Image by Otak. 200224 CoT CAS EL-INT DSC\_0125.JPG

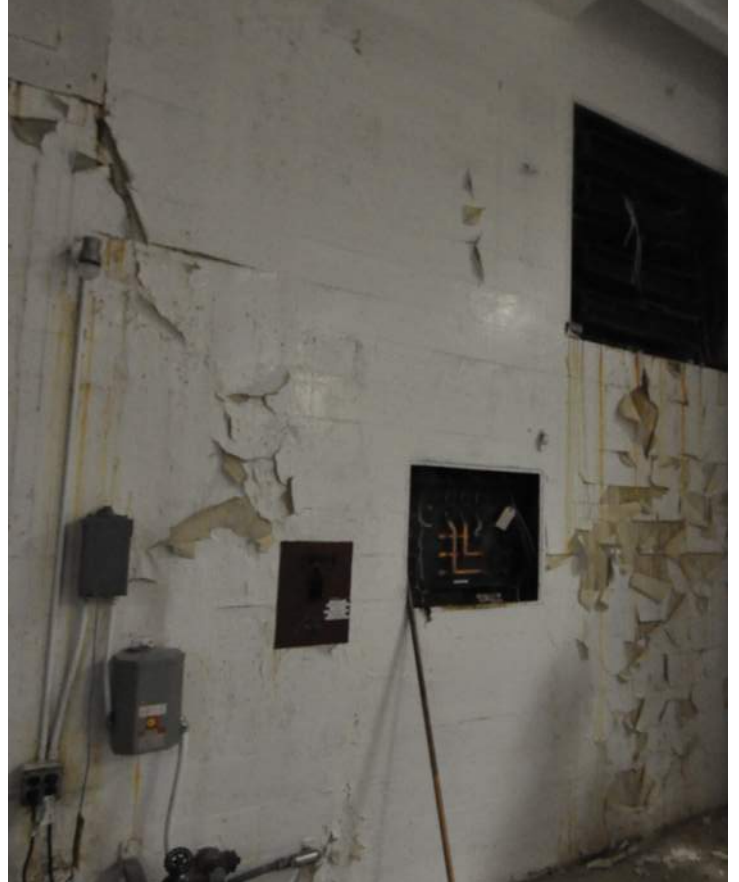
The location above shows concrete wall with the coating failing and peeling. Image by Otak. 200224 CoT CAS EL-INT DSC\_0126.JPG.

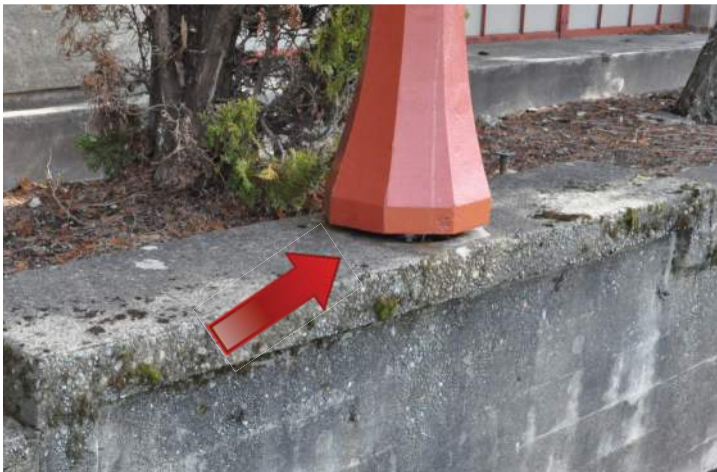
200224 CoT CAS EL-W DSC\_0047.JPG

In general, the ornamental lamp posts are in fair condition. Historic photos show rusted white painted lamp posts. However, it appears that the lamp posts have been recently painted.

There is a gap under some lamp posts. Image by Richaven Architecture and Preservation.

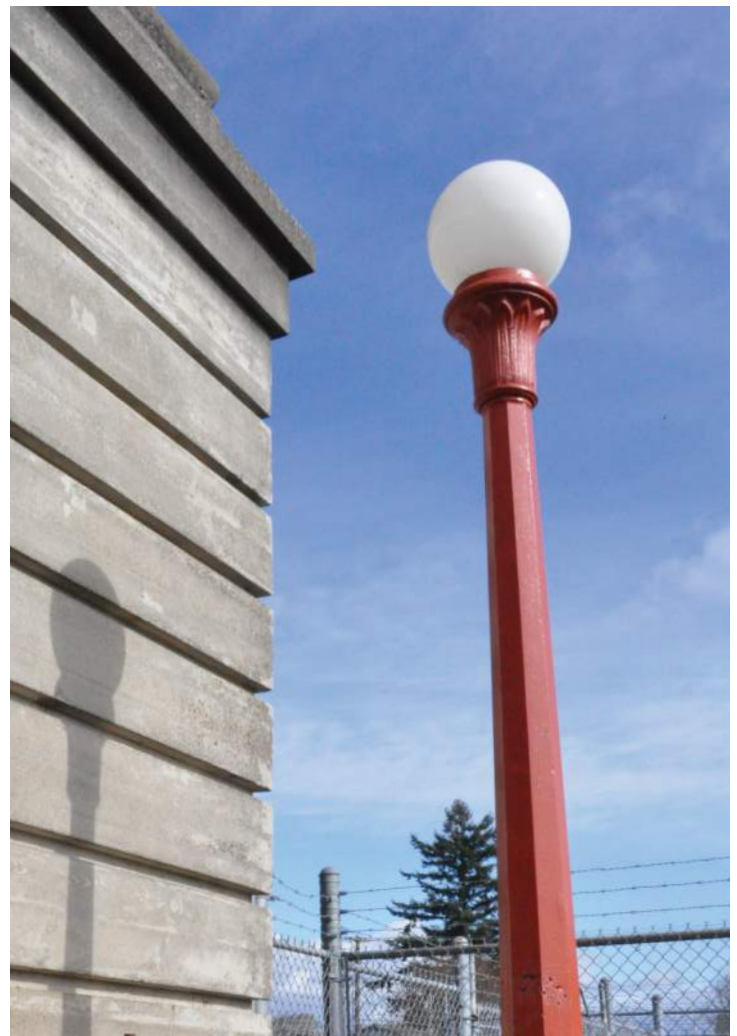
The lamp globes appear to have been replaced with round plastic globes. Historical photos show that the globes were not round but acorn-shaped. Image by Richaven Architecture and Preservation.

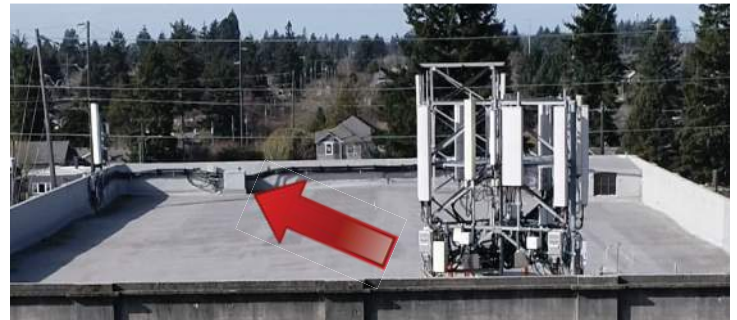
It is unclear how the equipment and cables attached to the parapet are anchored. Image by Richaven Architecture and Preservation, 200224, DJI\_0006.PNG

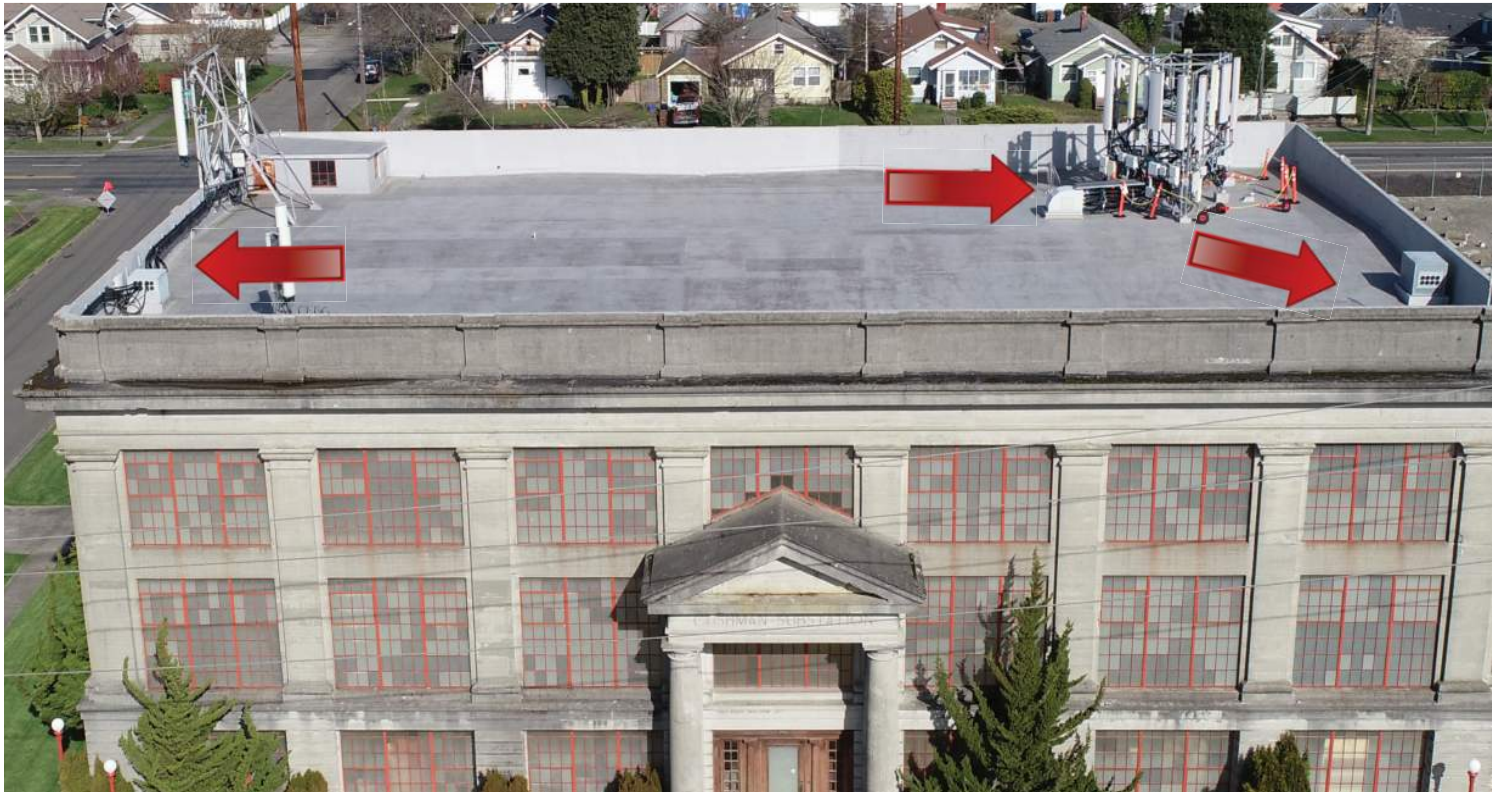
The concrete surface on the roof looks clean. There are multiple enclosures with holes in the roof and it is unclear how well sealed these are. It is unclear how the equipment and cables attached to the parapet are anchored.

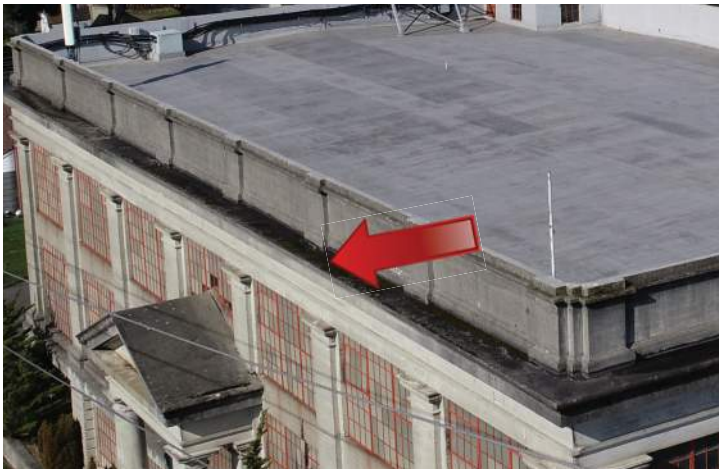
Algae growth on the cornice on the south elevation indicates that water is collecting. Image by Richaven Architecture and Preservation. 200224 CoT CAS EL-S DJI\_0037.JPG

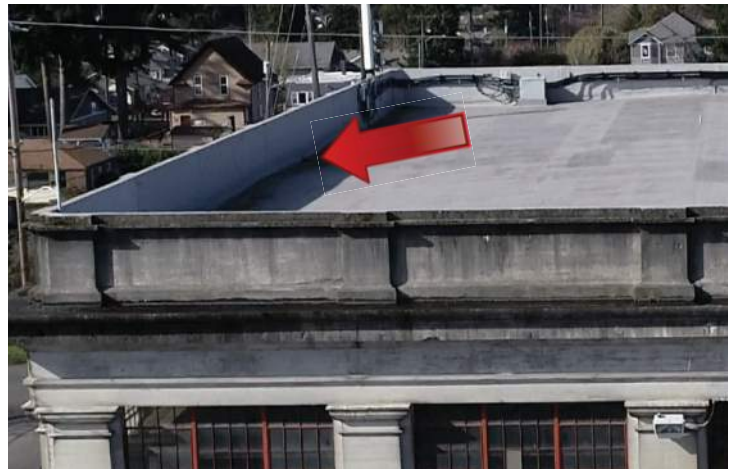
The back of the parapet on the south elevation has algae, indicating that water is collecting. Image by Richaven Architecture and Preservation. 200224 CoT CAS EL-E DJI\_0006.JPG

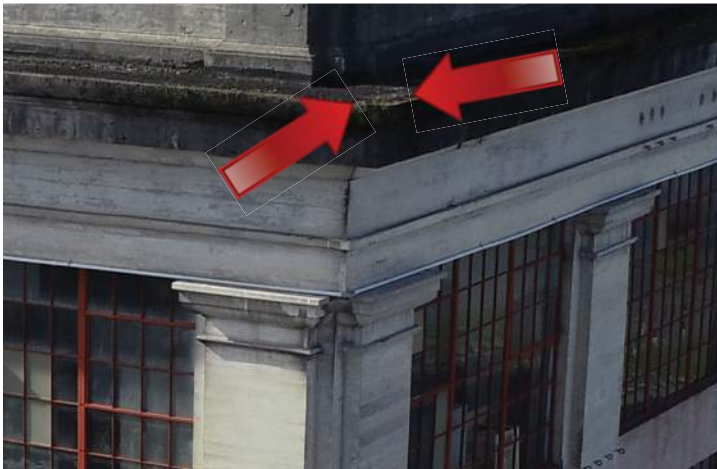
Water proofing on top of cornice, on the east corner of the south elevation appears to be failing. Image by Richaven Architecture and Preservation. 200224 CoT CAS EL-S-W DJI\_00036.jpg

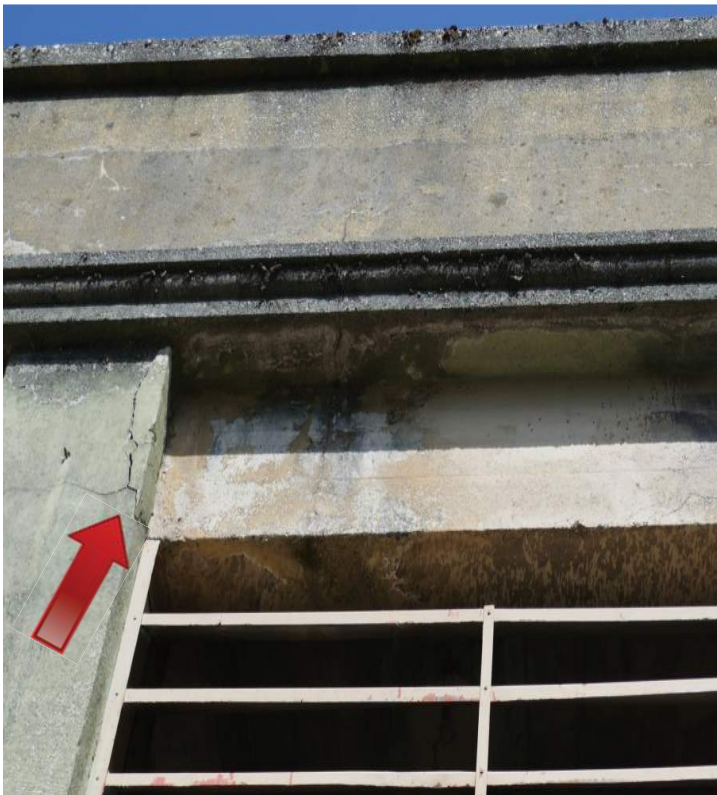
Cracking on the right edge of a pilaster on the east elevation. Image by Richaven Architecture and Preservation. 220620 CoT CAS EL-E P1000684.JPG

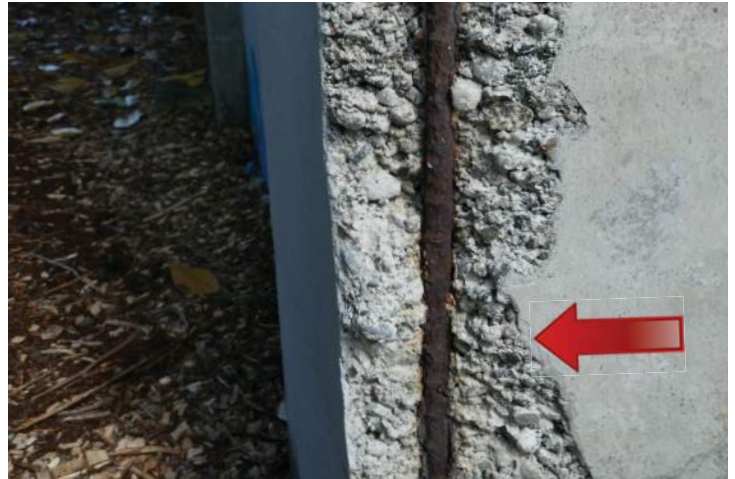
Failed concrete with exposed reinforcing steel on the left corner of a pilaster on the south elevation. Image by Richaven Architecture and Preservation. 220620 CoT CAS EL-S P1000675.JPG

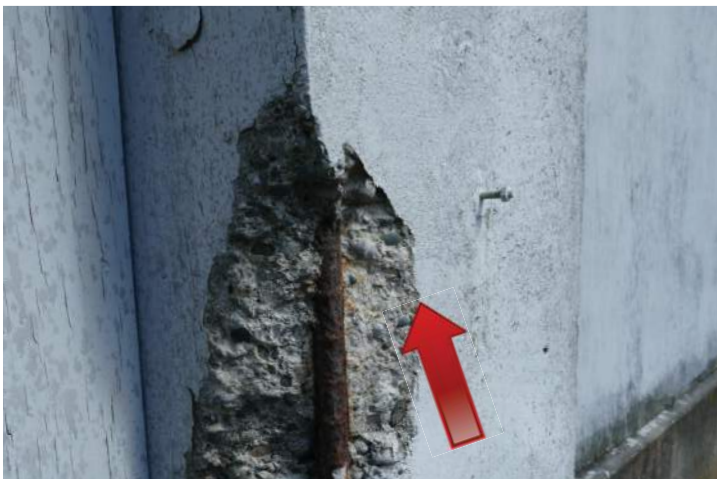
Spalling and exposed reinforcing steel immediately under cracks shown in the photo above. Image by Richaven Architecture and Preservation. 220620 CoT CAS EL-S P1000677.JPG

- Deficiency: Spalled concrete
- Recommendation: Because of visual observations further evaluation is needed to understand the chemical composition and condition of the concrete. Where spalling is present, removing all weak and damaged concrete is recommended. In areas where reinforcing steel is exposed it is recommended to create a space behind the reinforcing steel. The reinforcing steel should be cleaned and inspected to determine whether it should be replaced. If the reinforcement has to be replaced an engineer should be consulted. All exposed reinforcing steel should be thoroughly cleaned of all rust and other contaminants. All reinforcing steel that has been cleaned should be coated with a zinc-rich primer and or epoxy paint coating system. An anchorage systems should be installed. The material placement should be in-kind with matching color, texture, and physical properties of the existing material.

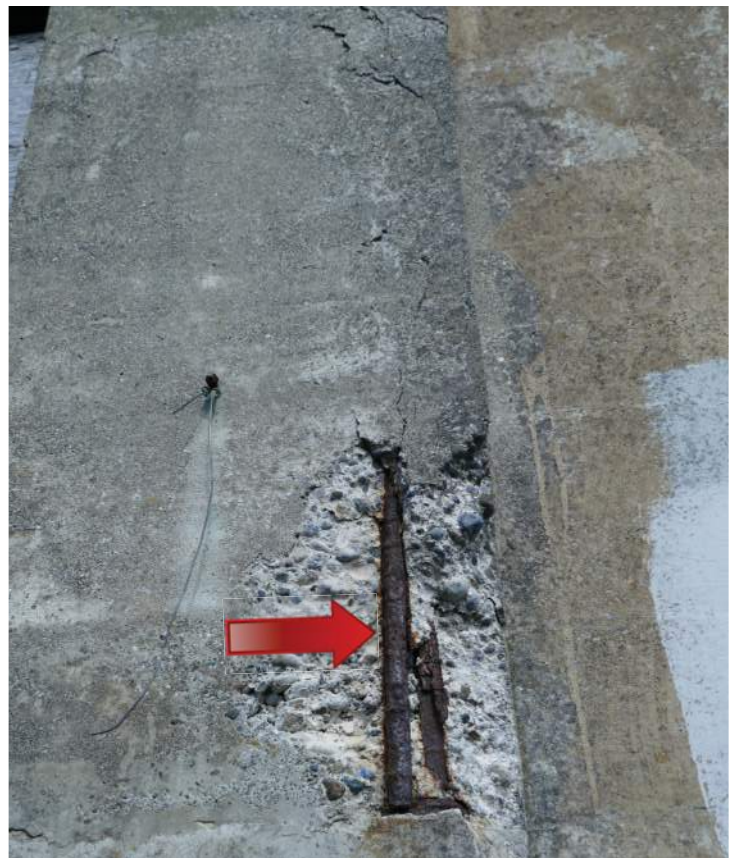
Severe separation from the substrate. Image by Richaven Architecture and Preservation. 220620 CoT CAS EL-W P1000679.JPG

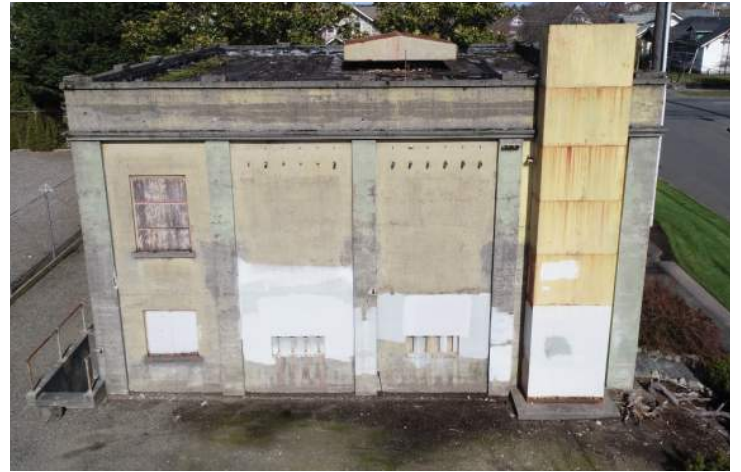
View of south elevation. White paint has been applied to the concrete walls to cover graffiti. Image by Richaven Architecture and Preservation. 200224 CoT CAS EL-S DJI\_0071.JPG

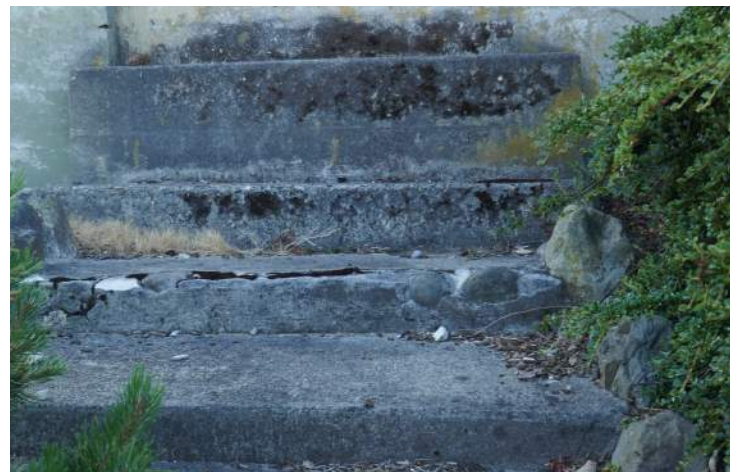
Organic soiling (algae and plants), observed on concrete stairs on the east elevation of the building. Image by Richaven Architecture and Preservation. 220620 CoT CAS EL-E P1000689.JPG

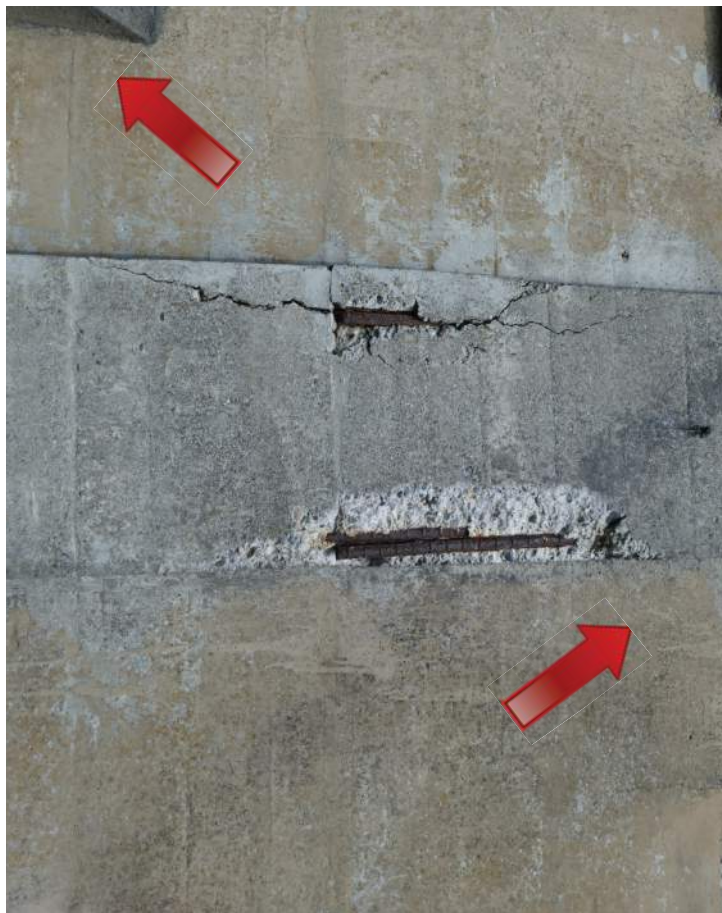
Discoloration of the yellow pigment is visible on all elevations on the building. Image by Richaven Architecture and Preservation. 220620 CoT CAS EL-W P1000681.JPG

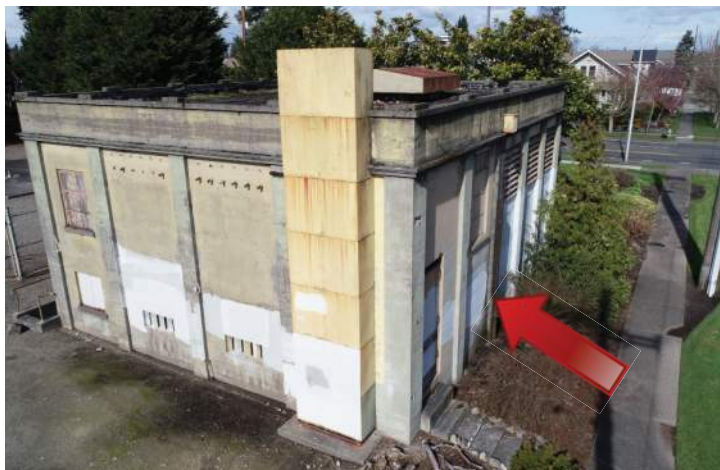
White paint used to cover graffiti. Image by Richaven Architecture and Preservation. 200224 CoT CAS EL-S-E DJI\_0073.JPG

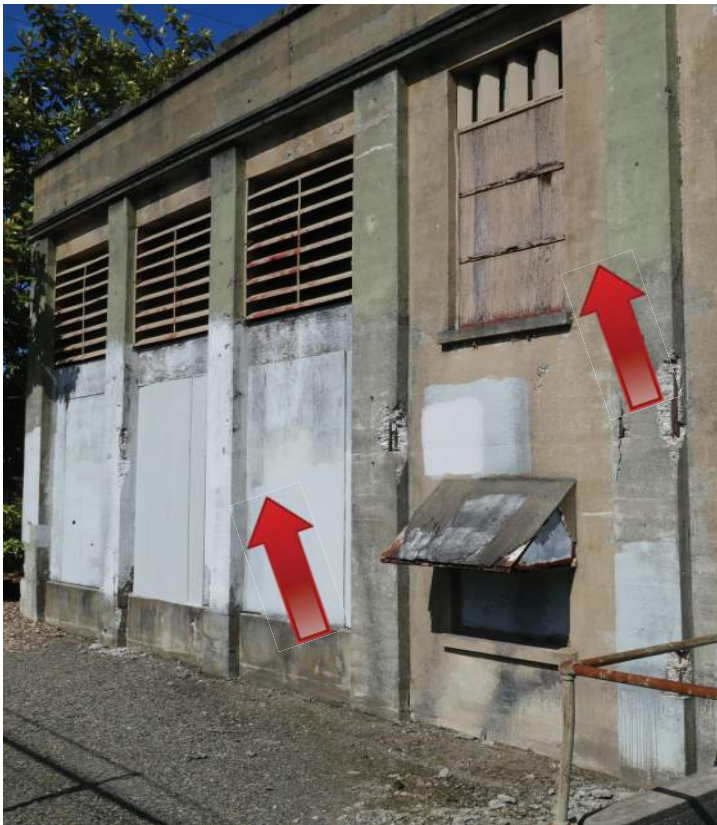
Missing windows and openings for ventilation under the louvers have been covered with plywood boards. Historical photos show single steel-framed nine-light windows with louvered vents above. Image by Richaven Architecture and Preservation. 220620 CoT CAS EL-W P1000685.JPG

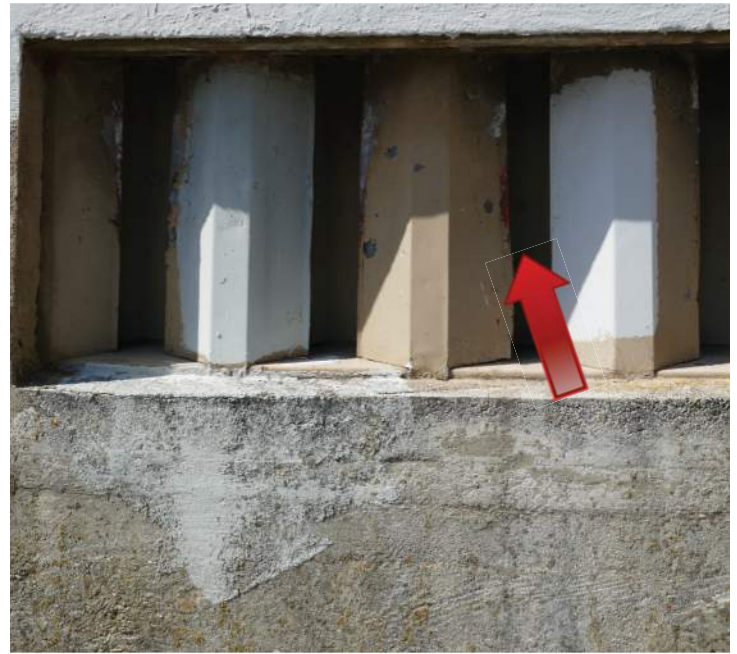
Vent on the south elevation with corrosion on the edges. Areas in white were painted to cover graffiti. Image by Richaven Architecture and Preservation. P000673.JPG.

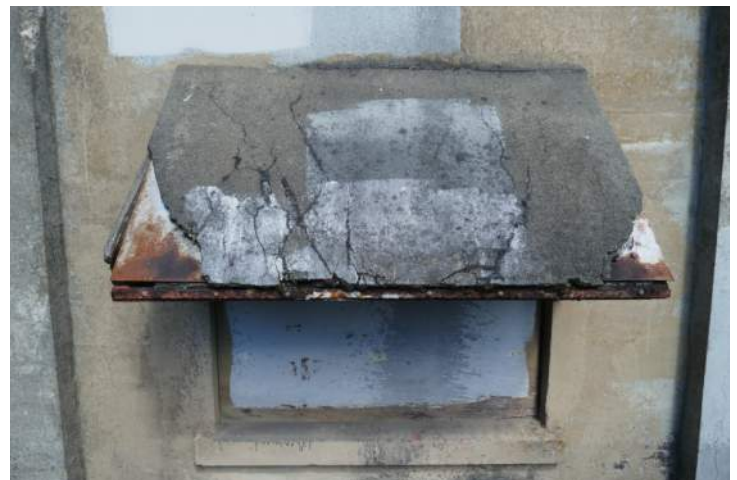
Metal awning on the west elevation is corroded. Layer of asphaltic material attached is 100% failed. Image by Richaven Architecture and Preservation. 220620 CoT CAS EL-W P1000680.JPG

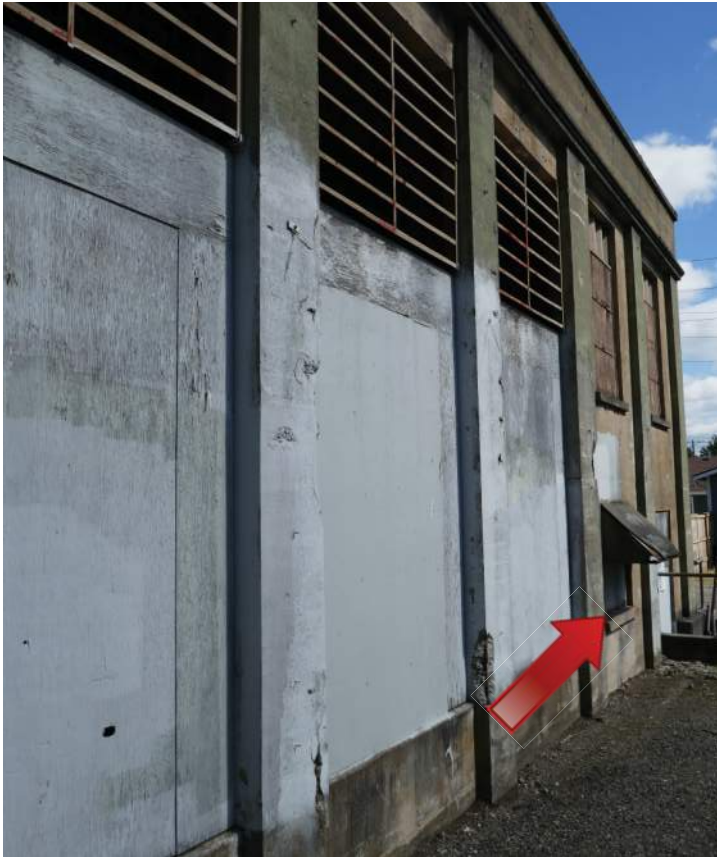
Metal louvers on the west elevation and a missing window covered with plywood boards. Image by Richaven Architecture and Preservation 06/20/22, 220620 CoT CAS EL-W P1000674.JPG

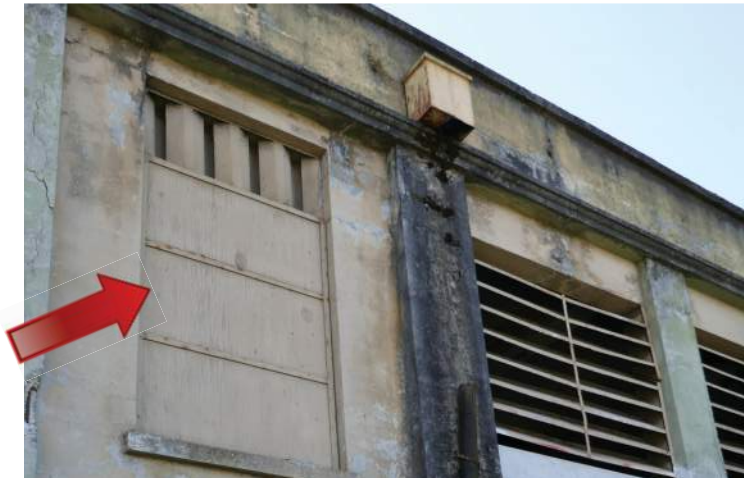
Missing steel windows and vents have been covered with plywood boards. Image by Richaven Architecture and Preservation. 220620 CoT CAS EL-E P1000691.JPG.

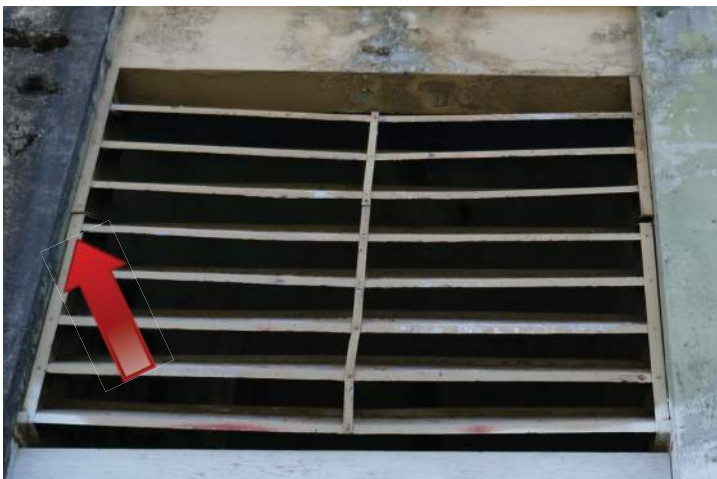
Metal louvers on the east elevation are bent and failing. There are visible gaps between the metal frame. Image by Richaven Architecture and Preservation. 220620 CoT CAS EL-E P1000692.JPG

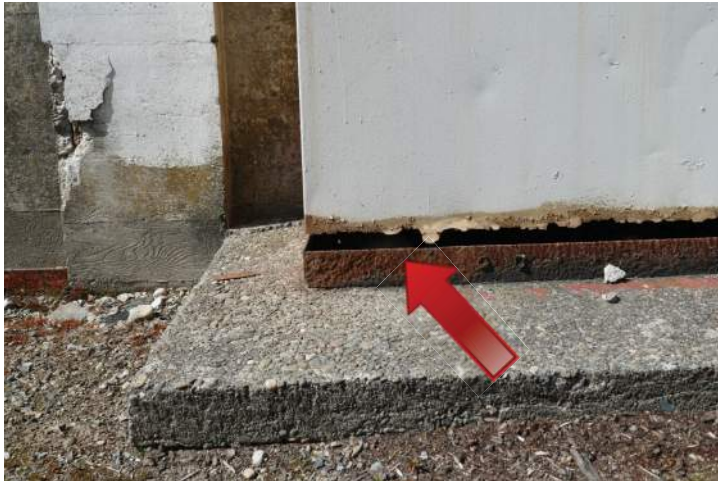
Richaven observed severe corrosion on the base of the steel ventilation stack on the south elevation. Image by Richaven Architecture and Preservation. 220620 CoT CAS EL-S P1000670.JPG

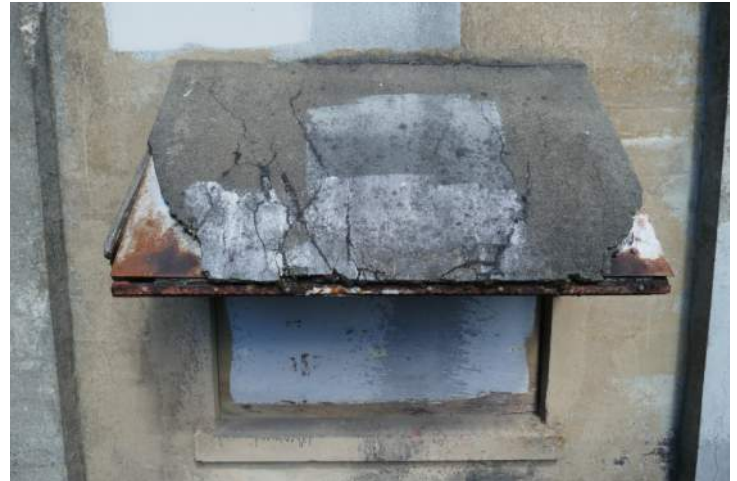
The metal awning on the west elevation is corroded. A layer of asphaltic material attached to its surface is severely damaged. Image by Richaven Architecture and Preservation. 220620 CoT CAS EL-W P1000680.JPG

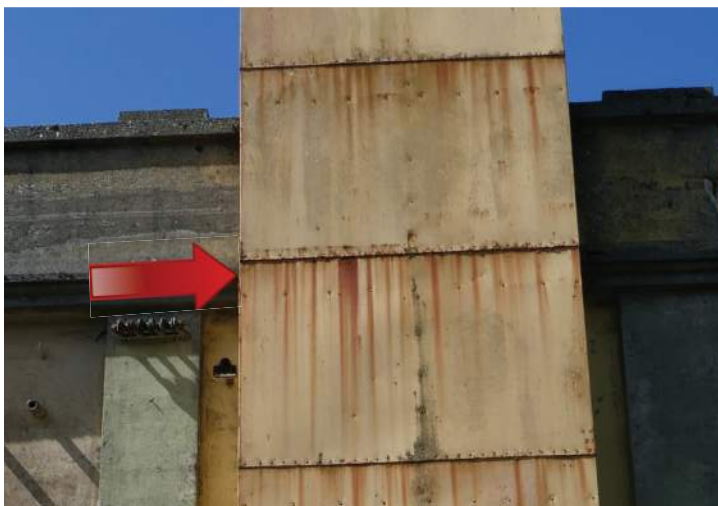
The panels that form the steel ventilation stack are severely corroded. Image by Richaven Architecture and Preservation. 220620 CoT CAS EL-S P1000671.JPG

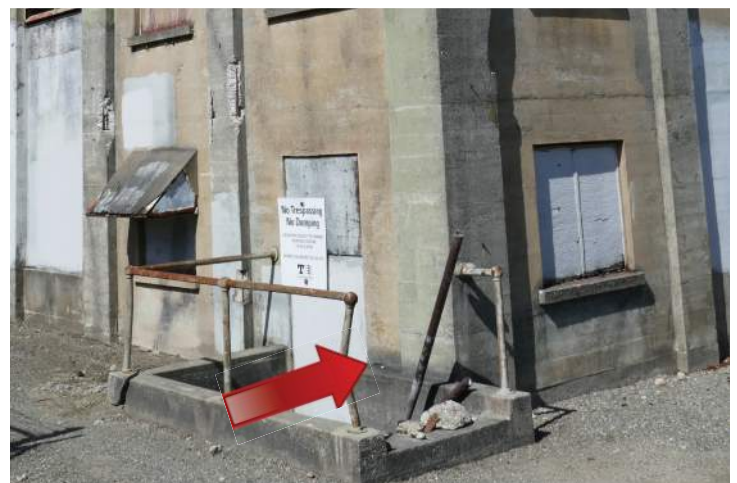
Pipe railings around the concrete stairway on the west elevation have failed. Image by Richaven Architecture and Preservation. 220620 CoT CAS EL-S-W P1000688.JPG

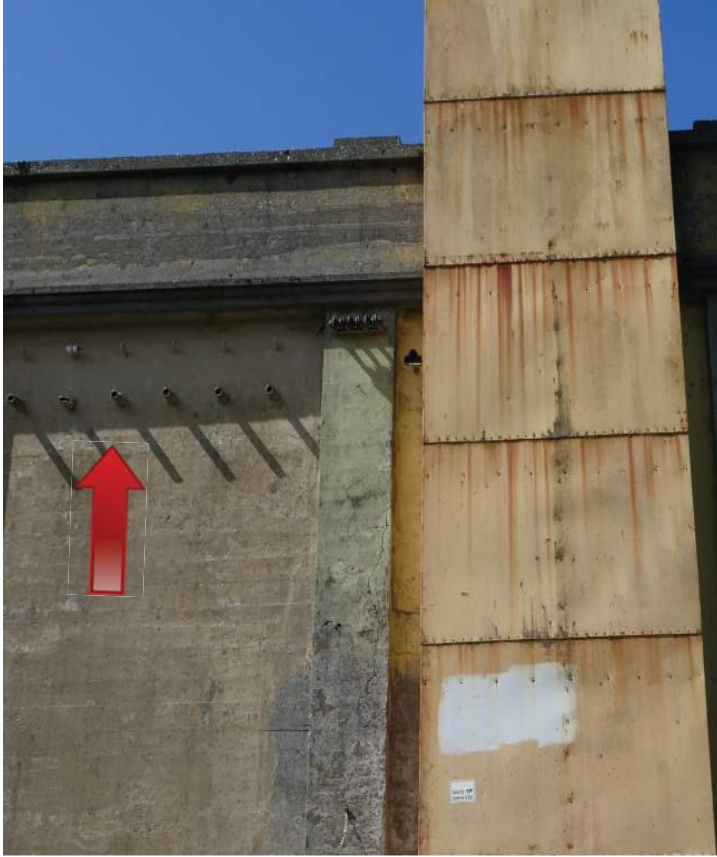
Observed steel eye bolts, pulleys, and severed tubes embedded into the concrete on the south elevation. The pipes embedded in the concrete appear not to be adequately sealed, allowing water infiltration into the wall. Image by Richaven Architecture and Preservation. 220620 CoT CAS EL-S P1000671.JPG

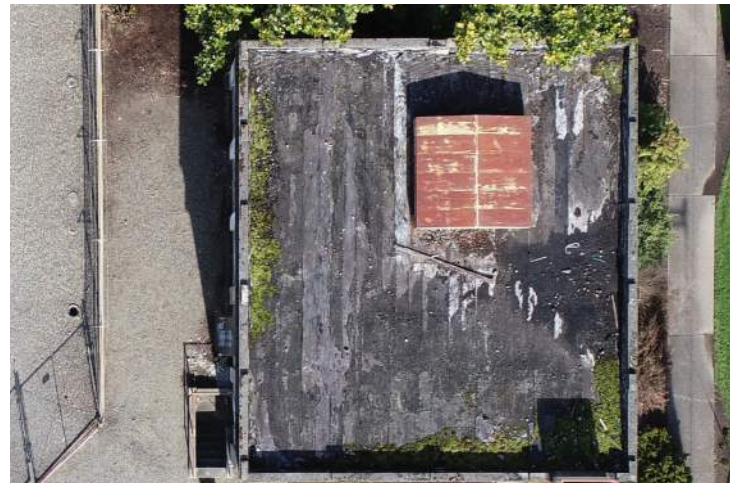
The monitor for ventilation is severely corroded. Image by Richaven Architecture and Preservation. 200224 CoT CAS ROOF DJI\_0063.JPG.

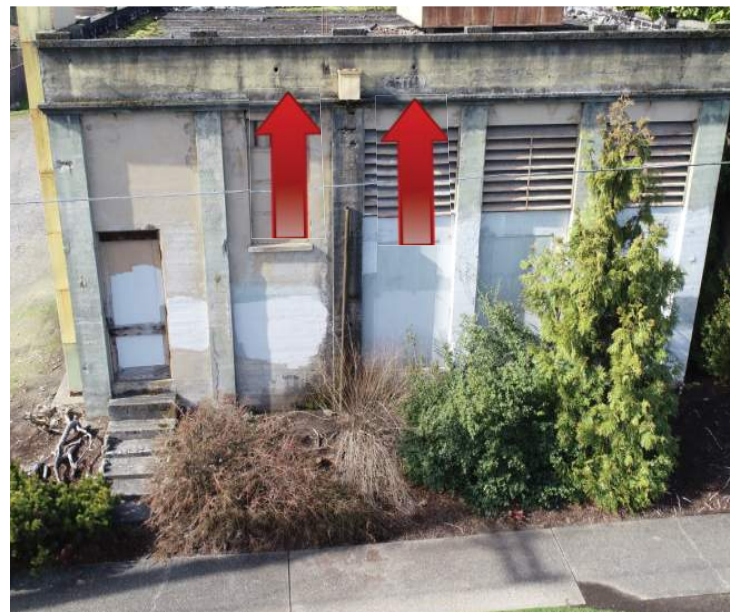
It is unknown if holes in the parapets are original. There is extensive atmospheric soiling around them. Image by Richaven Architecture and Preservation. 200224 CoT CAS EL-E DJI\_0075.JPG

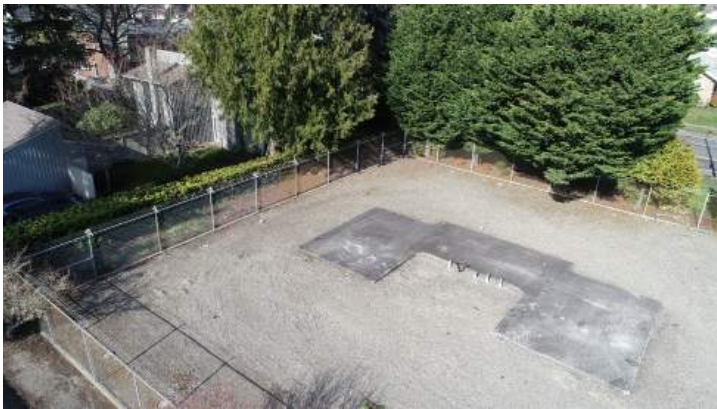
Image by Richaven Architecture and Preservation.  
200224 CoT CAS EL-MISC DJI\_0067.JPG

The substation switchyard is a level, square, graveled yard surrounded by a tall, chain-link fence with swinging doors on its southeast corner. Otherwise bare, one large concrete pad sits above the gravel surface.

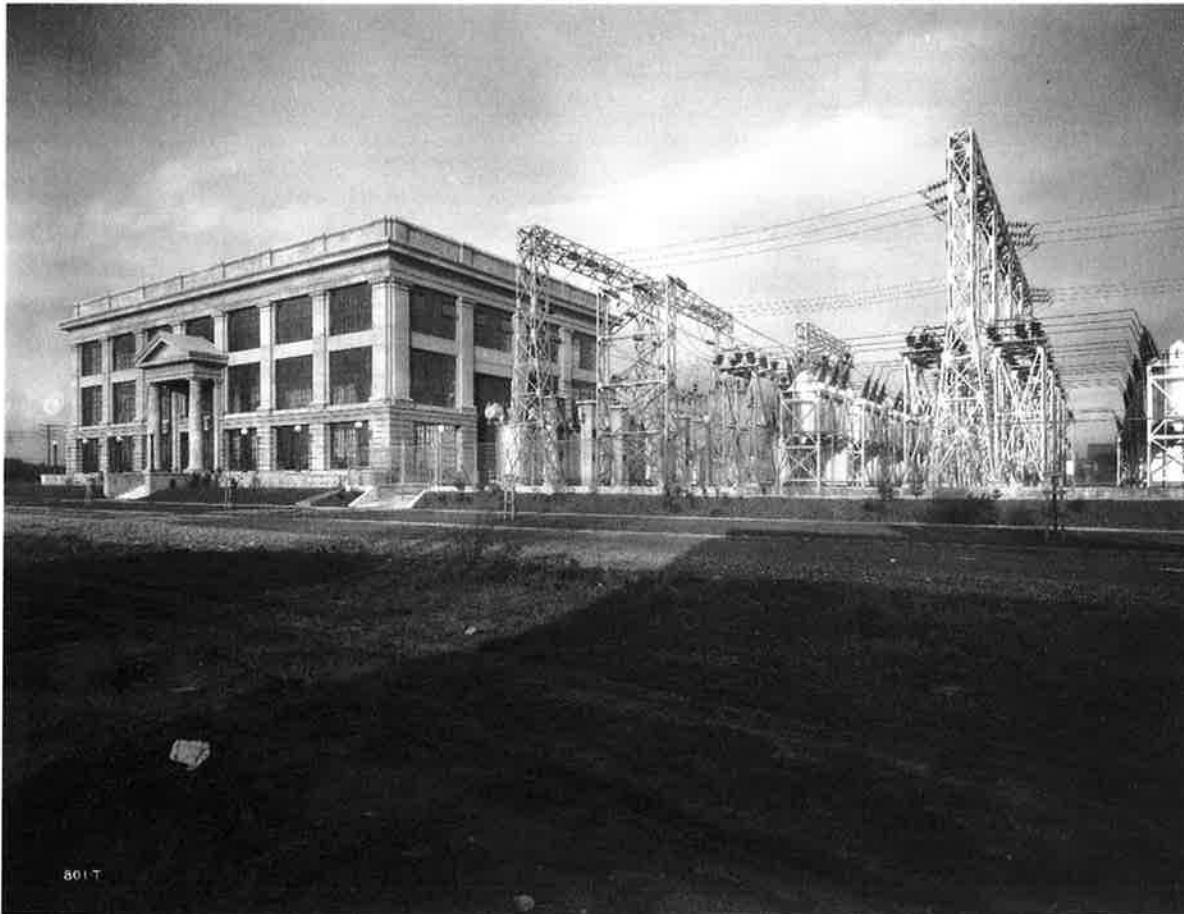
Figure 3. Cushman Substation, 1925, southeast oblique (viewing northwest) with view of switchyard (no longer extant). Image courtesy of Tacoma Power.

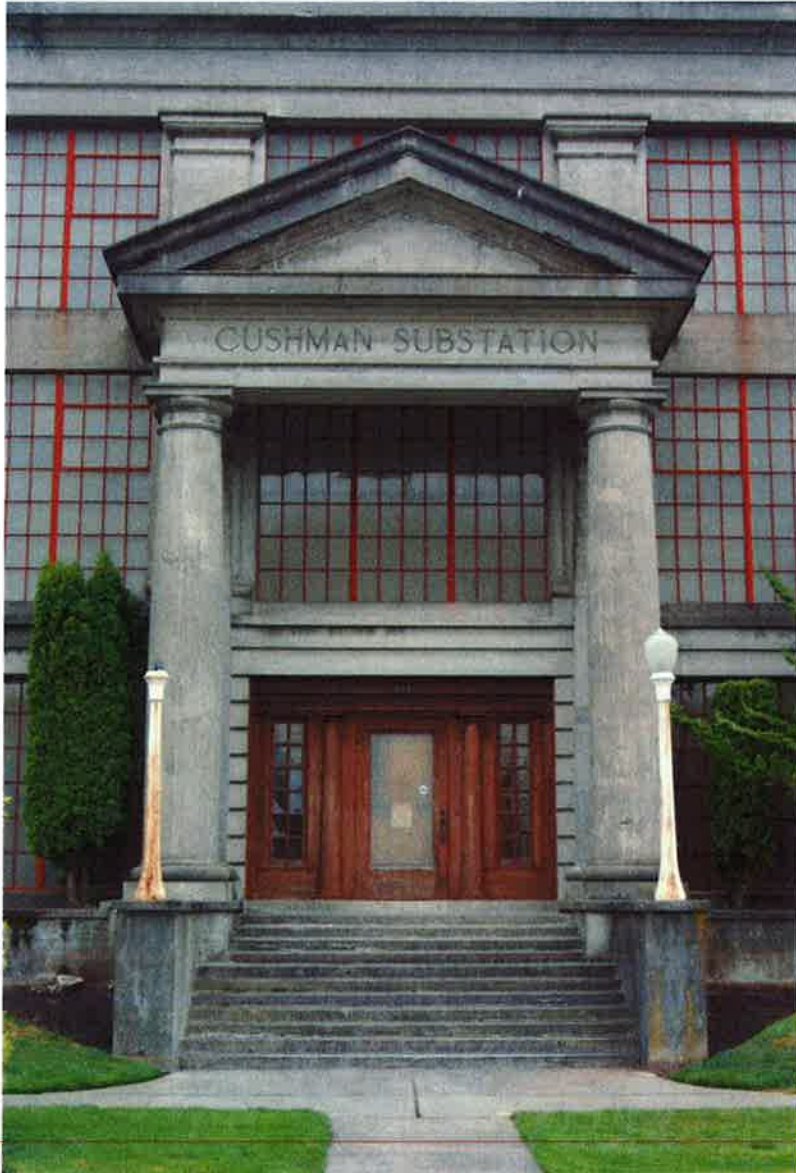
Photo 2 of 17. WA\_PierceCounty\_CushmanSubstation\_0002. View of the temple front entrance on the façade (south face) of Cushman Substation.

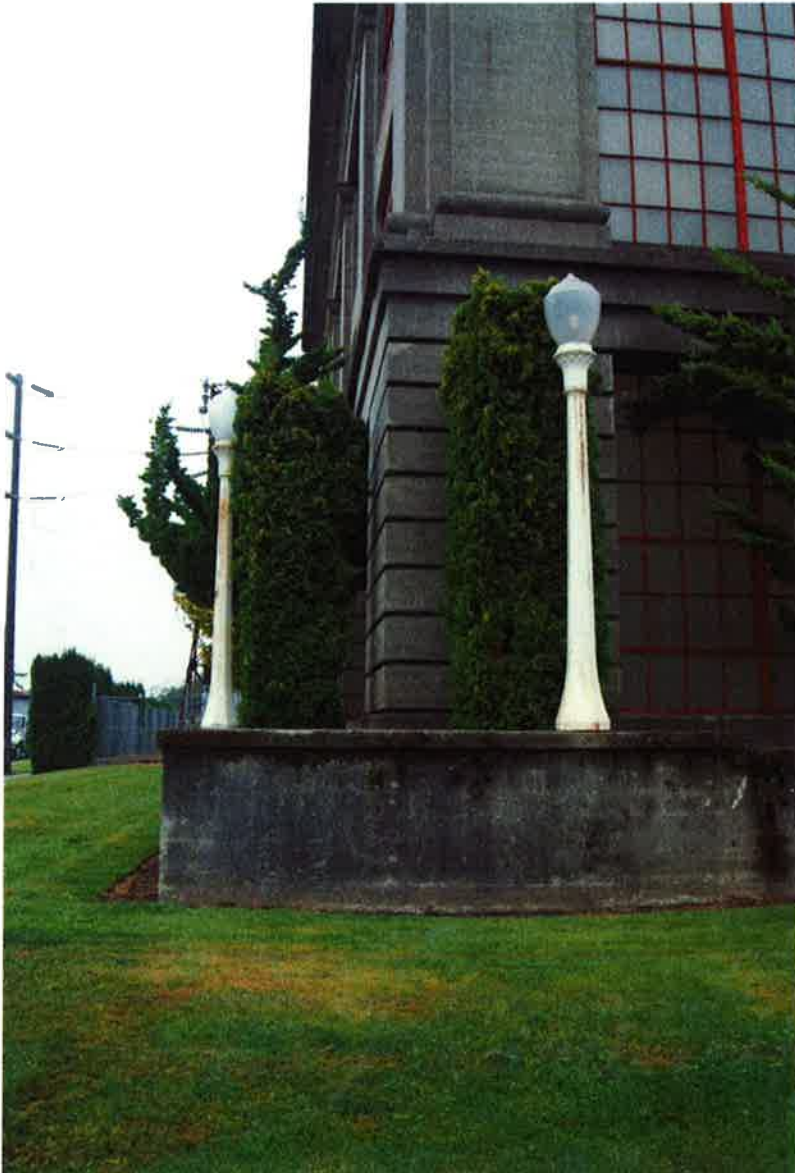
Photo 8 of 17. WA\_PierceCounty\_CushmanSubstation\_0008. Detail of the original cast concrete lamp posts located on the northwest corner of Cushman Substation. The globes are modern plastic.

Original cast-concrete light poles flank the stairway to the main entrance. The light poles are also located on the corners of the south elevation, as well as symmetrically arranged on the west elevation, for a total of seven poles currently extant. The light poles originally featured glass globes, though these have been replaced with plastic globes or, in some cases, are missing altogether.
