# Preliminary Evaluation of Building Conditions

## Cushman & Adams Street Substations

January 14, 2025

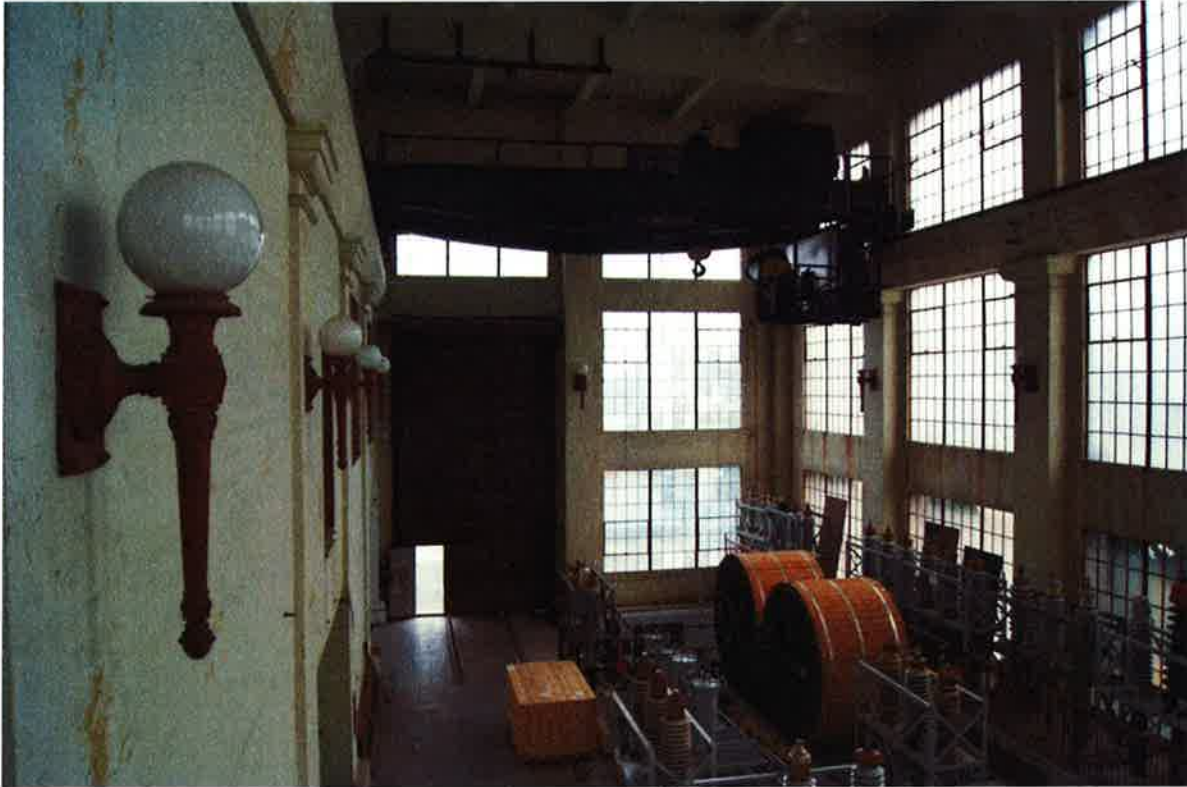
Photo 9 of 17. WA\_PierceCounty\_CushmanSubstation\_0009. Interior of Cushman Substation, which is now used for storage. Note the decorative lighting, gantry crane (at ceiling), and voluminous interior space three stories high. Engaged pilasters are visible on both the south wall (pictured right) and interior wall (pictured left).

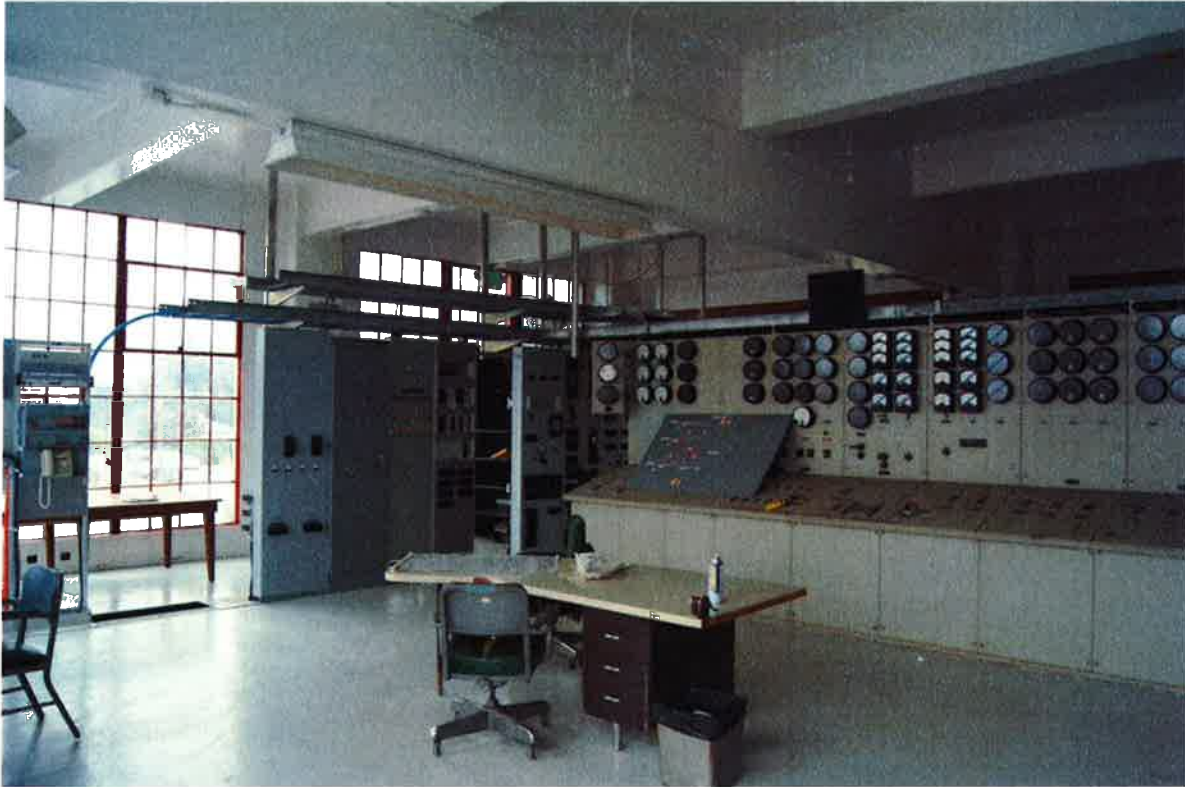
Photo 11 of 17. WA\_PierceCounty\_CushmanSubstation\_0011. Former control room at Cushman Substation. The equipment is modern, though the room retains its original function.

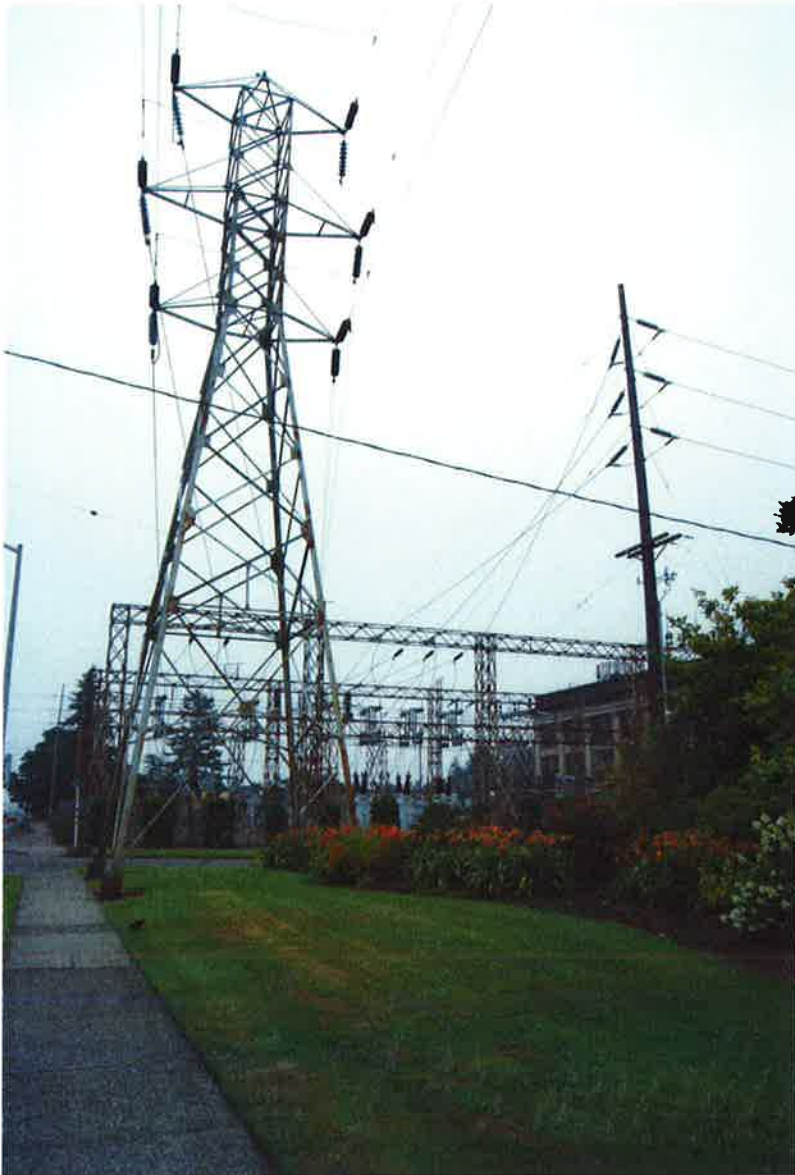
Photo 16 of 17. WA\_Pierce County\_Cushman Substation\_0016. First Tower as it leaves/enters substation

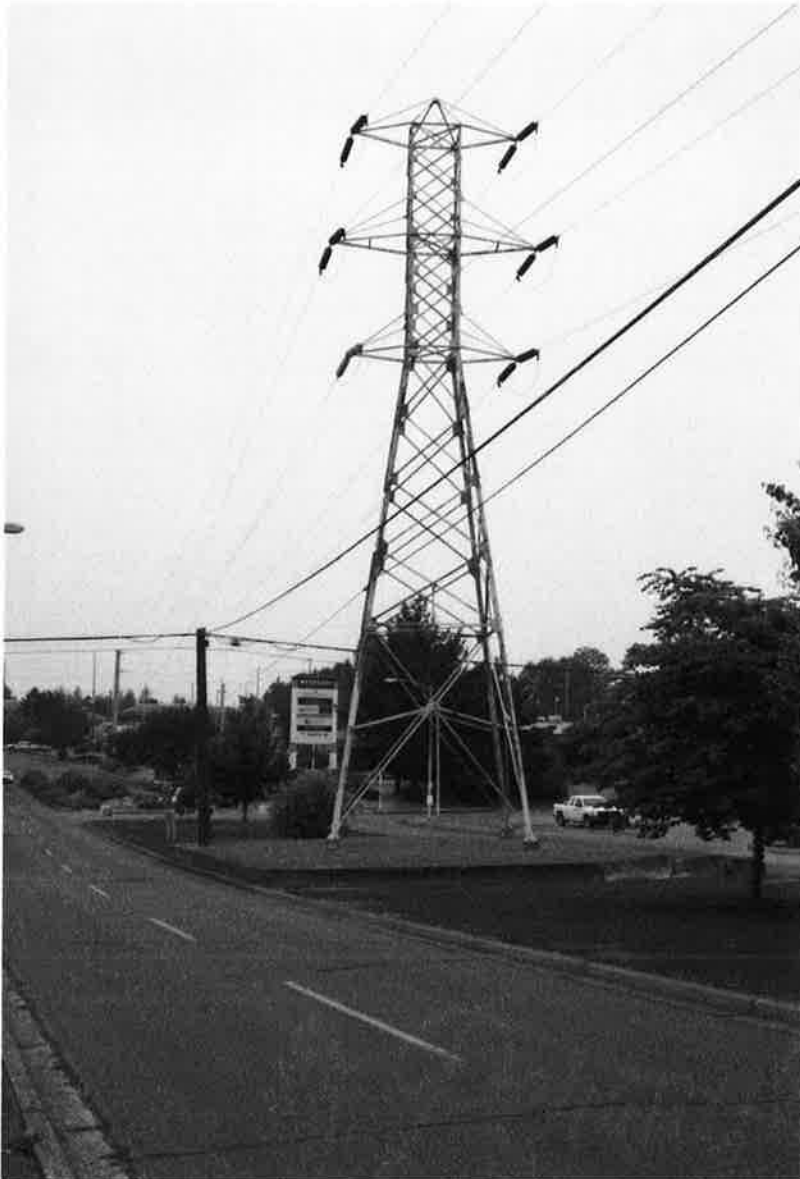
Photo 16 of 17. WA\_Pierce County\_Cushman Substation\_0016. Typical Tower as traverses down N 21<sup>st</sup> St.

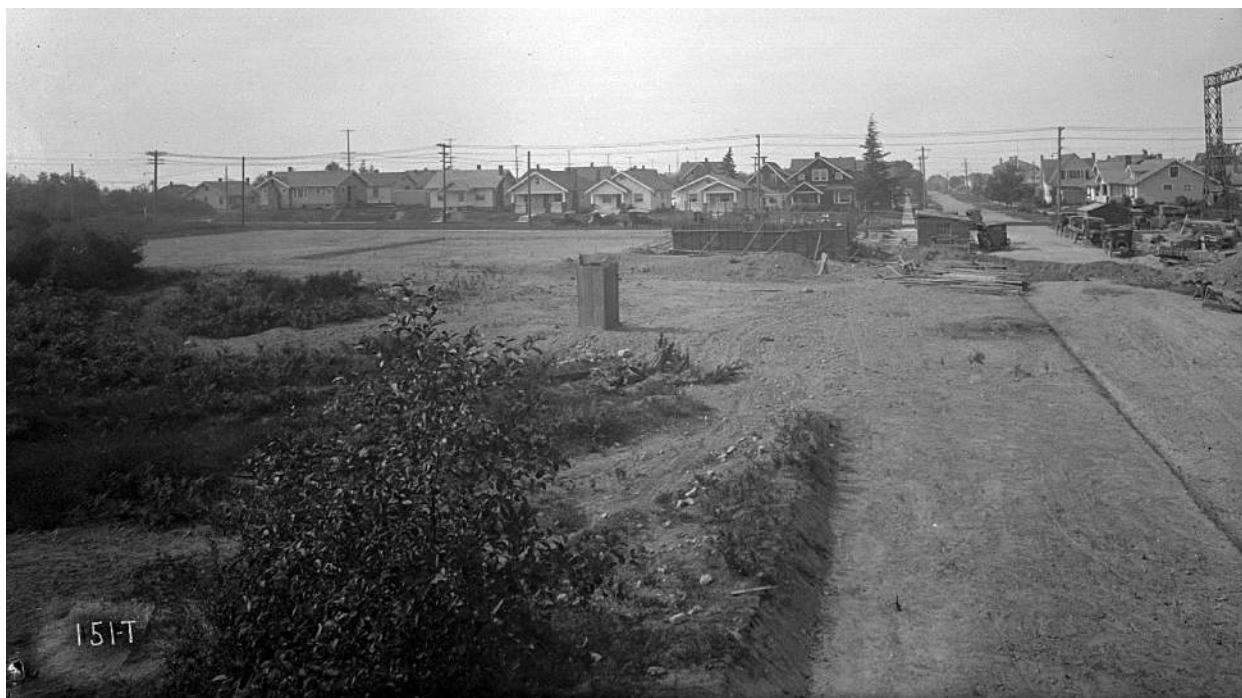
Figure 1. The site of the Adams St. Substation as construction begins, view north, 1925. Courtesy of Tacoma Power.

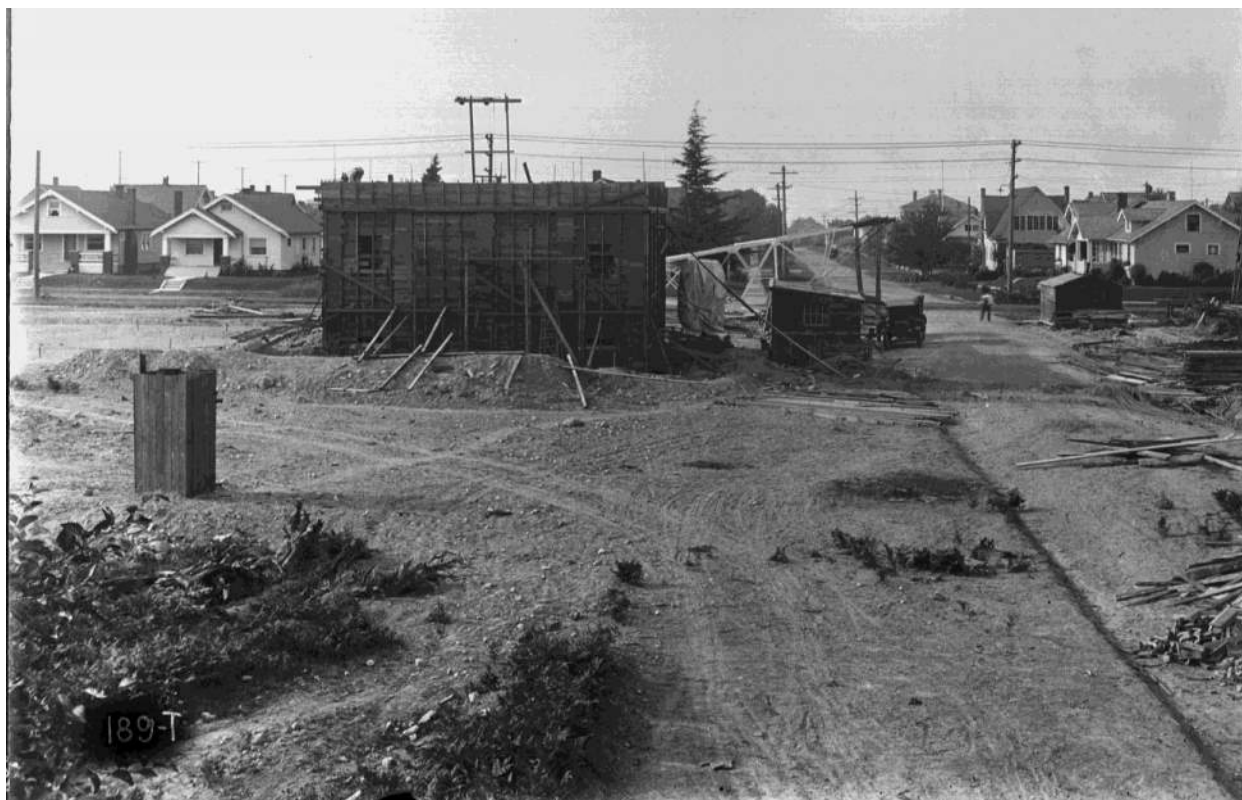
Figure 2. Construction of the Adams St. Substation continues, view north, 1925. Courtesy of Tacoma Power.

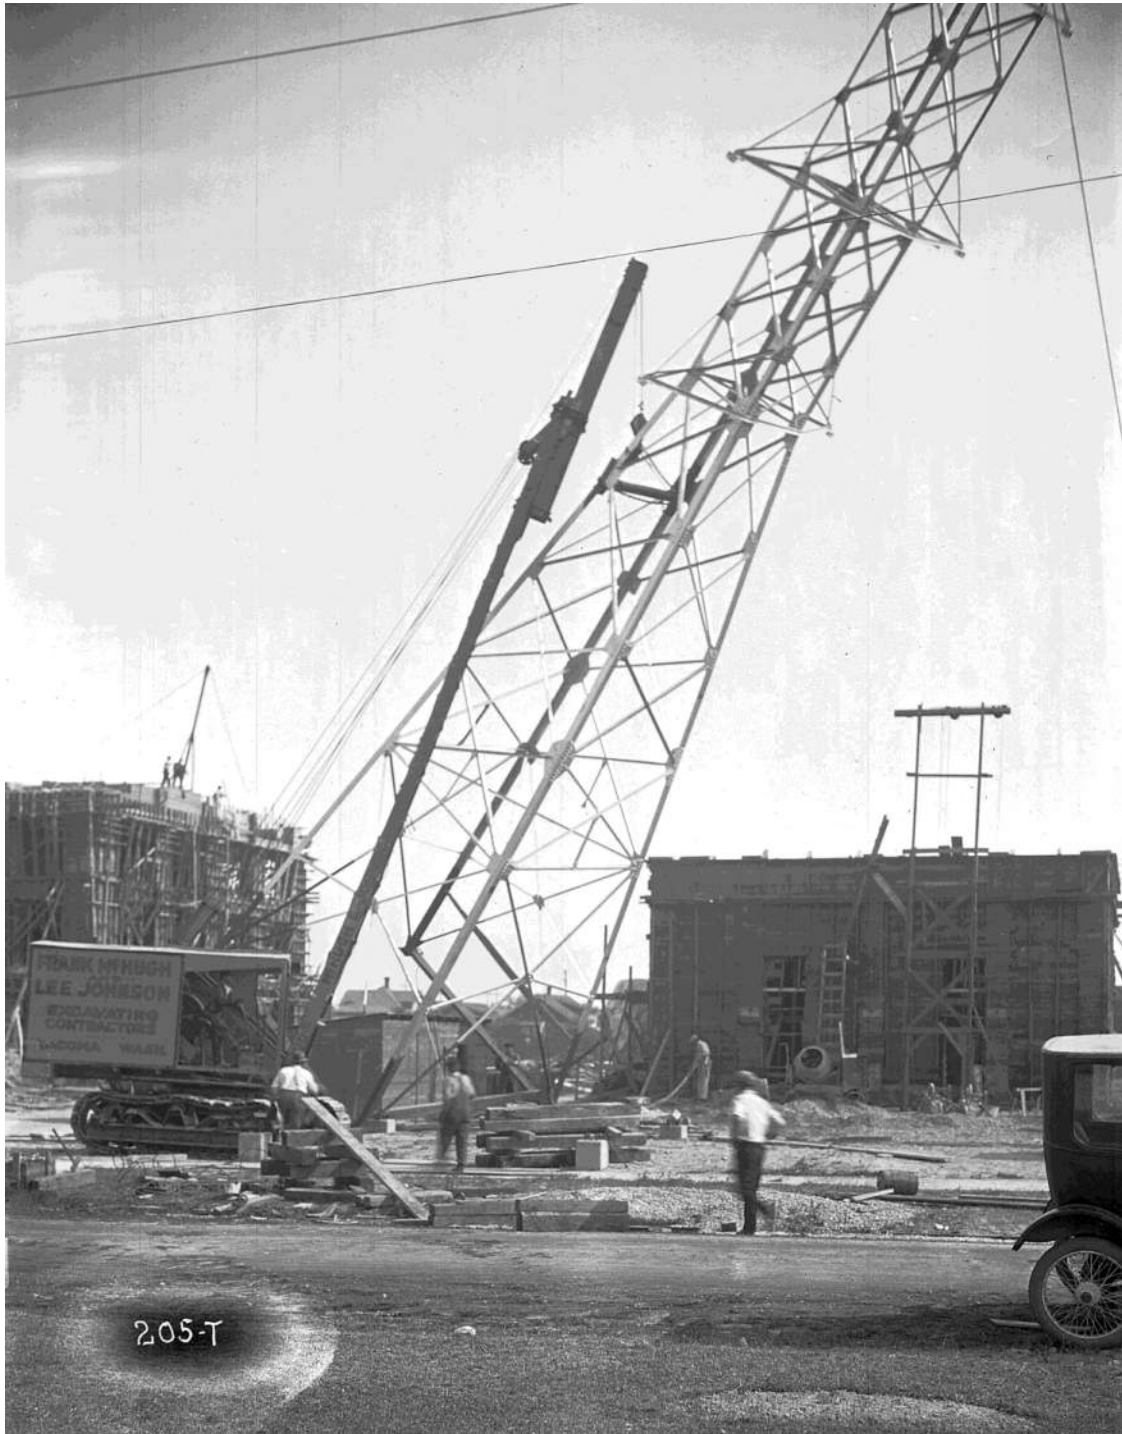
Figure 4. Steel lattice tower, constructed adjacent to the Adams St. Substation, view south, 1925. Courtesy of Tacoma Power.

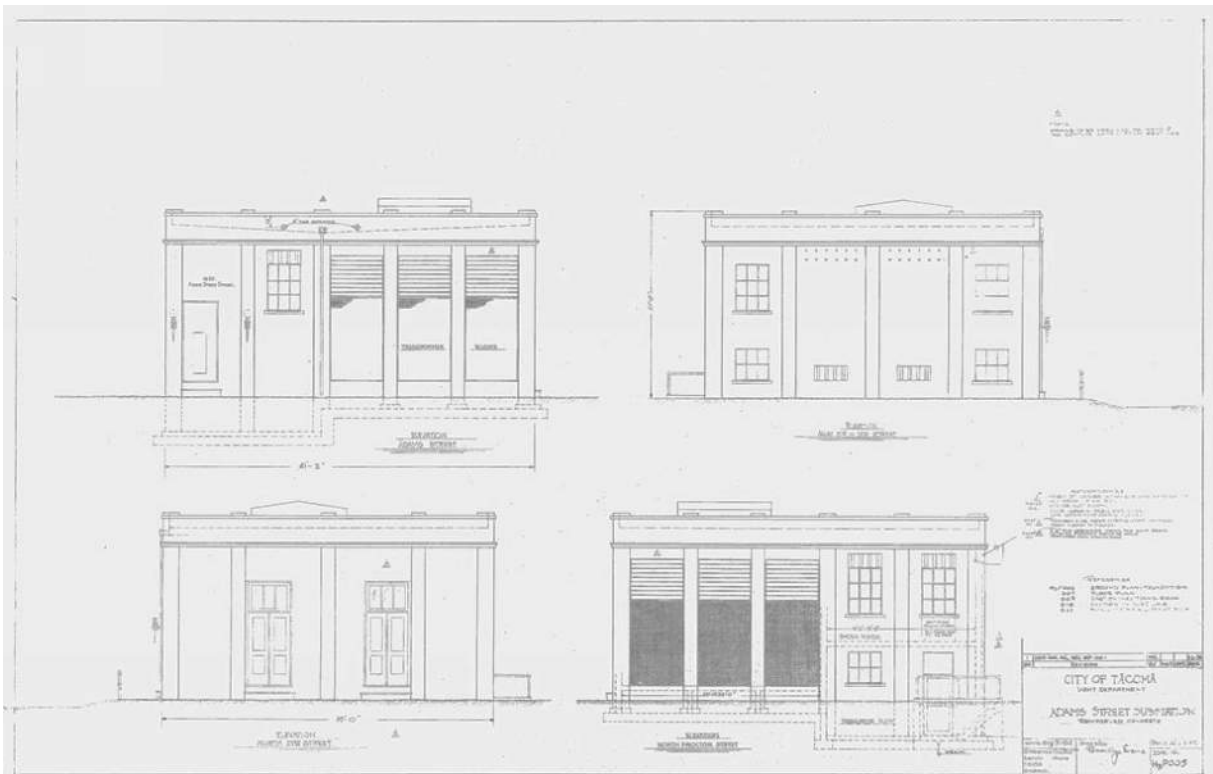
Figure 8. Adams St. Substation, elevation drawings, 1925. Courtesy of Tacoma Power.

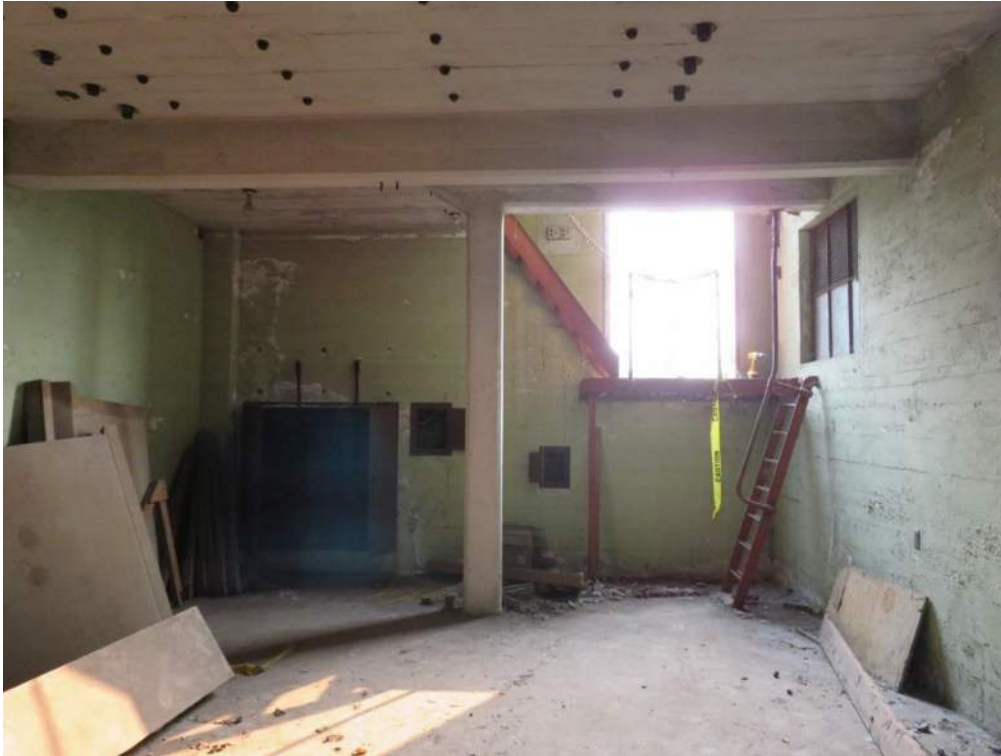
Photo 8 of 13. WA\_PierceCounty\_AdamsSt.Substation\_0008. Adams St. Substation, interior, regulator room, lower level, view east.

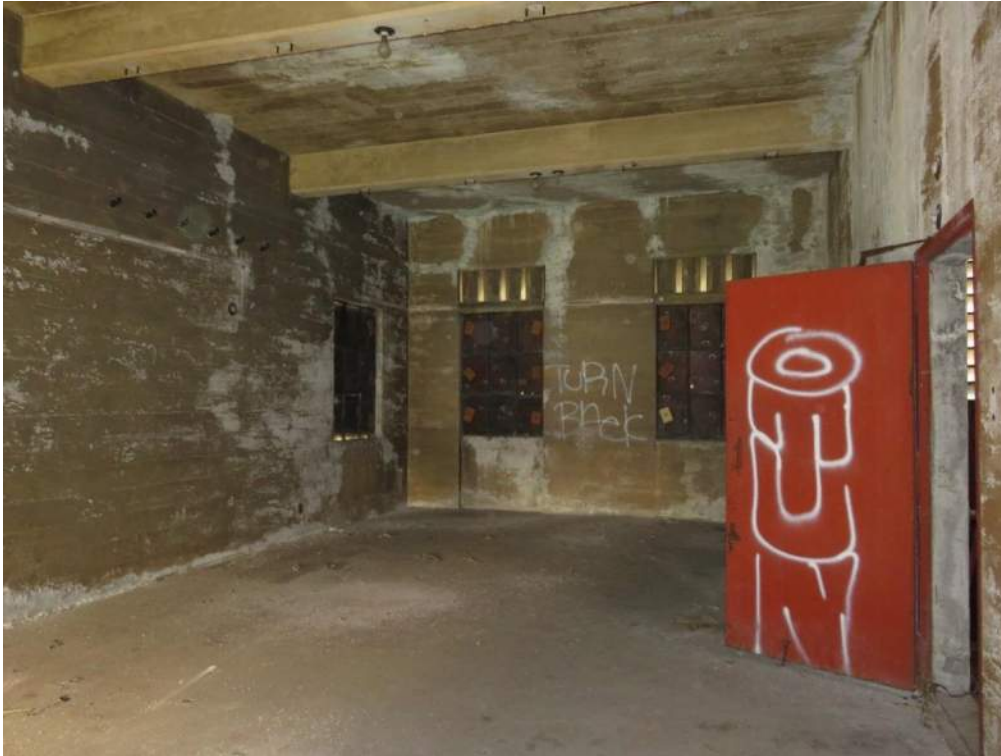
Photo 10 of 13. WA\_PierceCounty\_AdamsSt.Substation\_0010. Adams St. Substation, interior, switch room, upper level, view west.

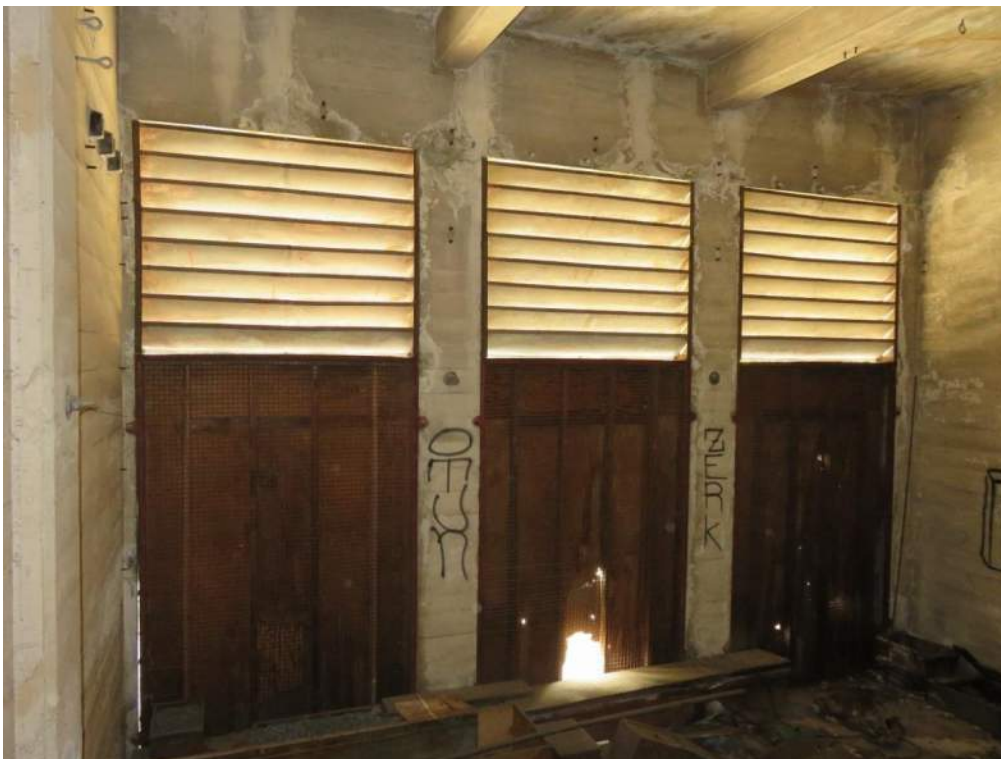
Photo 11 of 13. WA\_PierceCounty\_AdamsSt.Substation\_0011. Adams St. Substation, interior, transformer room, view west.

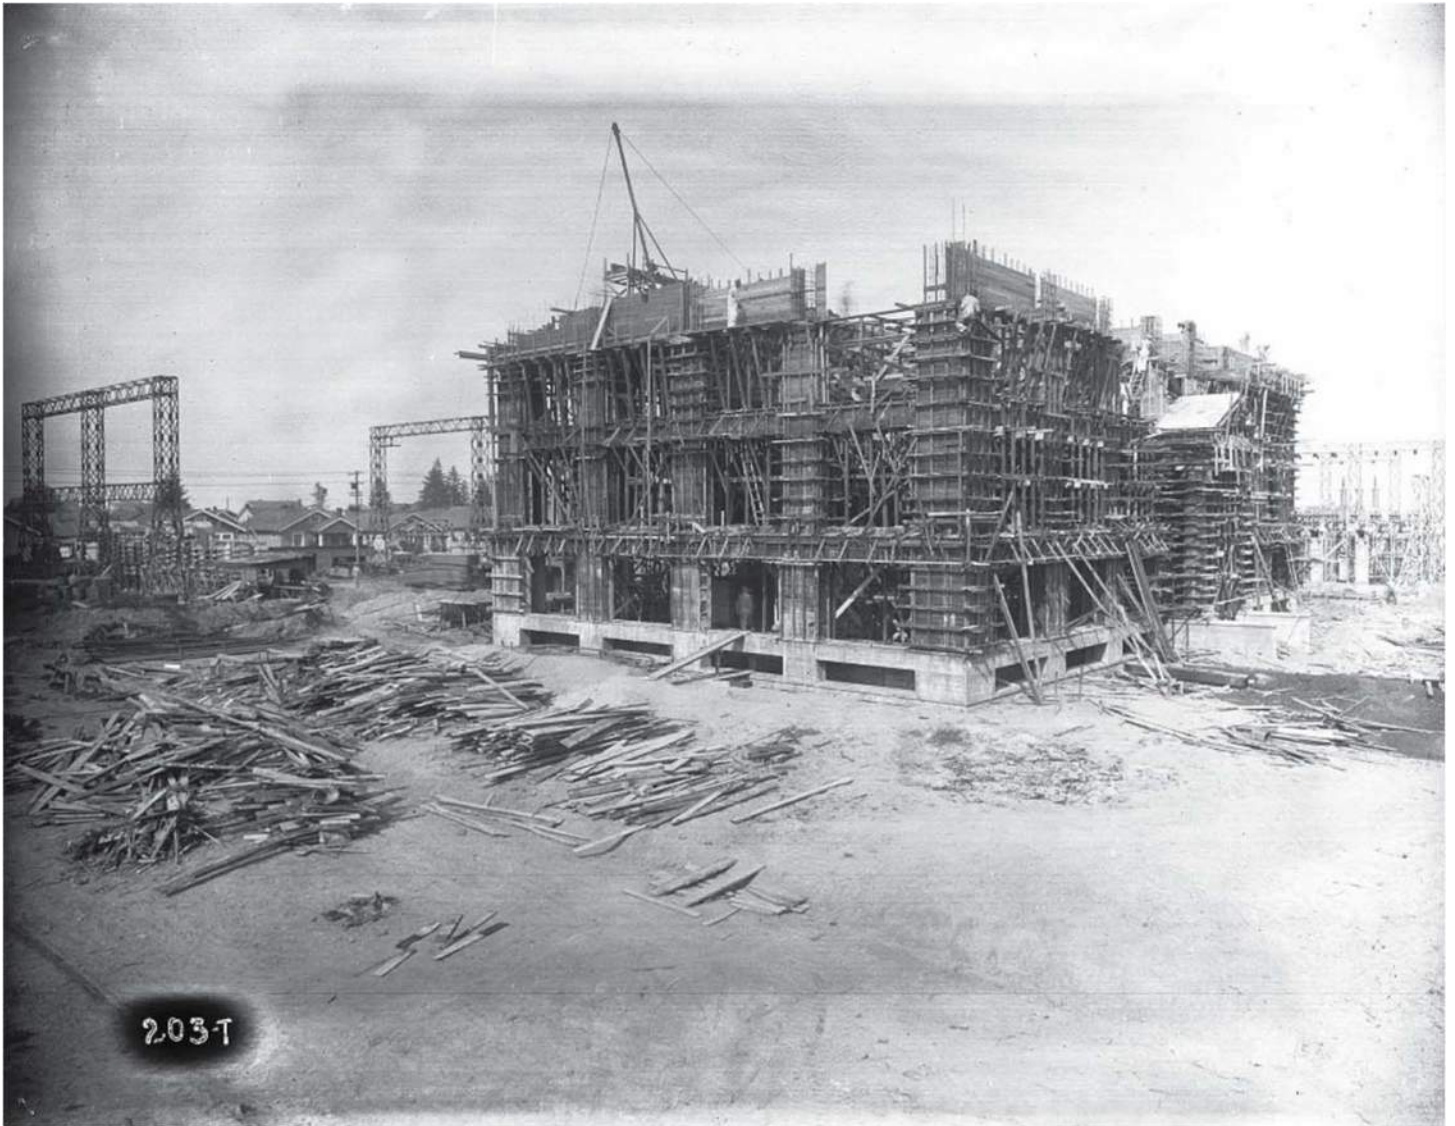
Figure 3 Cushman Substation under construction, board formed construction, August 3, 1925, Image courtesy of Tacoma Power

- Figure 3. Cushman Substation under construction, board formed construction, August 3, 1925, Image courtesy of Tacoma Power
- Figure 4. Raising of Tower 1 with Adams and Cushman Substation in background August 4, 1925, Image courtesy of Tacoma Power

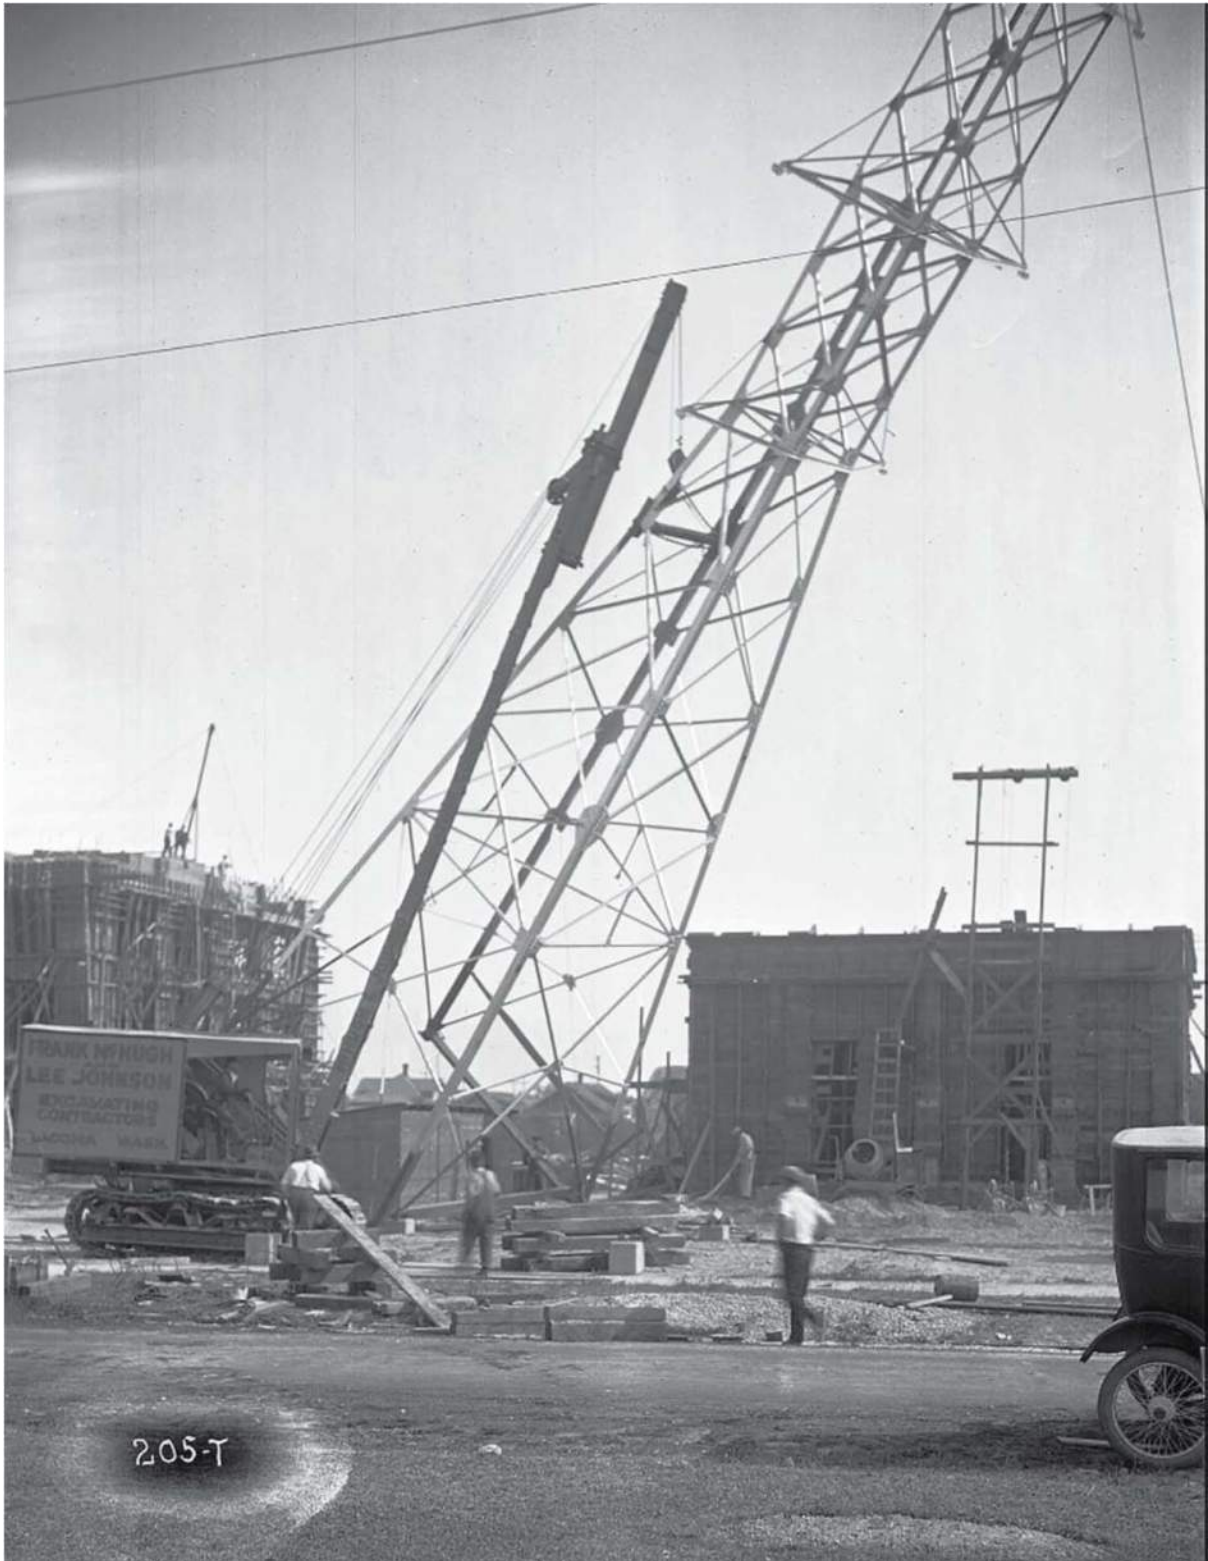
Figure 4 Raising of Tower 1 with Adams and Cushman Substation in background August 4, 1925, Image courtesy of Tacoma Power

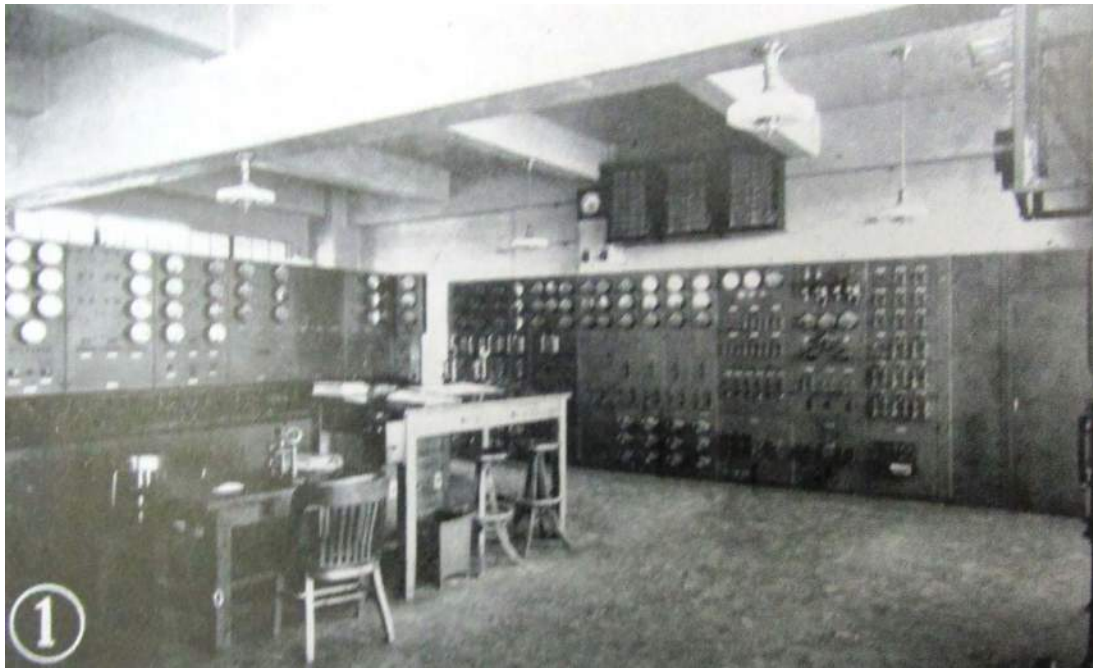
Figure 9 Cushman Substation Control Room ca. 1929, Image courtesy of Tacoma Public Library

- Figure 9. Cushman Substation Control Room ca. 1929, Image courtesy of Tacoma Public Library
- Figure 10. Cushman Substation Condenser room ca. 1929, Image courtesy of Tacoma Public Library

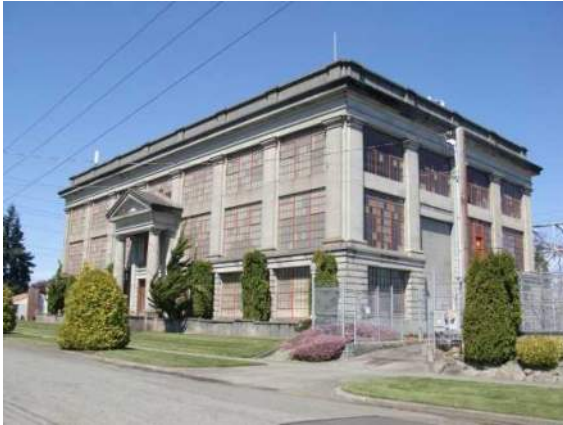
southeast corner

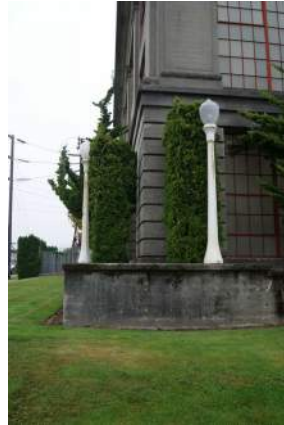
Detail of light poles

Original cast-concrete light poles flank the stairway to the main entrance. The light poles are also located on the corners of the south elevation, as well as symmetrically arranged on the west elevation, for a total of seven poles currently extant. The light poles originally featured glass globes, though these have been replaced with plastic globes or, in some cases, are missing altogether.

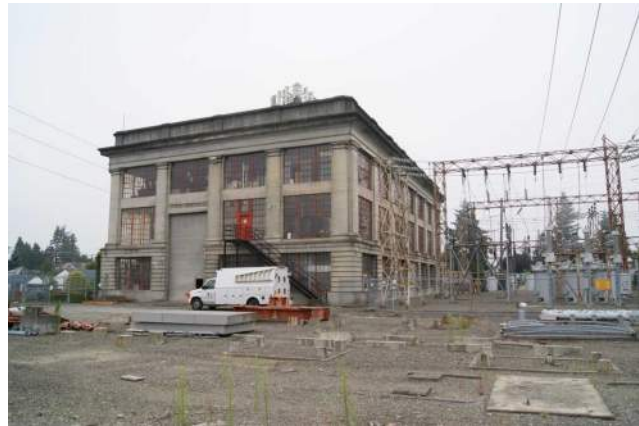
Northeast oblique

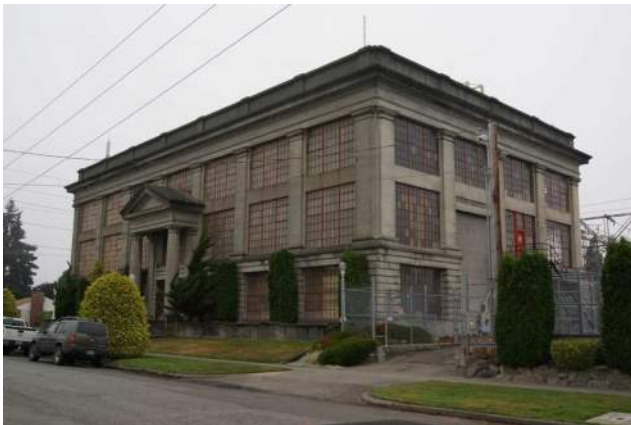
Southeast Oblique

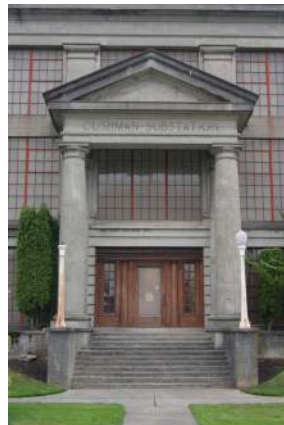
Temple front at main entrance

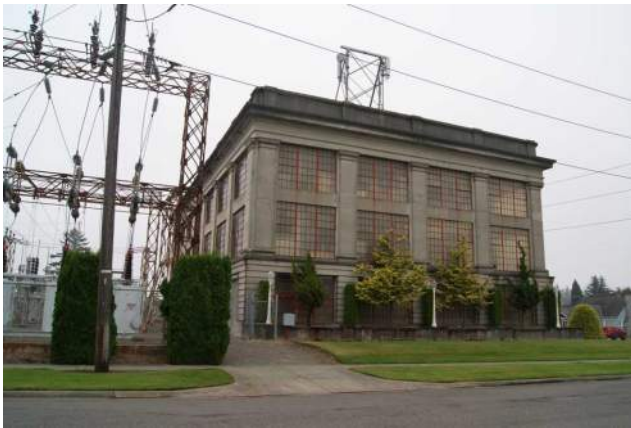
Northwest oblique
