Preliminary Evaluation of Building Conditions

Cushman & Adams Street Substations

Technical Work Completed: 2019-2020

Published February 2025

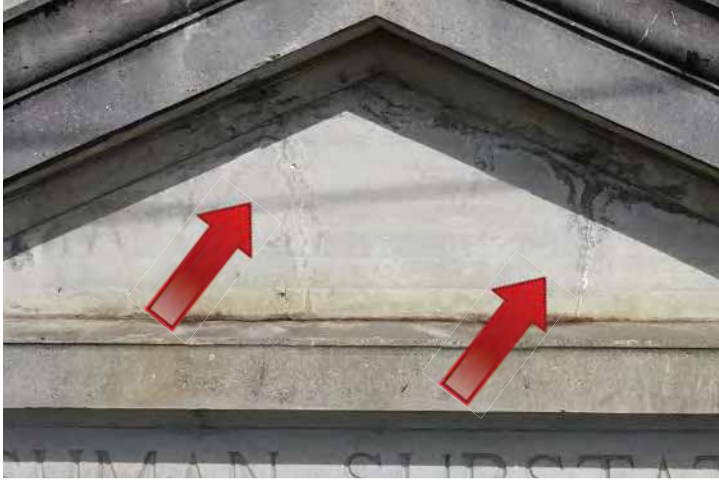
Spalling and efflorescence on the frieze. Image by Richaven Architecture and Preservation.
200224 CoT CAS EL-S DJI_00221.PNG

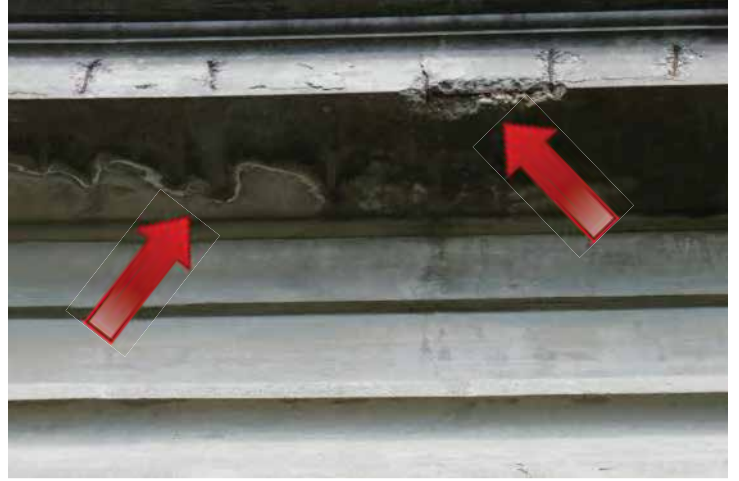
Section of the cornice on the west elevation shows spalling and reinforcing steel exposed due to water infiltration. Image by Richaven Architecture and Preservation.
220620 CoT CAS EL-W P1000649.JPG

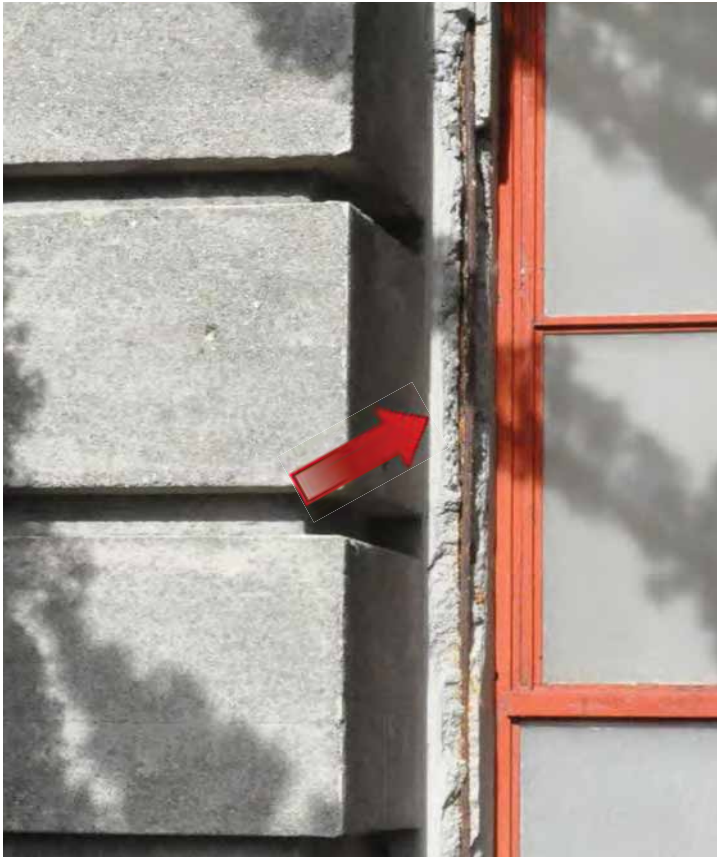
Spalling around a window frame on the west elevation and reinforcing steel bar exposed due to carbonation-induced corrosion. Often occurs in areas with a shallow concrete cove Image by Richaven Architecture and Preservation. 200224 CoT CAS EL-W DSC_0026.JPG

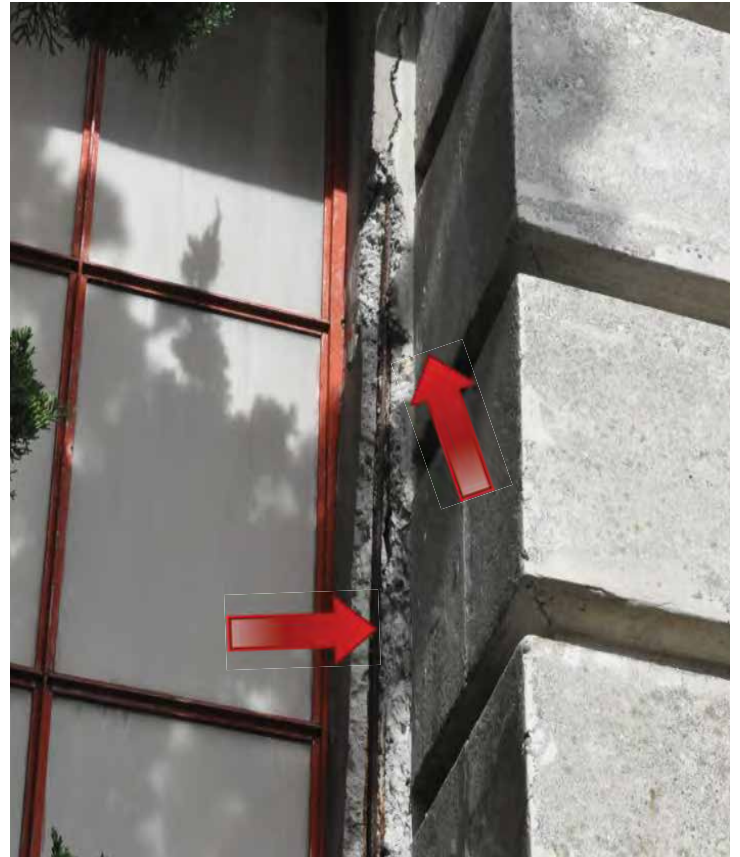
Exposed reinforcing steel and failed concrete around one of the ground-level window bays on the west elevation. There is some amount of corrosion visible. Image by Richaven Architecture and Preservation. 200224 CoT CAS EL-W DSC_0028.JPG

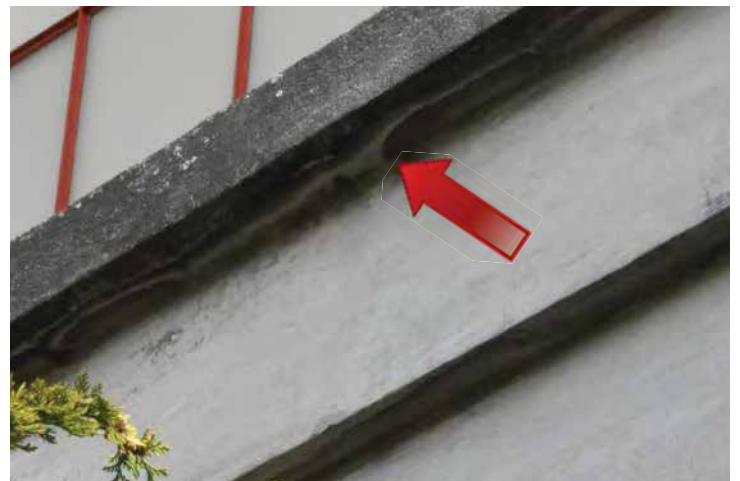
Efflorescence under a window ledge on the west elevation. Moisture infiltration will result in spalling. Image by Richaven Architecture and Preservation. 200224 CoT CAS EL-W DSC_0034

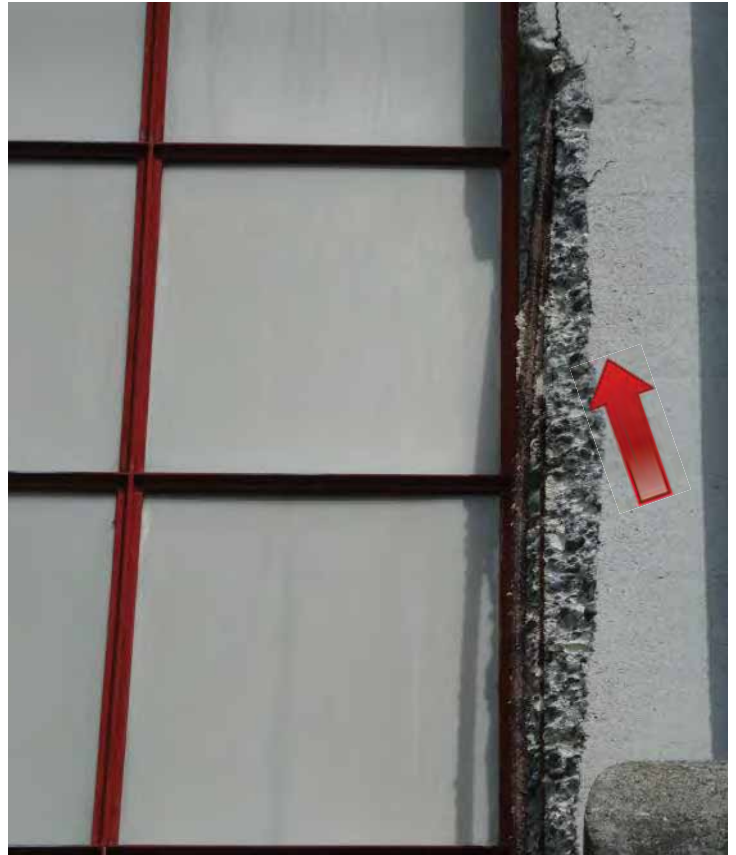
Severe spalling and separation from the substrate around a window on the west elevation. Image by Richaven Architecture and Preservation. 220620 CoT CAS EL-W P1000647.JPG

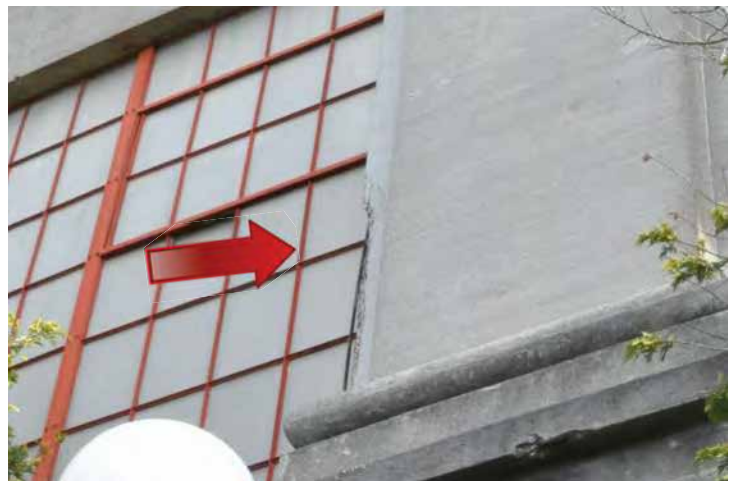
Severe separation from the substrate on the left edge of a pilaster on the west elevation. Image by Richaven Architecture and Preservation. 200224 CoT CAS EL-W DSC_0036.JPG

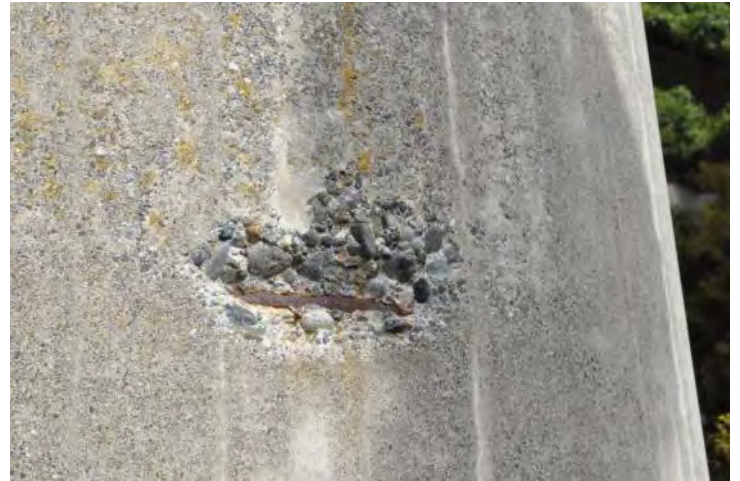
Reinforcing steel and aggregates being exposed on a wall corner on the west elevation. Spalling is present in all elevations on the building. Image by Richaven Architecture and Preservation. 200224 CoT CAS EL-S DSC_0013.JPG

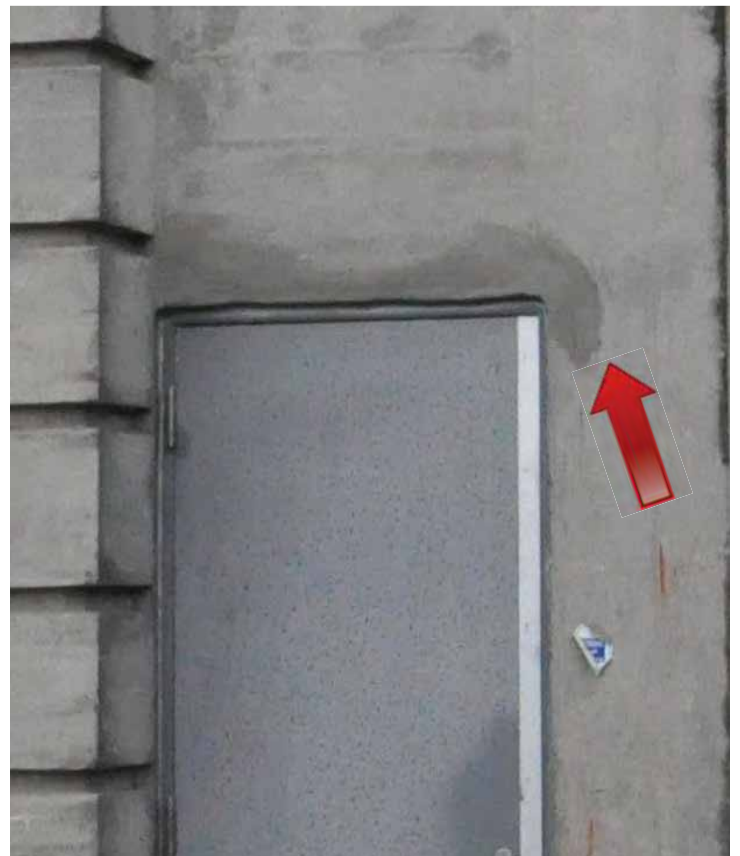
Cementitious repair above the door on the north elevation. Image by Richaven Architecture and Preservation. Image by Richaven Architecture and Preservation. 200224 CoT CAS EL-N DSC_0189.JPG

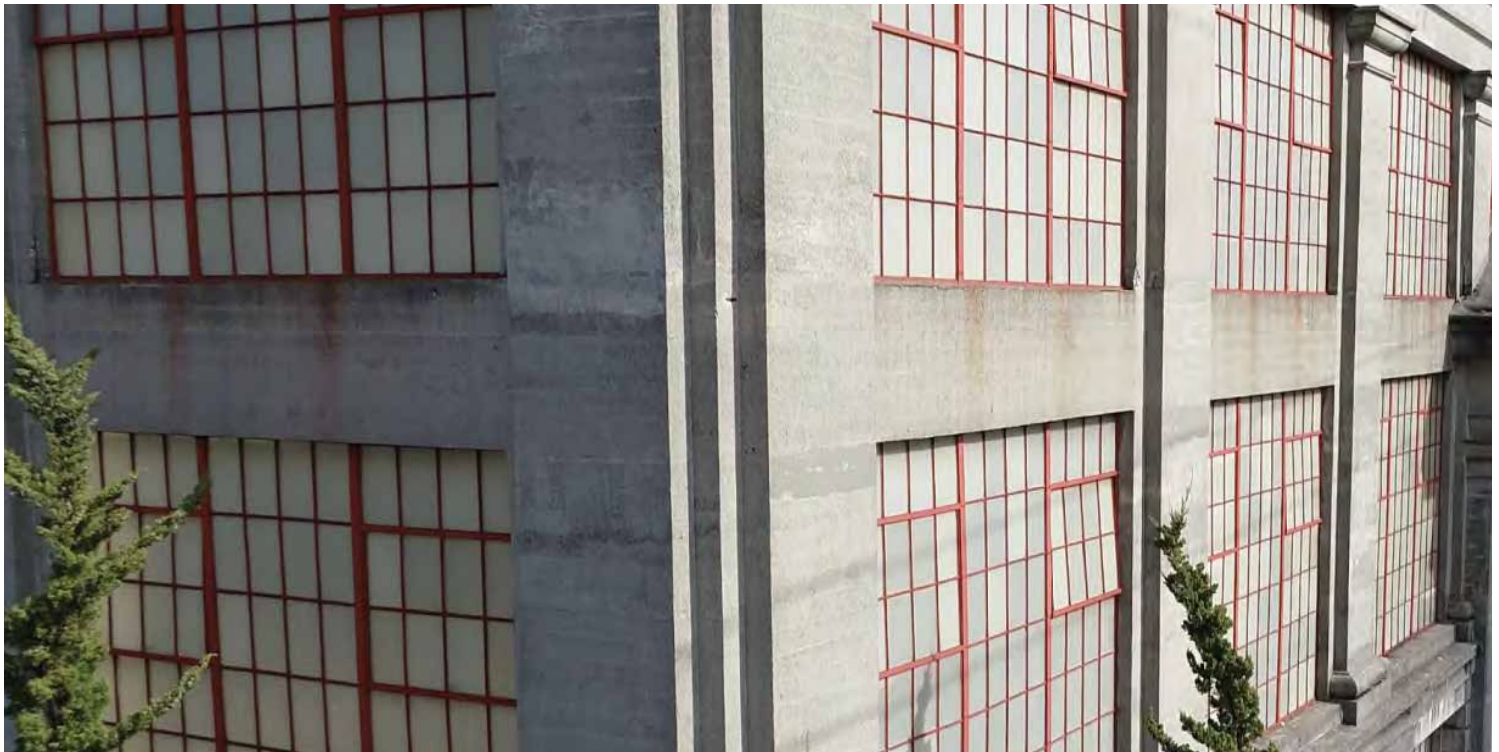
Bleeding marks of rust and paint have stained the concrete surfaces on all elevations of the building. 200224 CoT CAS EL-S-W
200224 CoT CAS EL-S-W DJI_00281.PNG

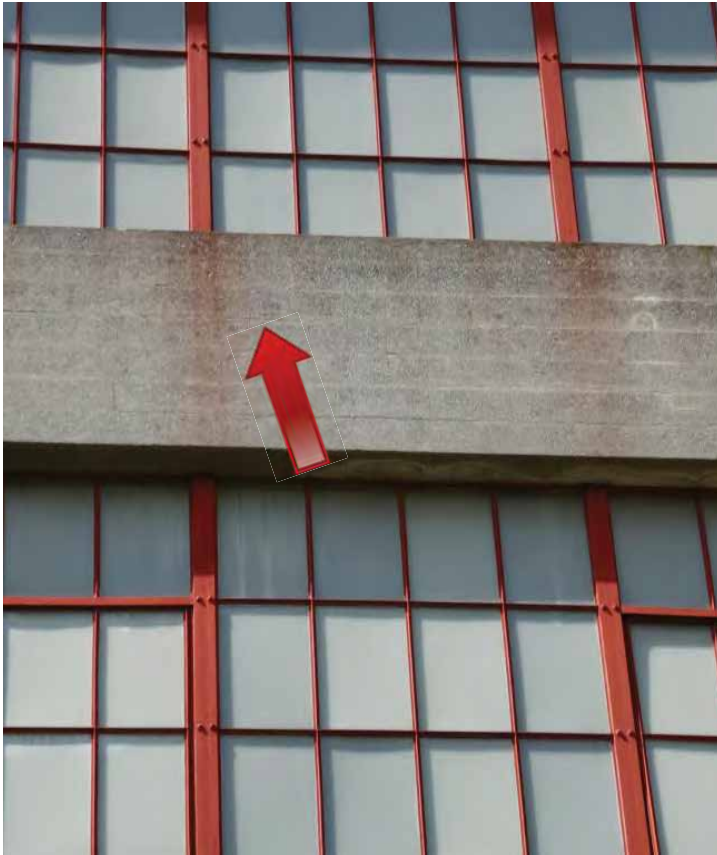
Bleeding marks of rust and paint have stained the concrete surfaces on all elevations of the building. Image by Richaven Architecture and Preservation. 220620 CoT CAS EL-W P1000667.JPG

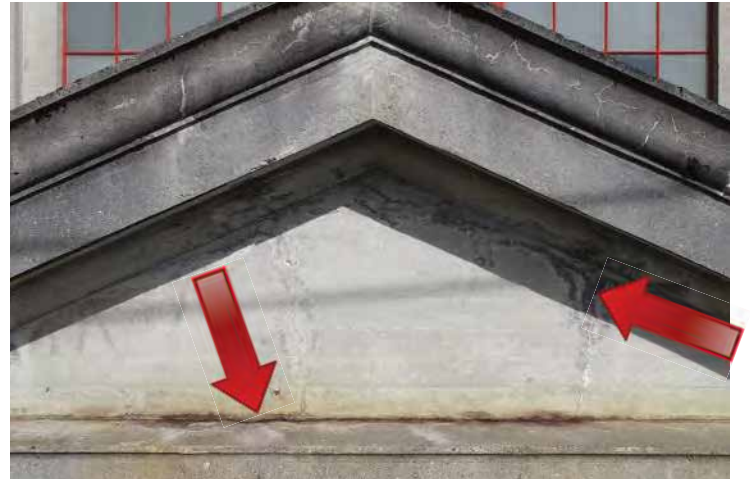
The pediment above the main entrance on the south elevation shows the build-up of atmospheric soiling that has adhered to the concrete and visible stains due to corrosion of the reinforcing steel. Efflorescence is also observed. Image by Richaven Architecture and Preservation. 200224 CoT CAS EL-S DJI_0023.JPG

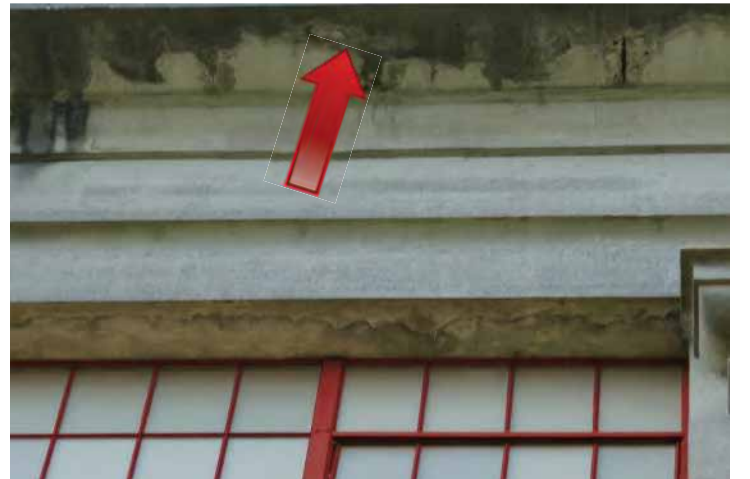
Build-up of airborne pollutants that have adhered and stained the concrete under the cornice on the south elevation. Efflorescence is also observed. Image by Richaven Architecture and Preservation. 220620 CoT CAS EL-W P1000666.JPG

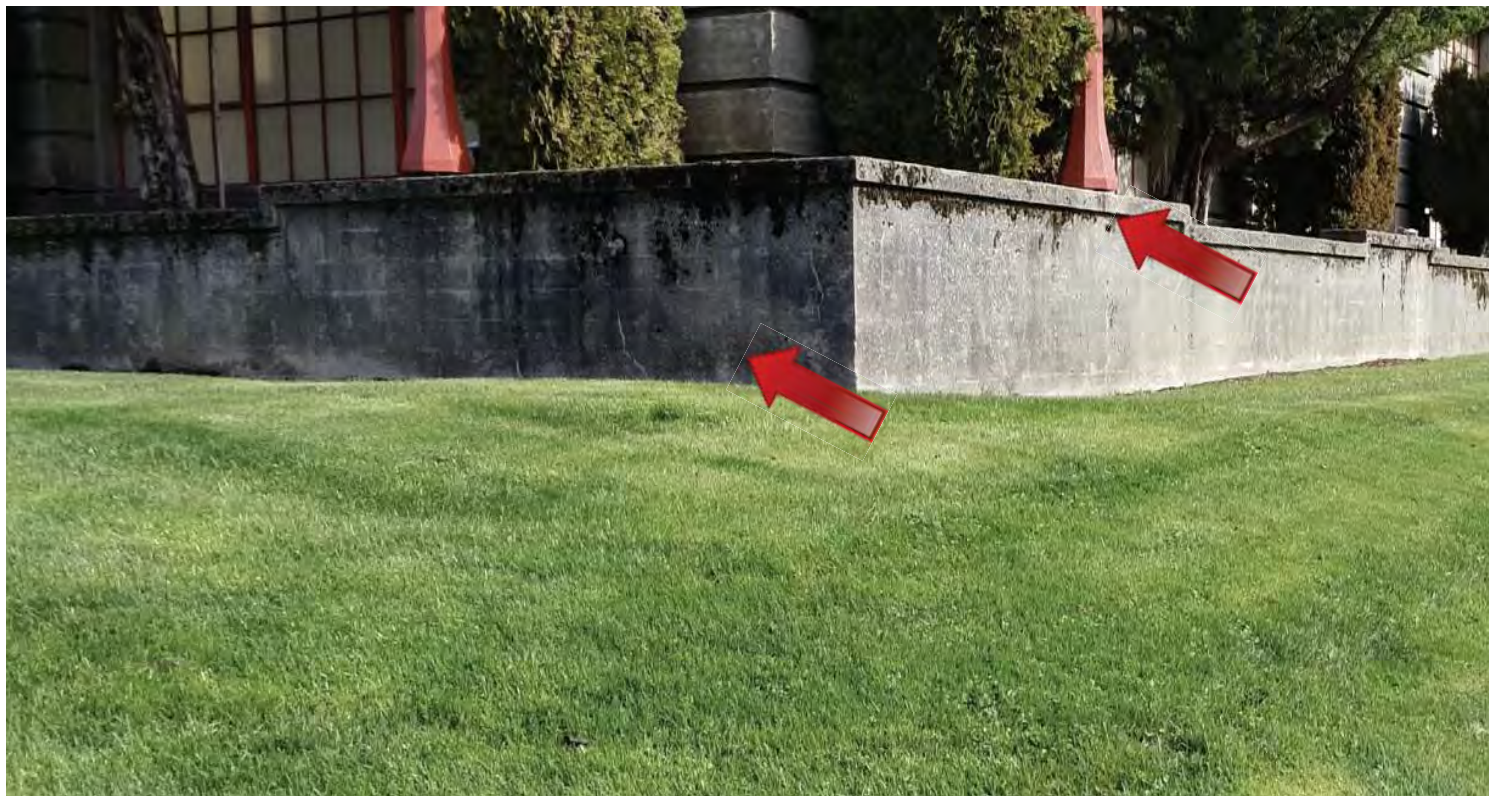
A substantial amount of organic soiling (algae) and atmospheric soiling was observed on walls on the west and south elevations. Image by Richaven Architecture and Preservation. 200224 CoT CAS EL-S-W 200224 CoT CAS EL-S-W DJI_0028.PNG

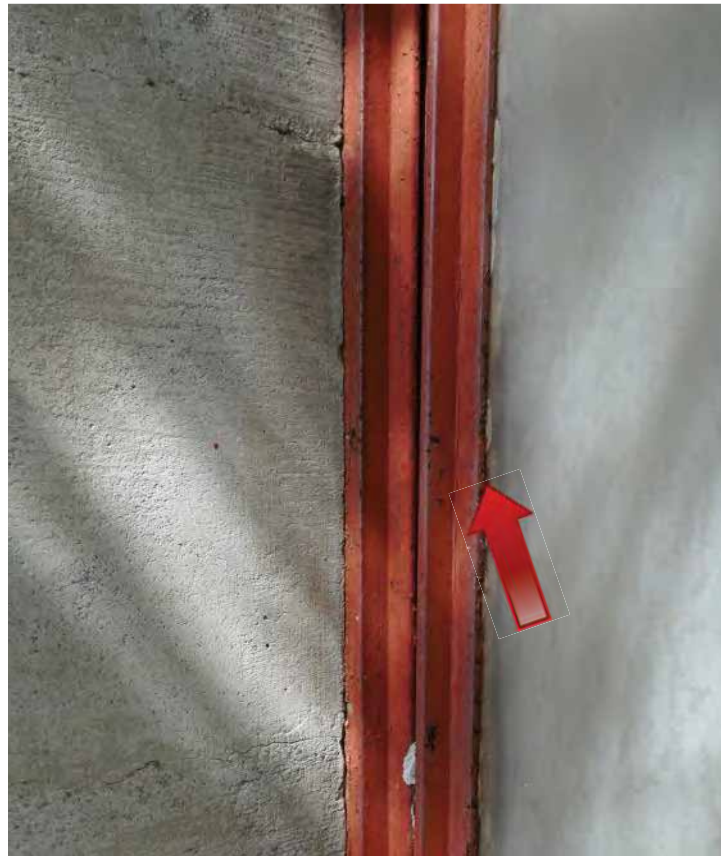
Detail of the cast-in-place steel window frame exhibits delamination, corrosion, and missing glazing compound. Image by Richaven Architecture and Preservation. 220620 CoT CAS EL-W P1000664.JPG

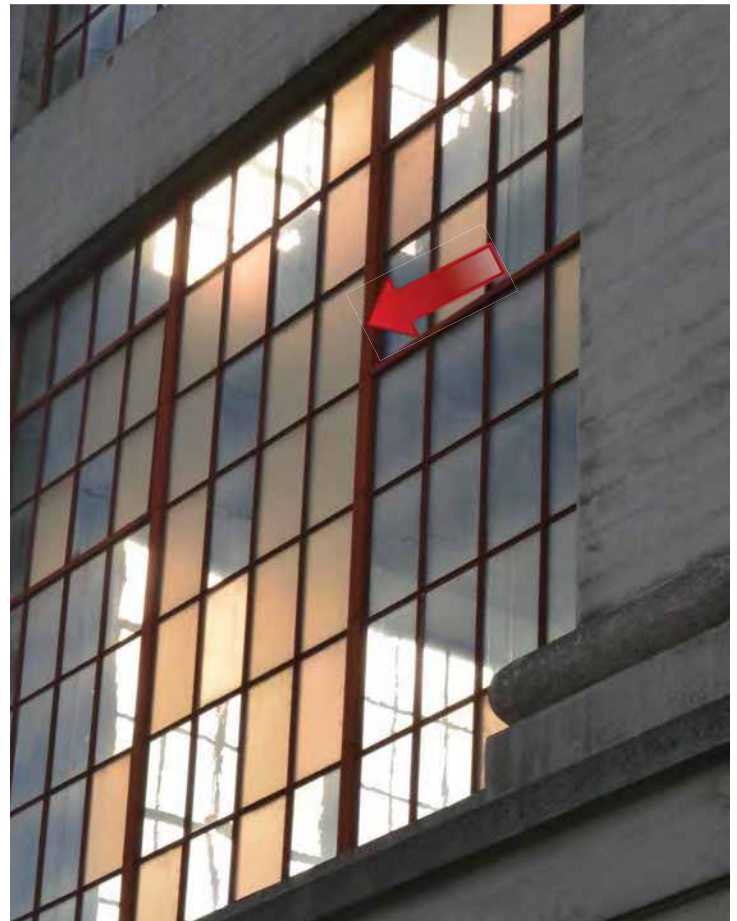
The original glass appears translucent and yellow, but it is unclear if this is due to soiling or the nature of the glass. Image by Otak. 200224 CoT CAS EL-S DSC_1057.JPG

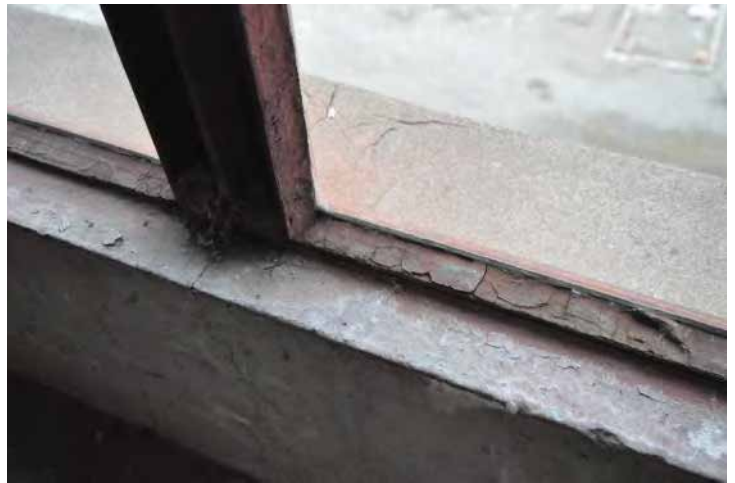
The cast-in-place steel windows exhibit extensive corrosion around the frame and loss of glazing compound. Image by Otak. 200224 CoT CAS EL-INT DSC_0092.JPG

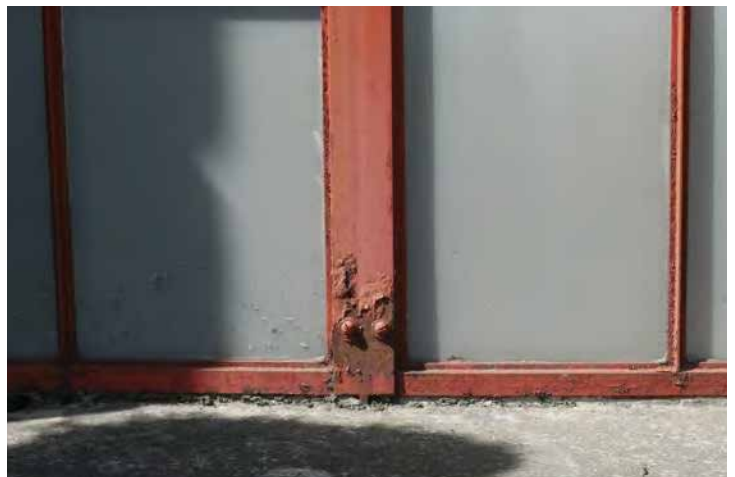
Visible corrosion around the fasteners of a window on the west elevation. Image by Richaven Architecture and Preservation. CoT CAS EL-W P1000654

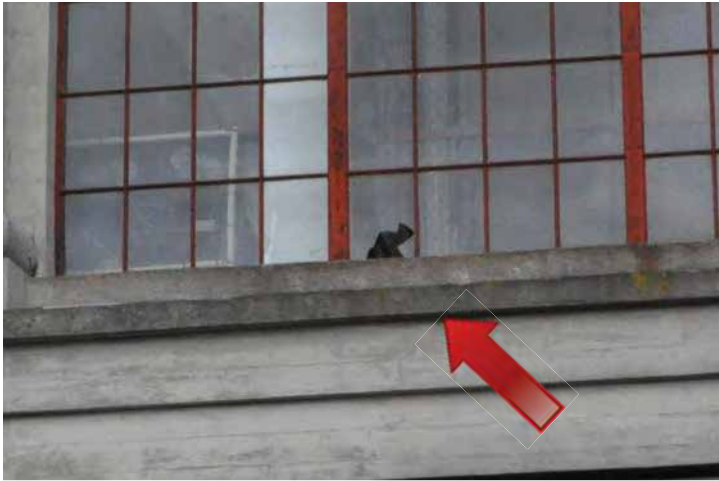
Broken glass pane on window bay above rolling gate on the north elevation. Image by Richaven Architecture and Preservation 200224 CoT CAS EL-N DSC_0189.JPG

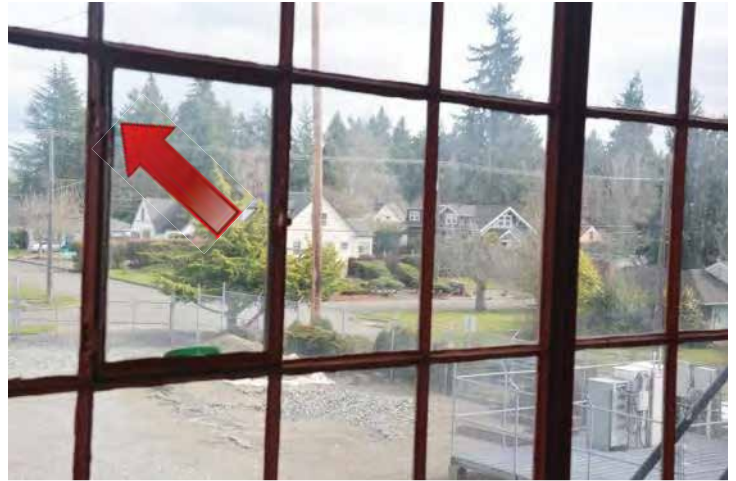
Badly corroded steel window frames and loss of glazing compound. Image by Otak. 200224 CoT CAS EL-INT DSC_10099.jpg

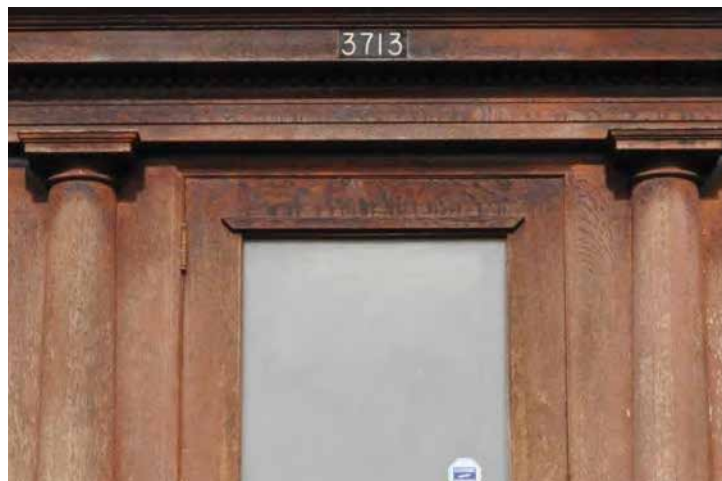
Door frame with a significant amount of fading and discoloration. Image by Richaven Architecture and Preservation. 200224 CoT CAS EL-S DSC_0011.JPG

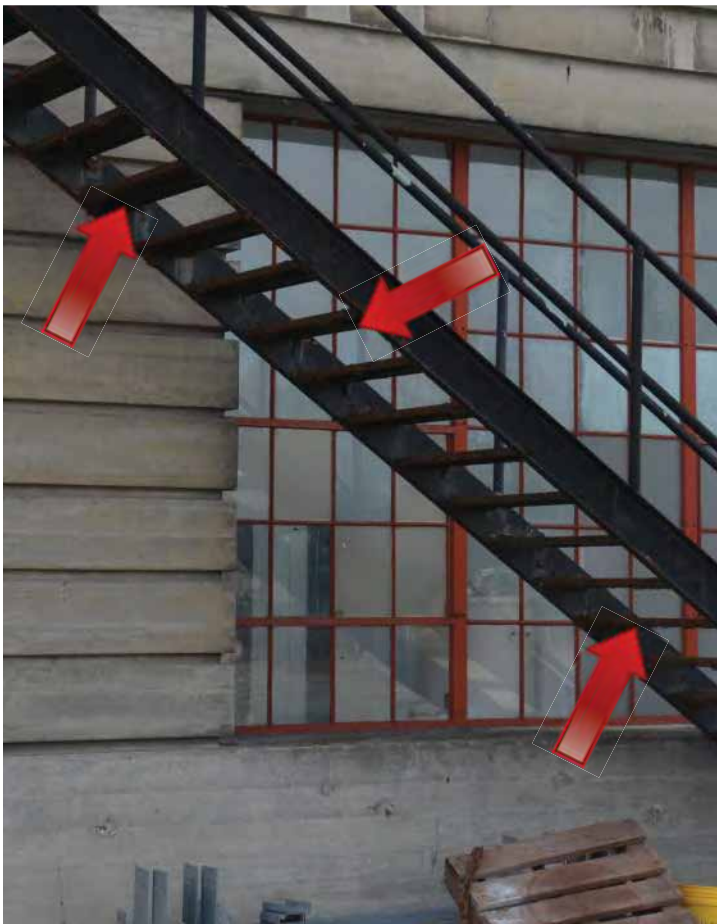
Richaven observed a substantial amount of corrosion on the steps and railings of the stairwell structure. Image by Otak. 200224 CoT CAS EL-E DSC_1045.JPG

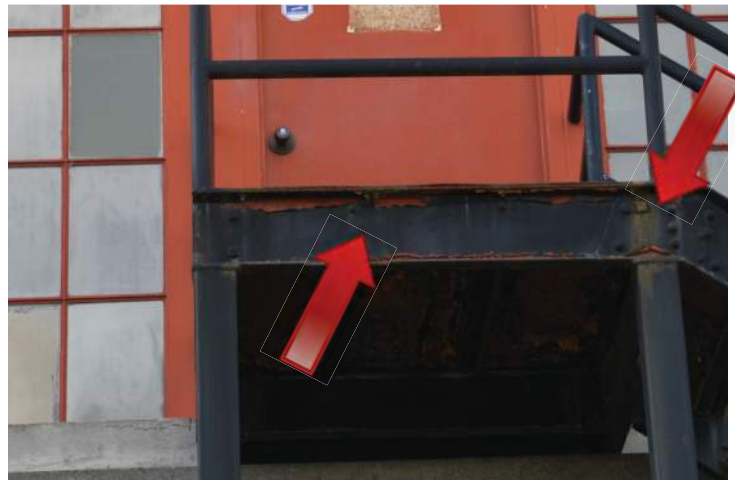
There is visible paint failure on the structure and signs of corrosion. Image by Otak. 200224 CoT CAS EL-E DSC_1039.JPG

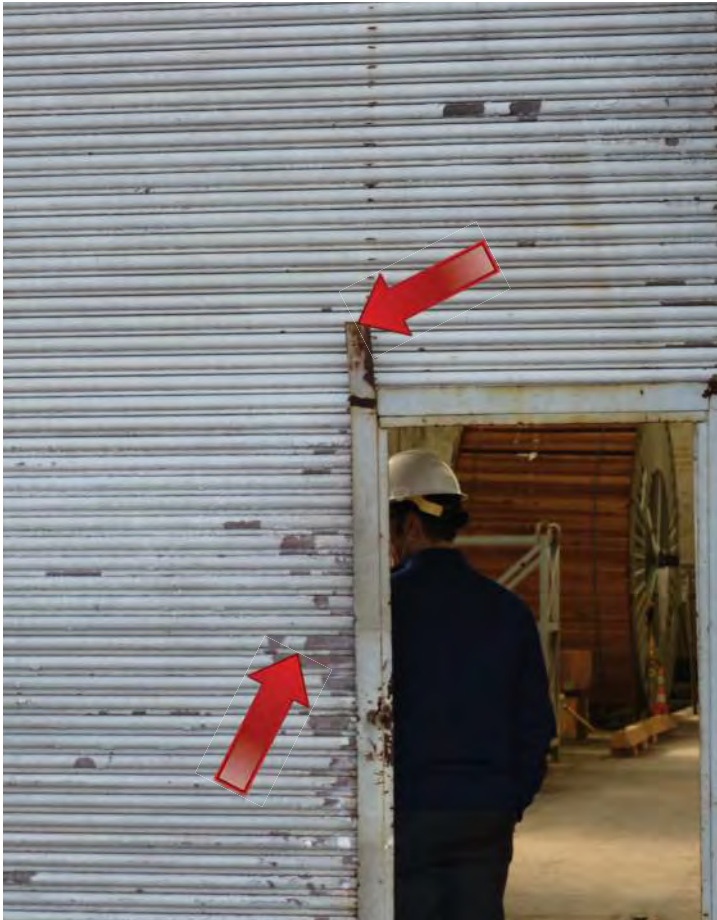
Richaven observed paint failure on the surface of the roll-up door on the north elevation, and corrosion around the steel frame door insert. Image by Otak. 200224 CoT CAS EL-E DSC_1056.JPG

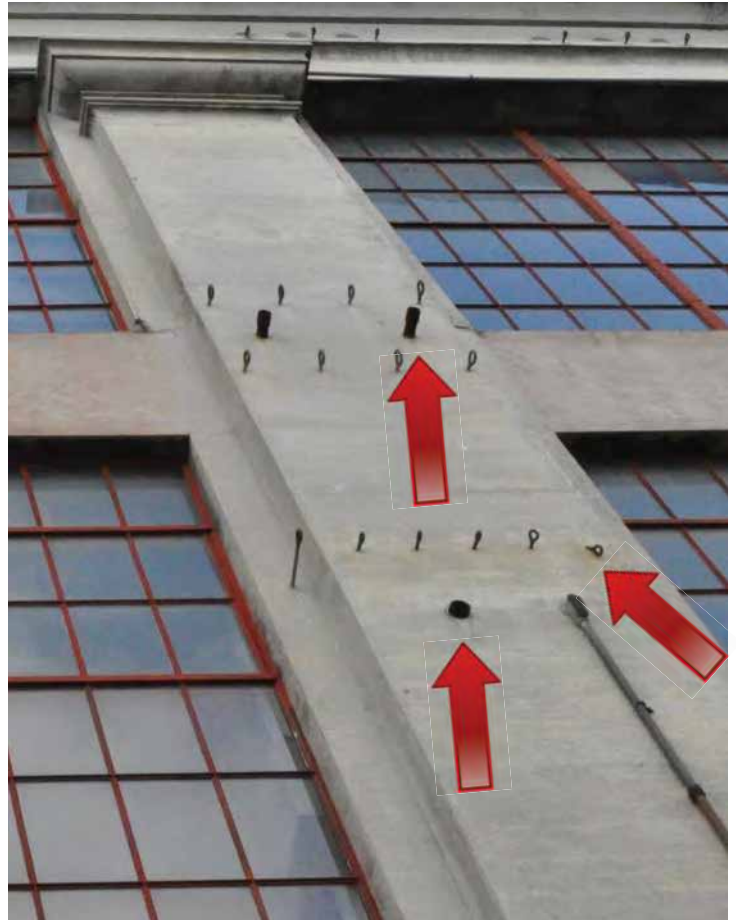
Observed steel eye bolts and several tubes embedded in the concrete on the east elevation. Image by Richaven Architecture and Preservation. 200224 CoT CAS EL-E DSC_0189.JPG

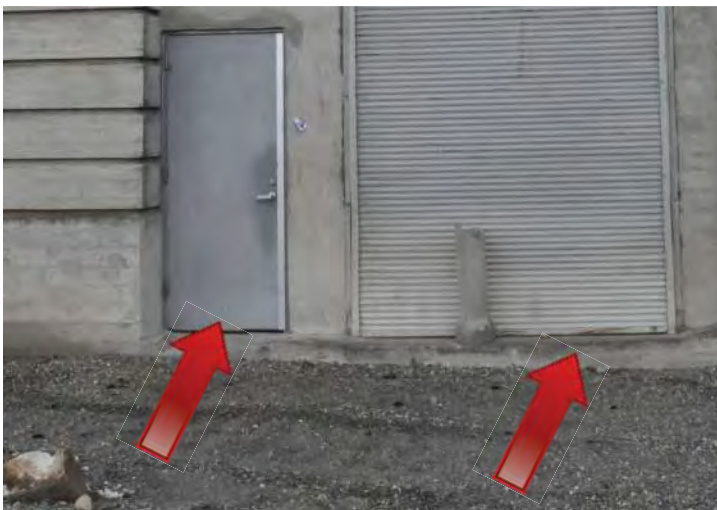
Doors on the north elevation are beginning to deteriorate. Image by Richaven Architecture and Preservation. 200224 CoT CAS EL-S DSC_0189.JPG

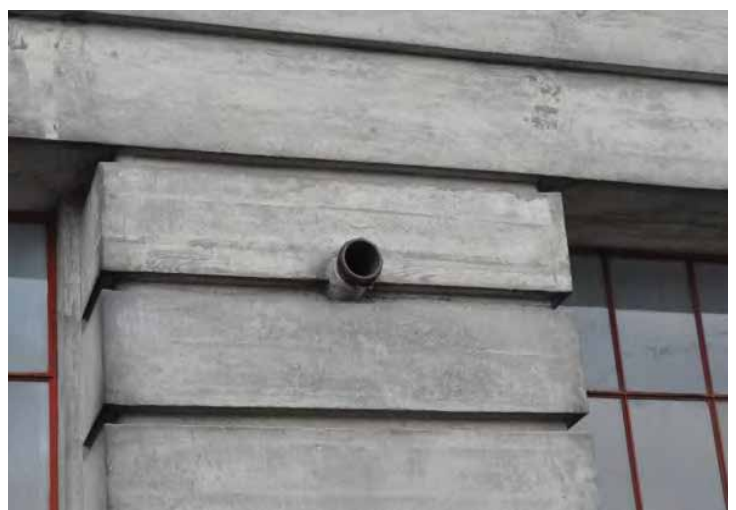
The tube embedded in the concrete appears not to be adequately sealed. It will allow water infiltration into the wall. 200224 CoT CAS EL-N DSC_0183.JPG

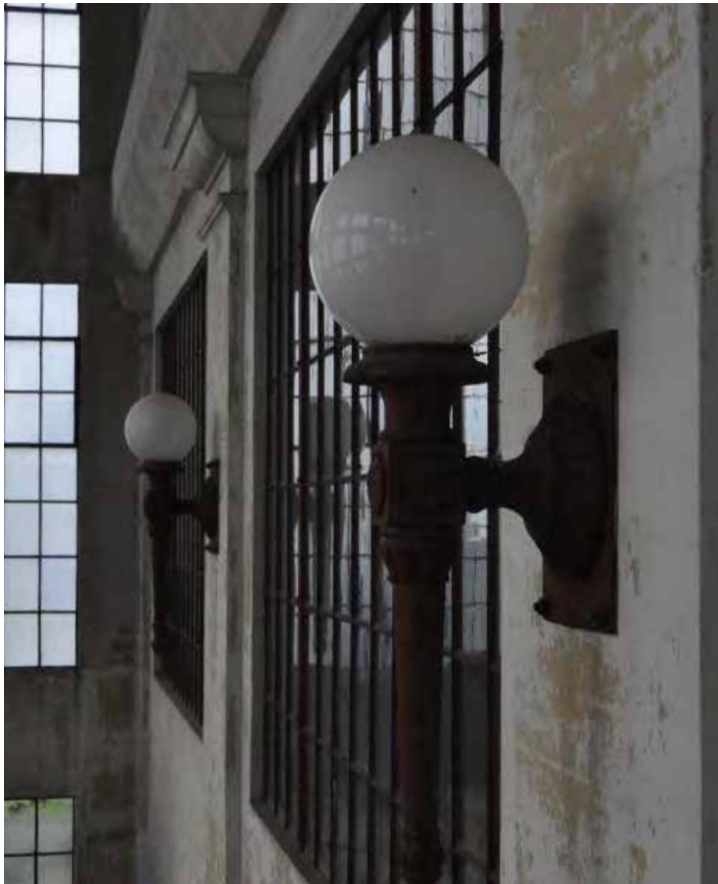
Visible paint failure in large areas in interior walls. Image by Otak. 200224 CoT CAS EL-INT DSC_0083.JPG

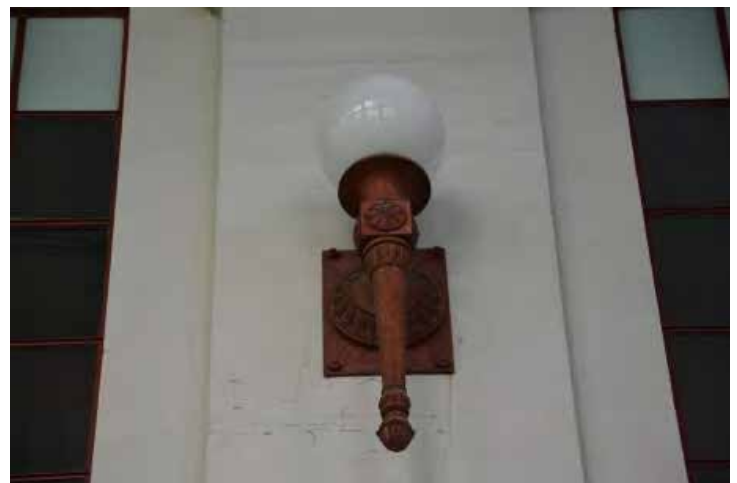
Cast iron decorative light fixture exhibiting corrosion. Image by Otak. 200224 CoT CAS INT DSC_0970.JPG

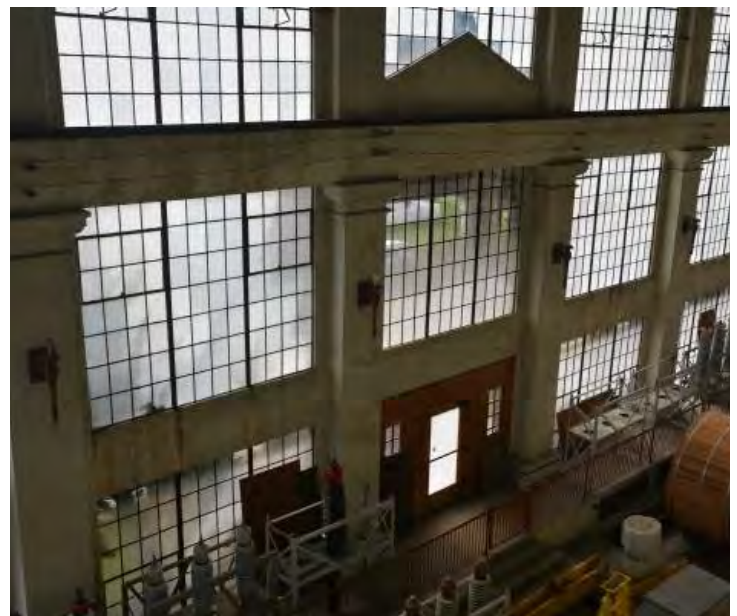
Glass globes are missing on the light fixtures above the main entrance. Image by Otak. 200224 CoT CAS EL-INT DSC_0999.JPG

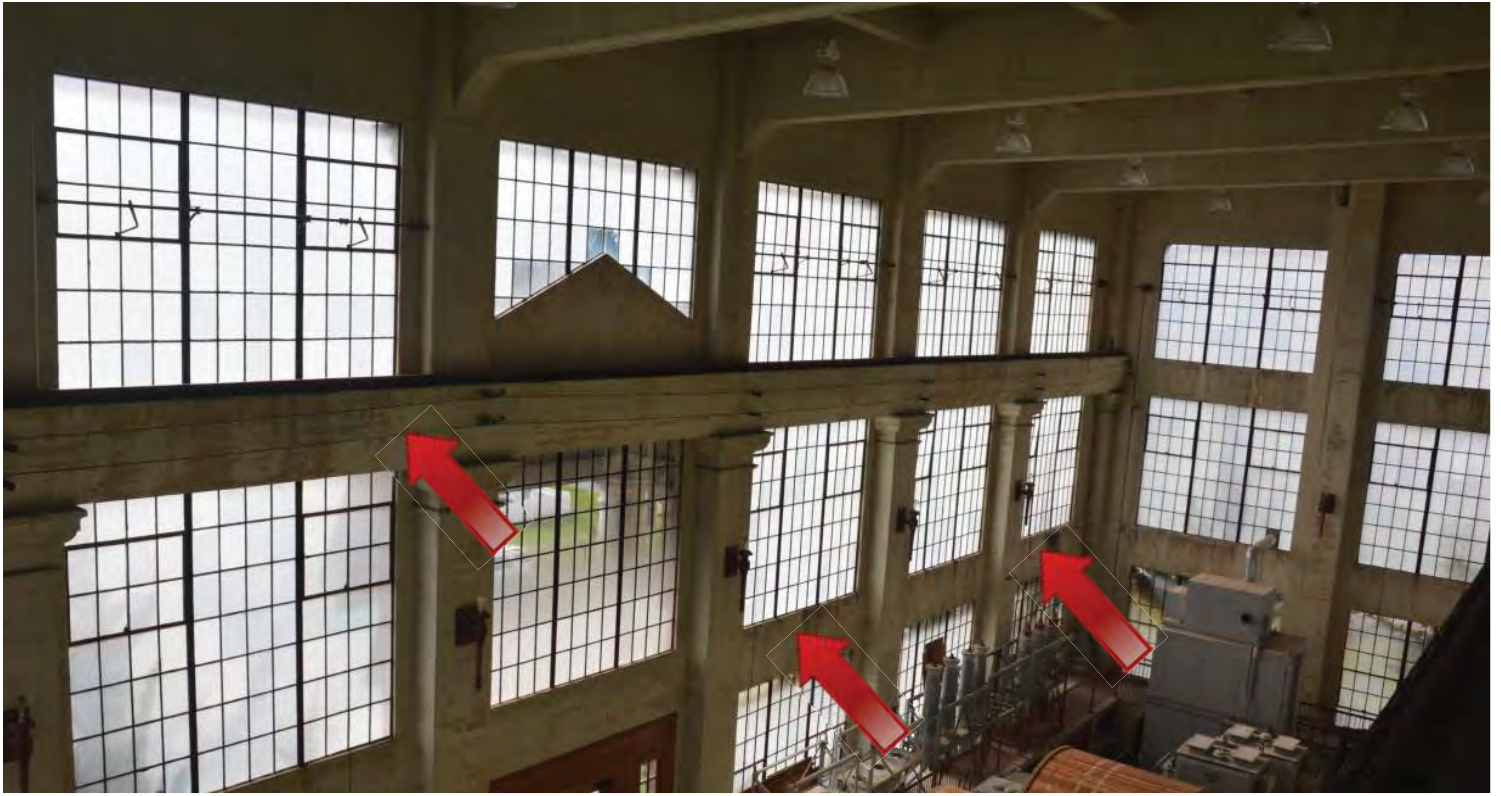
The dark areas under the windows appear to be organic growth (algae), indicating water infiltration. There is also a substantial amount of paint failure on the walls. Image by Otak. 200224 CoT CAS EL-INT DSC_0998.jpg

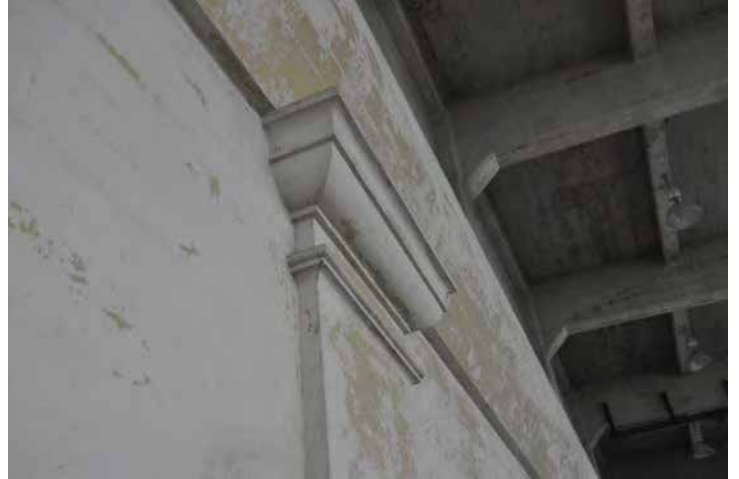
Visible paint failure, flaking, and peeling. Image by Otak. 200224 CoT CAS EL-INT DSC_0082.JPG.

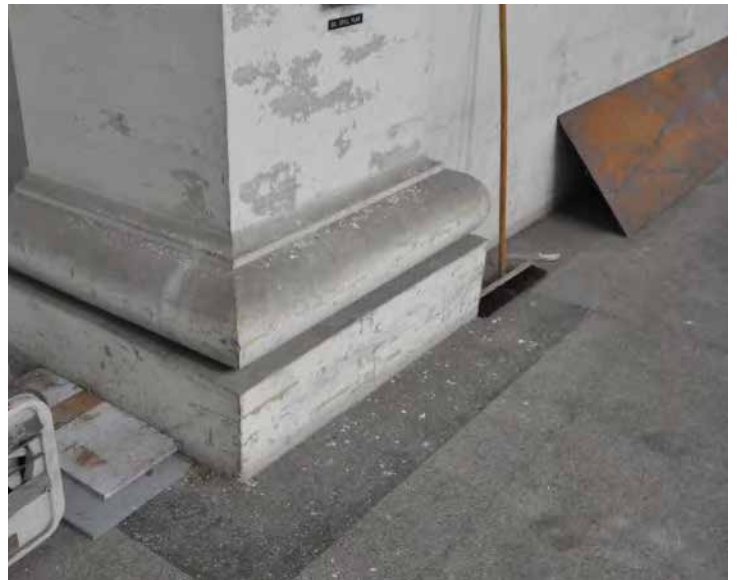
Paint failure and dust / dirt soiling on the base of the pilaster. Image by Otak. 200224 CoT CAS EL-INT DSC_0078.JPG

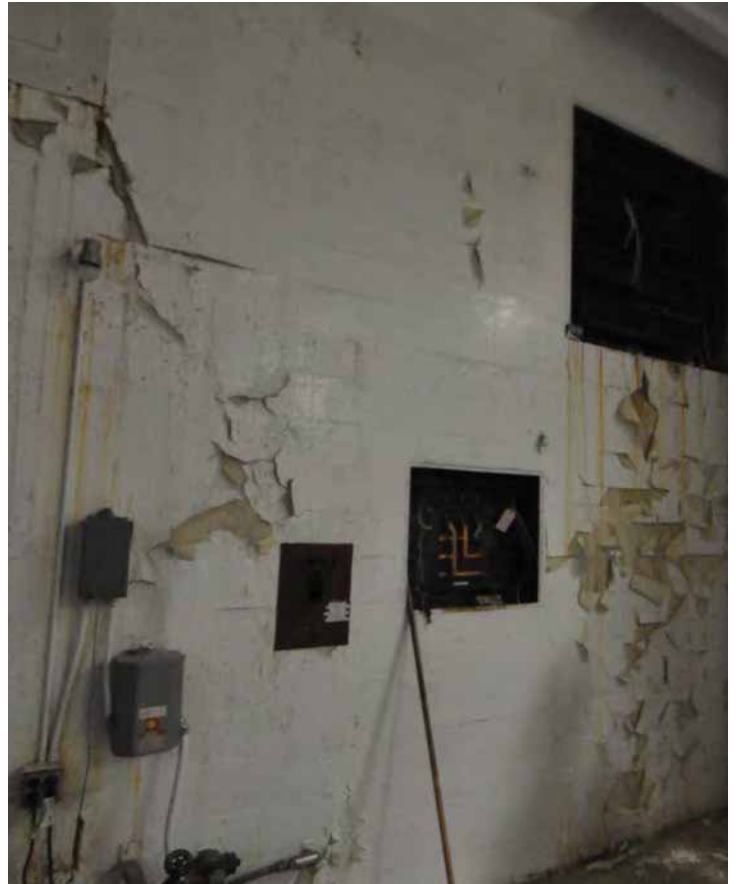
The location above shows concrete wall with the coating failing and peeling. Image by Otak. 200224 CoT CAS EL-INT DSC_0126.JPG.

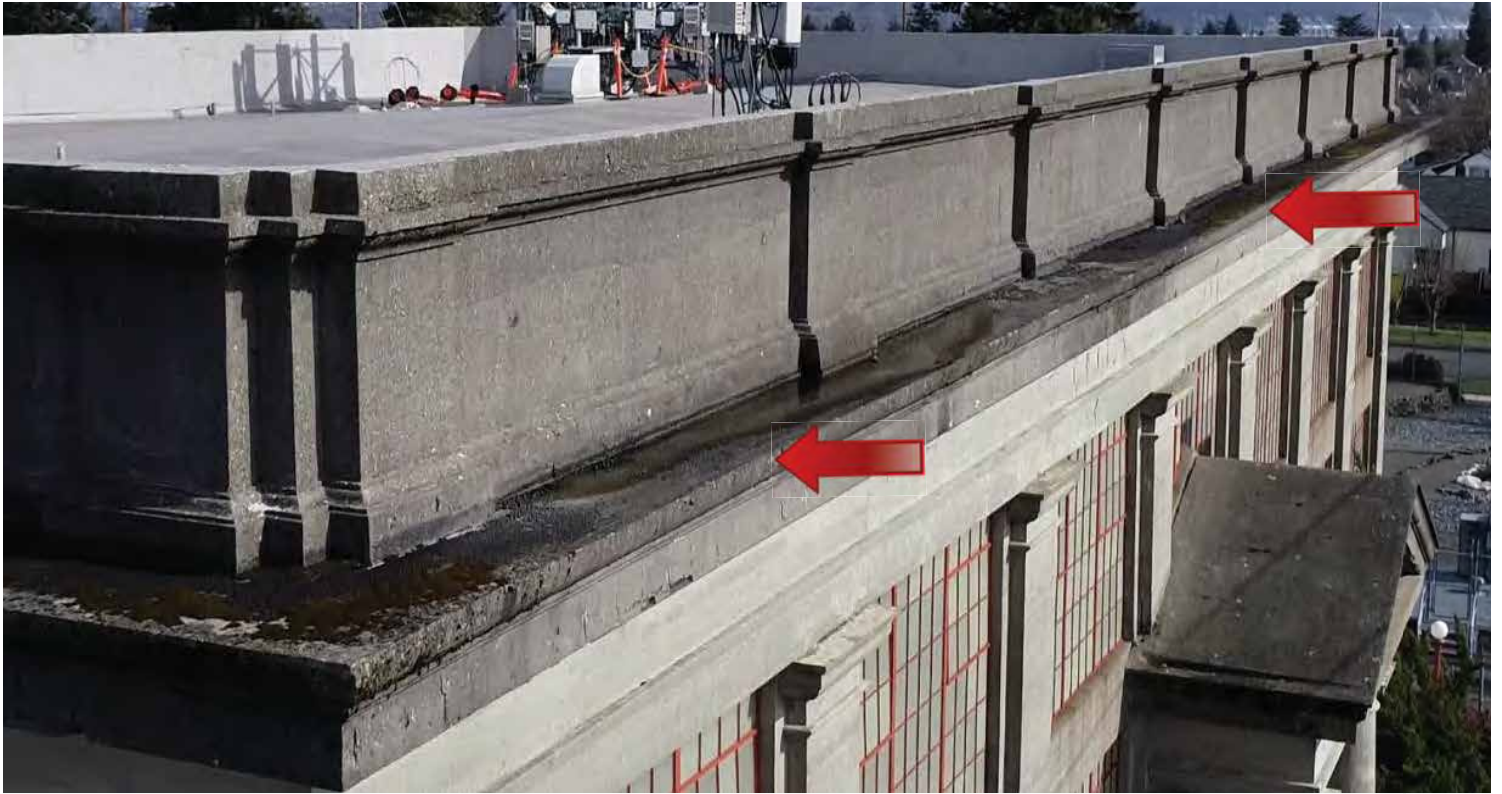
Organic soiling (algae, moss, etc.) and water collection observed on the cornice on the south elevation.
200224 CoT CAS EL-N DJI_00282.JPG

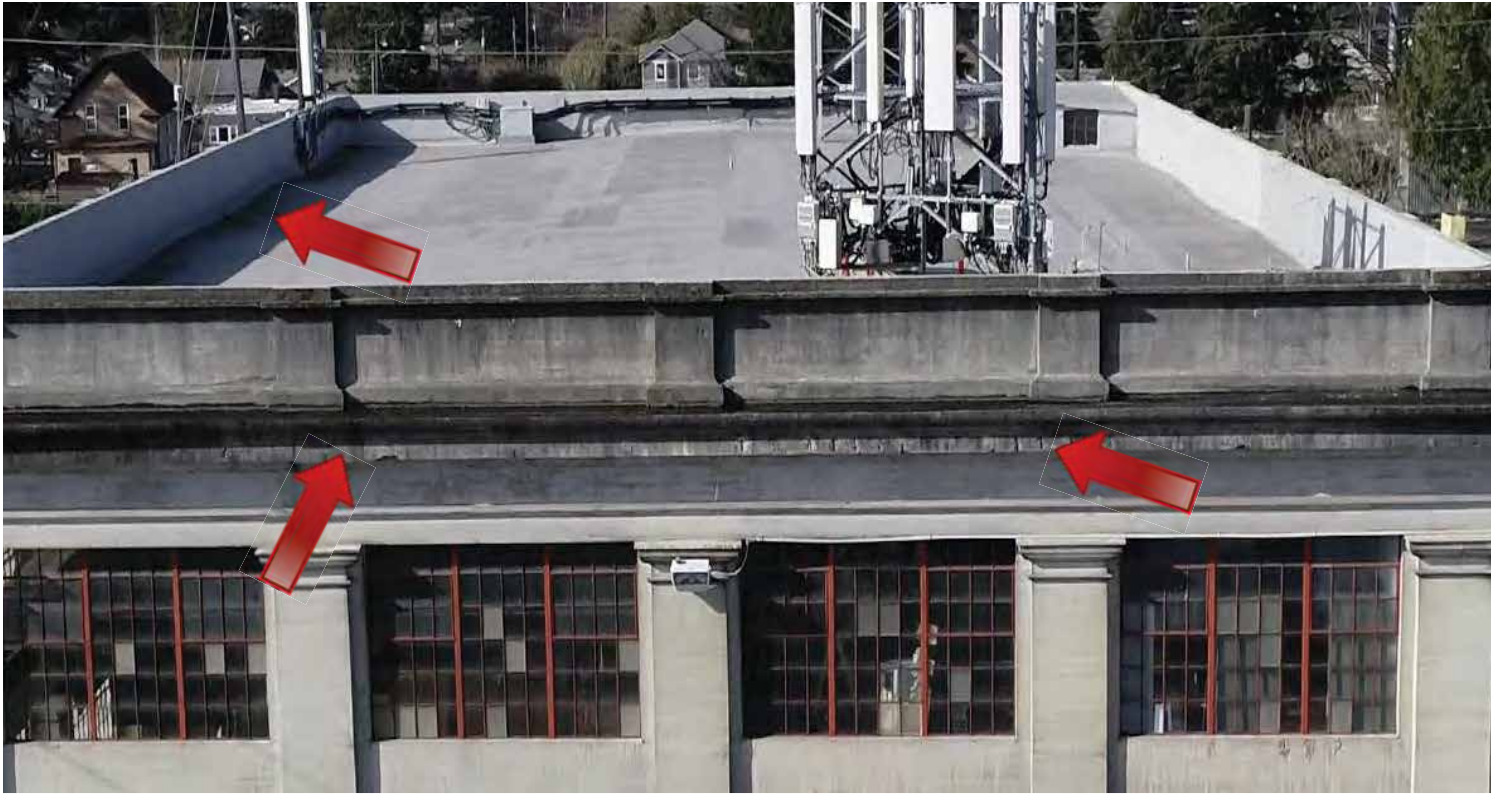
The back of the parapet on the south elevation has algae, indicating that water is collecting. There is also severe spalling on the cornice on the east elevation. There is a significant amount of atmospheric soiling. Image by Richaven Architecture and Preservation. 200224 CoT CAS EL-E DJI_0006.PNG

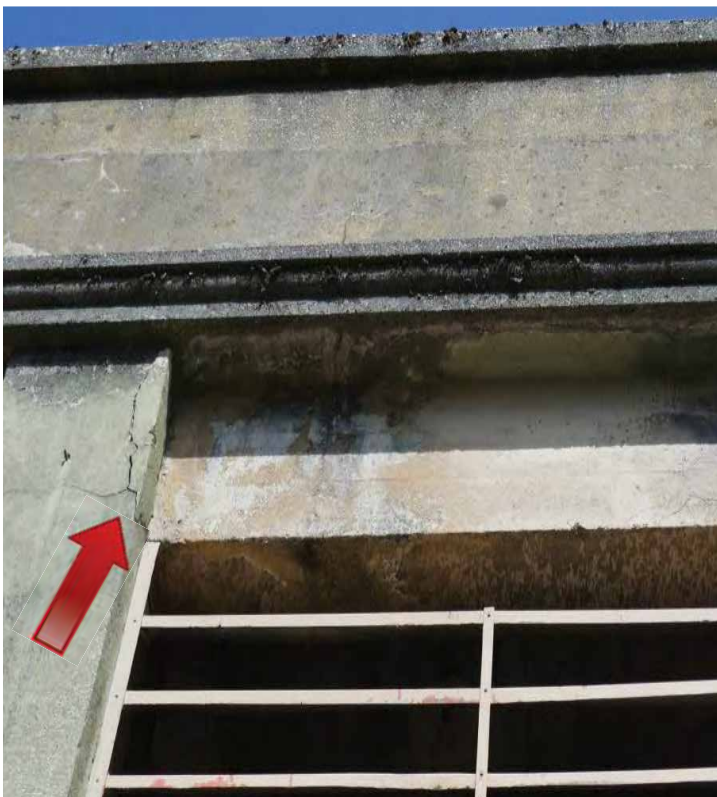
Cracking on the right edge of a pilaster on the east elevation. Image by Richaven Architecture and Preservation. 220620 CoT CAS EL-E P1000684.JPG
