Preliminary Evaluation of Building Conditions

Cushman & Adams Street Substations

Technical Work Completed: 2019-2020

Published February 2025

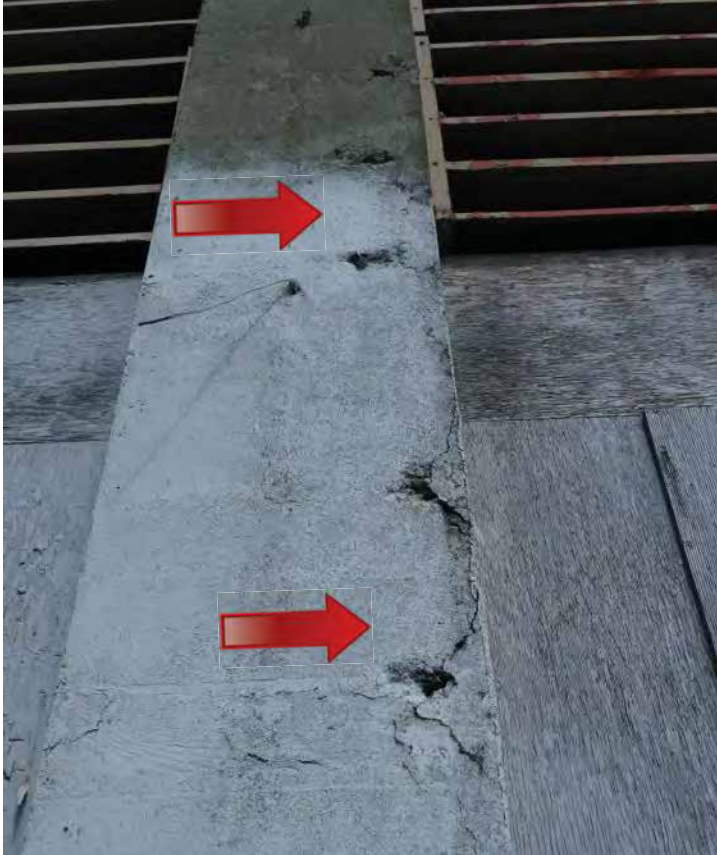
Severe spalling and cracking on a pilaster on the west elevation. Image by Richaven Architecture and Preservation. 220620 CoT CAS EL-E P1000678.JPG

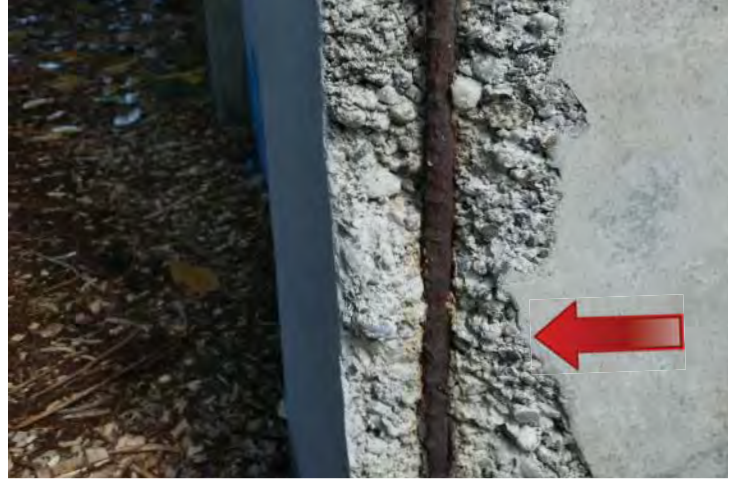
Failed concrete with exposed reinforcing steel on the left corner of a pilaster on the south elevation. Image by Richaven Architecture and Preservation. 220620 CoT CAS EL-S P1000675.JPG

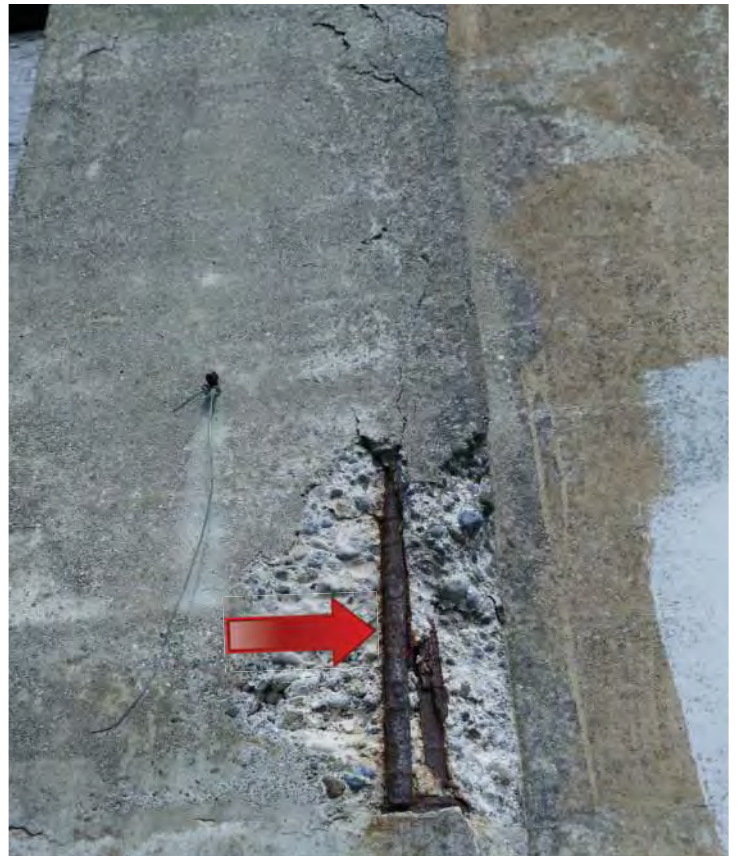
Severe separation from the substrate. Image by Richaven Architecture and Preservation. 220620 CoT CAS EL-W P1000679.JPG

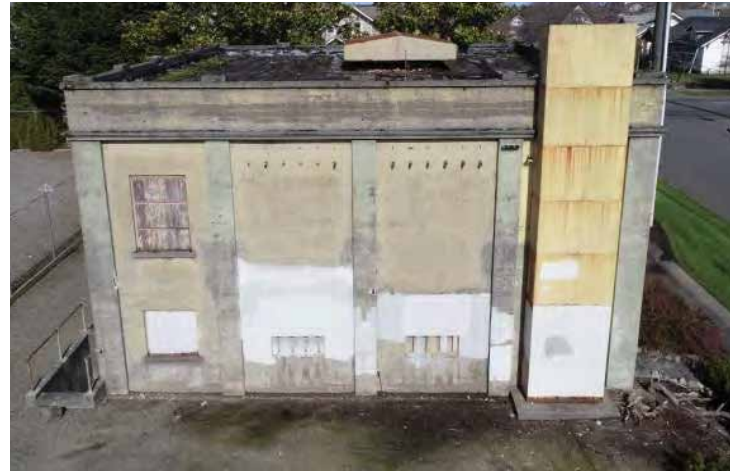
View of south elevation. White paint has been applied to the concrete walls to cover graffiti. Image by Richaven Architecture and Preservation. 200224 CoT CAS EL-S DJI_0071.JPG

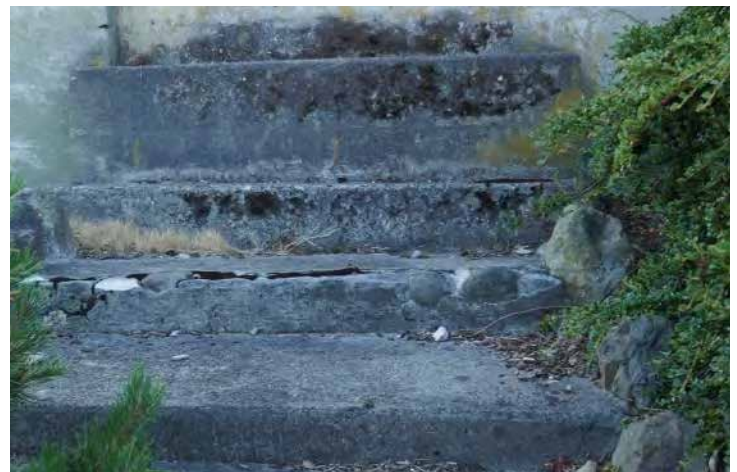
Organic soiling (algae and plants), observed on concrete stairs on the east elevation of the building. Image by Richaven Architecture and Preservation. 220620 CoT CAS EL-E P1000689.JPG

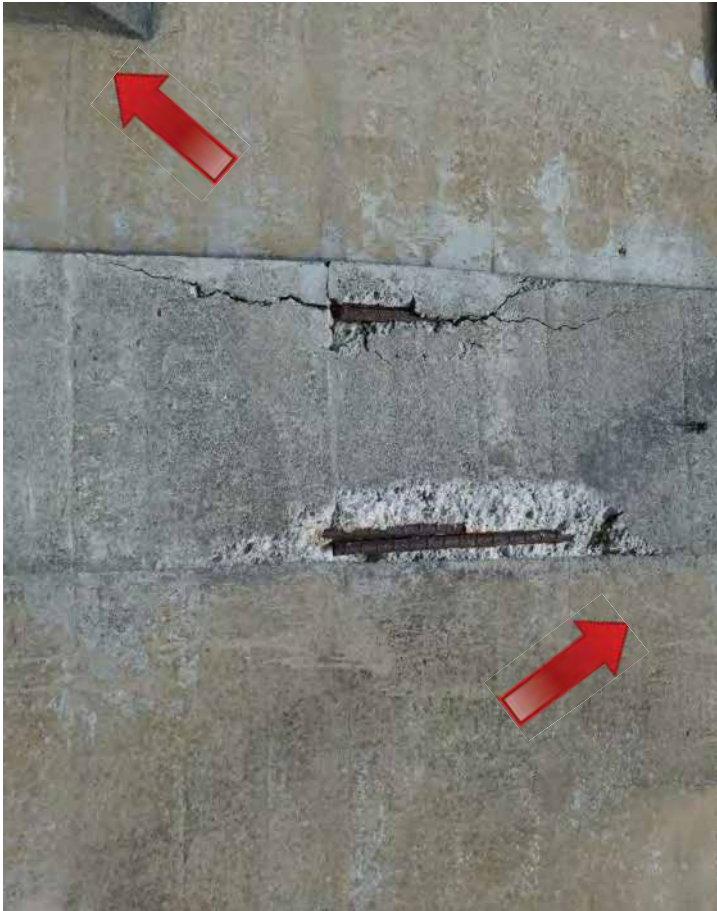
Discoloration of the yellow pigment is visible on all elevations on the building. Image by Richaven Architecture and Preservation. 220620 CoT CAS EL-W P1000681.JPG

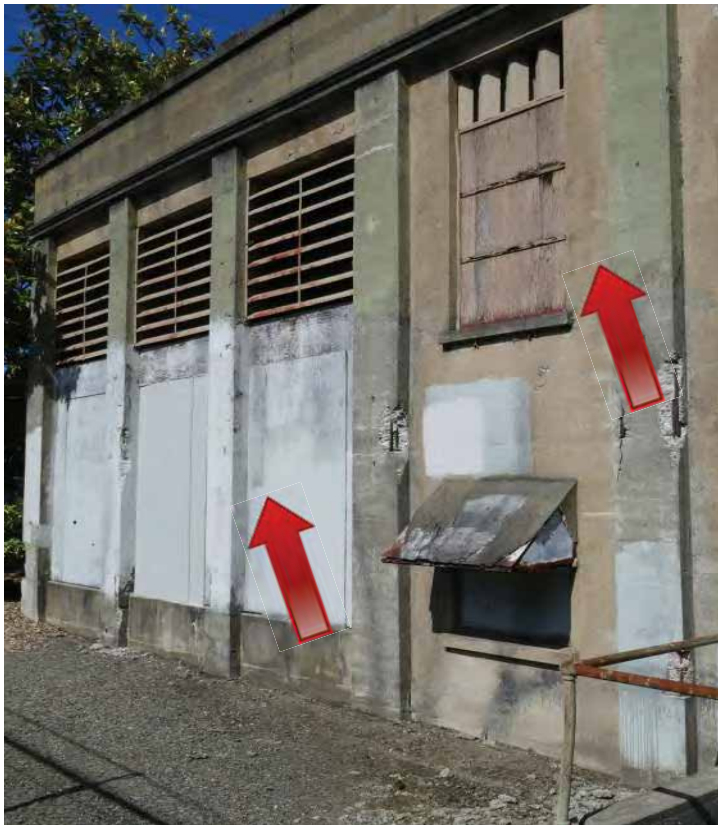
Missing windows and openings for ventilation under the louvers have been covered with plywood boards. Historical photos show single steel-framed nine-light windows with louvered vents above. Image by Richaven Architecture and Preservation. 220620 CoT CAS EL-W P1000685.JPG

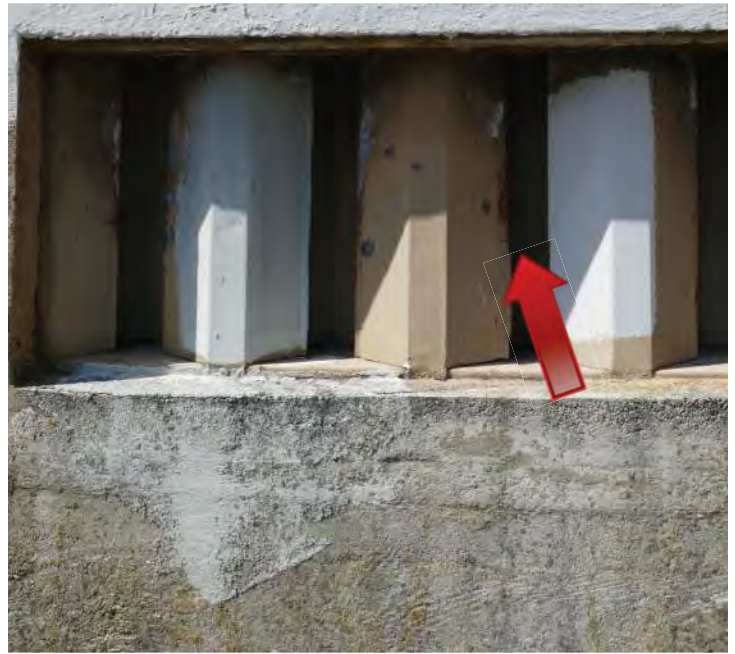
Vent on the south elevation with corrosion on the edges. Areas in white were painted to cover graffiti. Image by Richaven Architecture and Preservation. P000673.JPG.

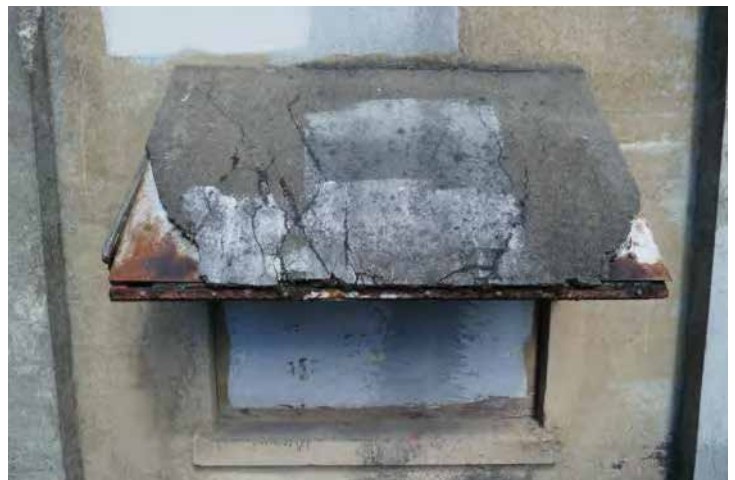
Metal awning on the west elevation is corroded. Layer of asphaltic material attached is 100% failed. Image by Richaven Architecture and Preservation. 220620 CoT CAS EL-W P1000680.JPG

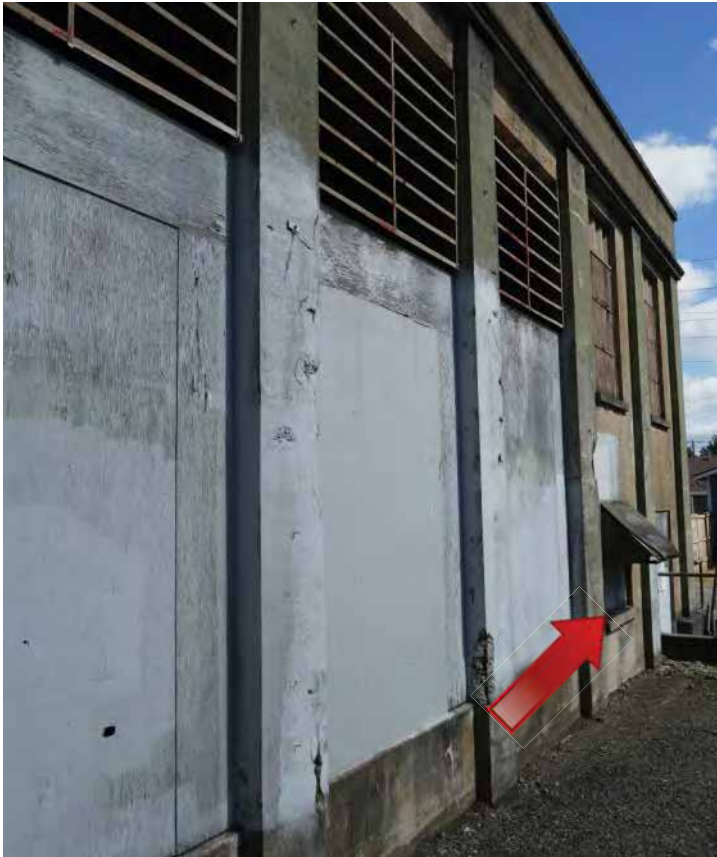
Metal louvers on the west elevation and a missing window covered with plywood boards. Image by Richaven Architecture and Preservation 06/20/22, 220620 CoT CAS EL-W P1000674.JPG

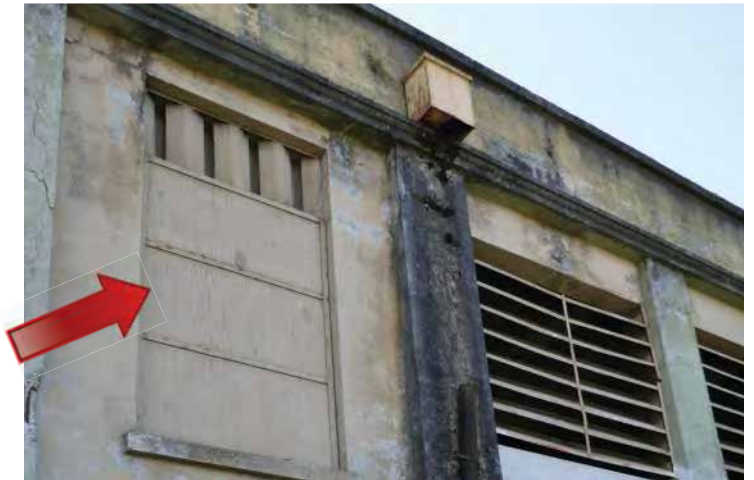
Missing steel windows and vents have been covered with plywood boards. Image by Richaven Architecture and Preservation. 220620 CoT CAS EL-E P1000691.JPG.

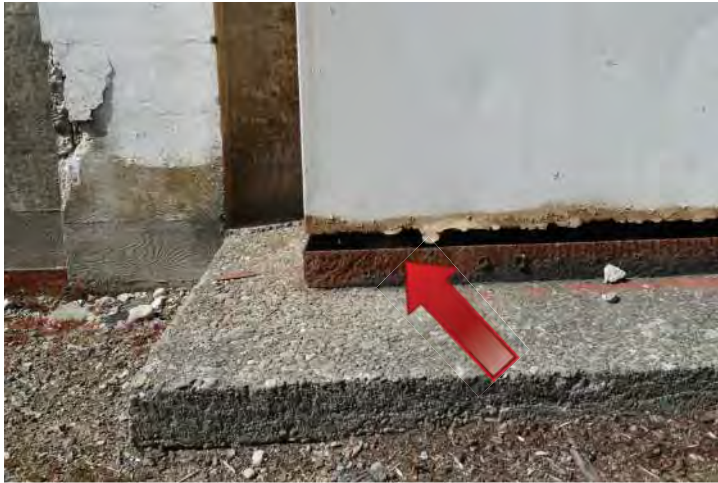
Richaven observed severe corrosion on the base of the steel ventilation stack on the south elevation. Image by Richaven Architecture and Preservation. 220620 CoT CAS EL-S P1000670.JPG

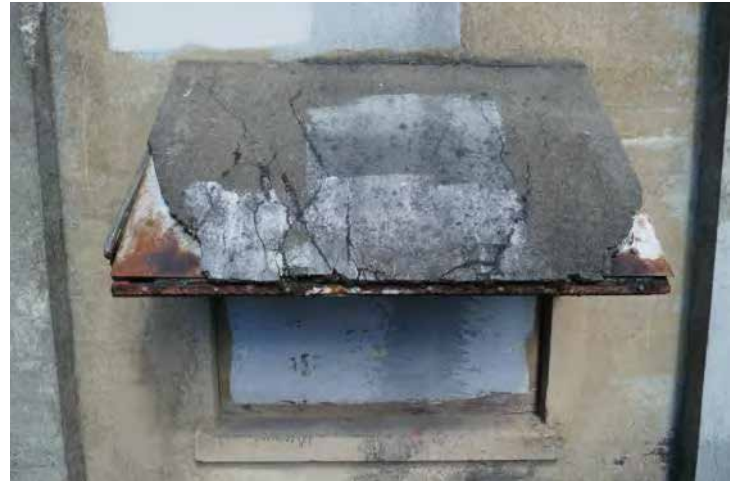
The metal awning on the west elevation is corroded. A layer of asphaltic material attached to its surface is severely damaged. Image by Richaven Architecture and Preservation. 220620 CoT CAS EL-W P1000680.JPG

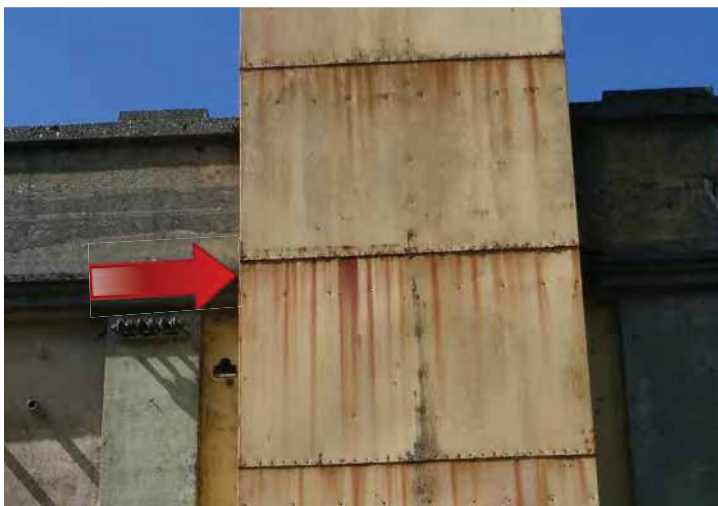
The panels that form the steel ventilation stack are severely corroded. Image by Richaven Architecture and Preservation. 220620 CoT CAS EL-S P1000671.JPG

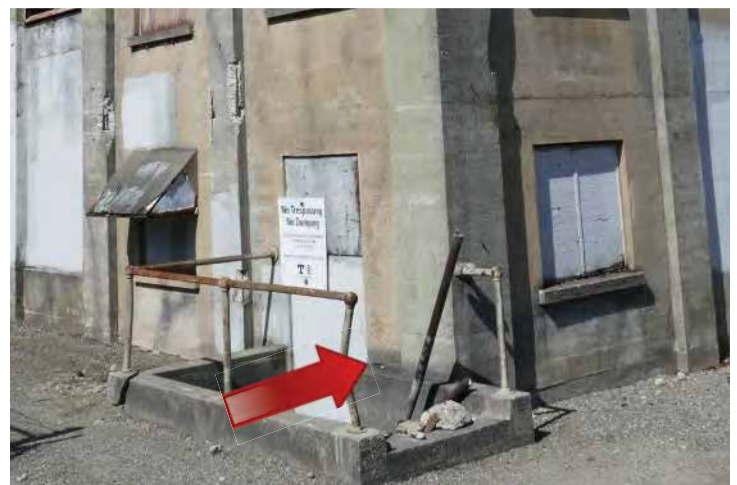
Pipe railings around the concrete stairway on the west elevation have failed. Image by Richaven Architecture and Preservation. 220620 CoT CAS EL-S-W P1000688.JPG

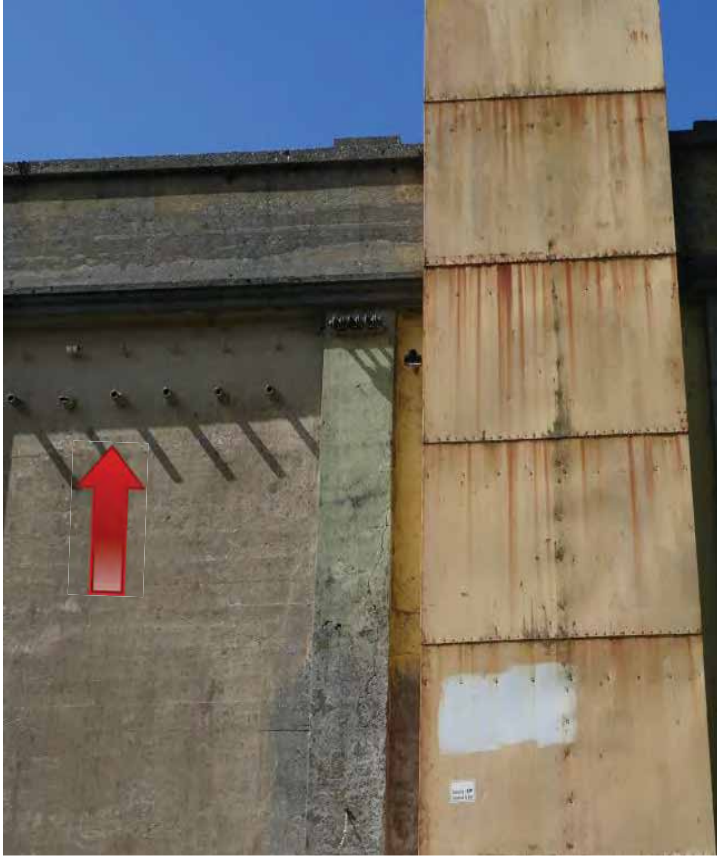
Observed steel eye bolts, pulleys, and severed tubes embedded into the concrete on the south elevation. The pipes embedded in the concrete appear not to be adequately sealed, allowing water infiltration into the wall. Image by Richaven Architecture and Preservation. 220620 CoT CAS EL-S P1000671.JPG

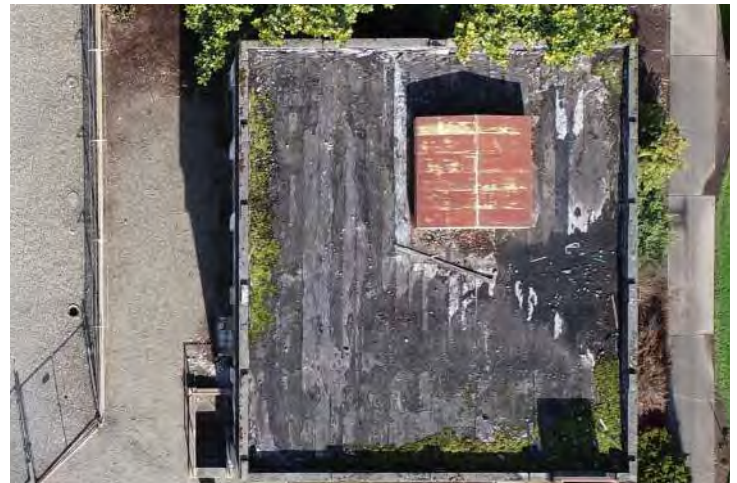
The monitor for ventilation is severely corroded. Image by Richaven Architecture and Preservation. 200224 CoT CAS ROOF DJI_0063.JPG.

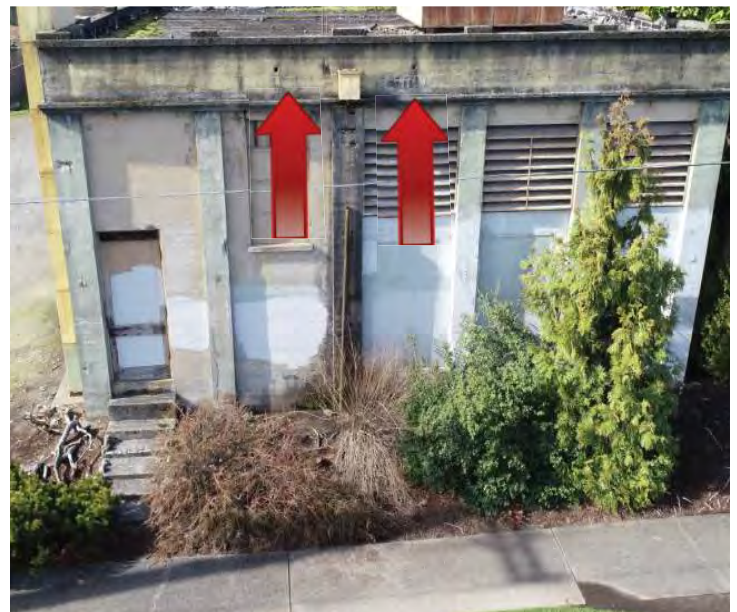
It is unknown if holes in the parapets are original. There is extensive atmospheric soiling around them. Image by Richaven Architecture and Preservation. 200224 CoT CAS EL-E DJI_0075.JPG
