Tacoma Vision Zero Road Safety Audits

September 2024 ■ Year 1 Report

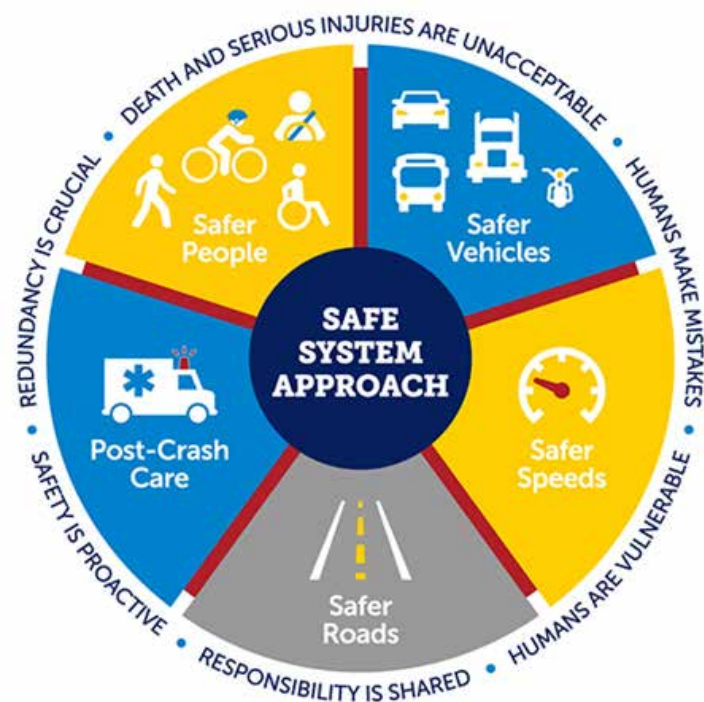
FIGURE 1 FHWA Safe System Approach Wheel (FHWA, 2022)

Safe System Principles are illustrated in the outer ring of the graphic with the Safe System elements found on the inner ring: Safer People, Safer Vehicles, Safer Speeds, Safer Roads, and Post-Crash Care.

The Tacoma Vision Zero Road Safety Audit is framed around the Safe System Approach (Figure 1). The Federal Highway Administration (FHWA) provides guidance on the Safe System Approach, which recognizes that road safety is a shared responsibility between those that design, build, operate, and use the road system. It recognizes that to reduce risks to humans all parts of the transportation system must be strengthened, so that if one part fails, the other parts still protect people.

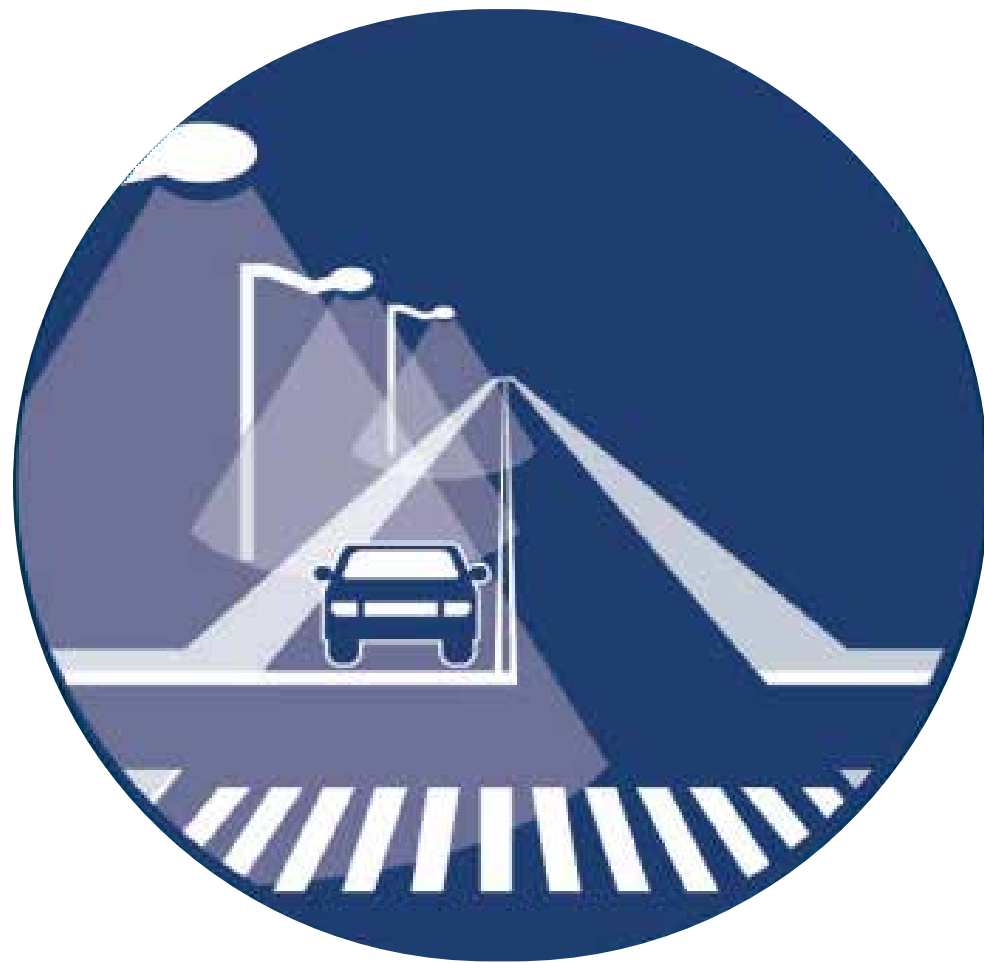
Lighting can be applied continuously along segments and at spot locations such as intersections and pedestrian crossings to reduce the chances of a crash. Adequate lighting (i.e., at or above minimum acceptable standards) is based on research recommending horizontal and vertical illuminance levels to provide safety benefits to all users of the roadway environment. Adequate lighting can also provide benefits in terms of personal security for pedestrians, wheelchair and other mobility device users, bicyclists, and transit users as they travel along and across roadways.

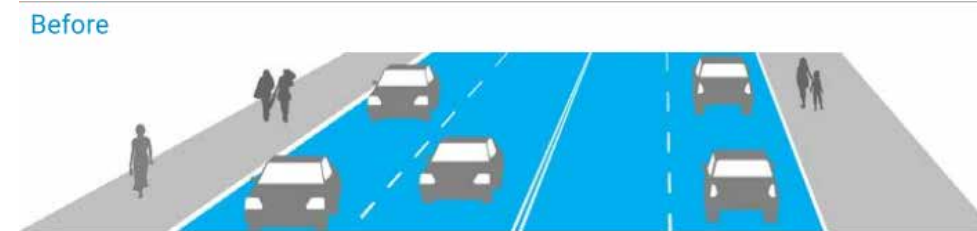
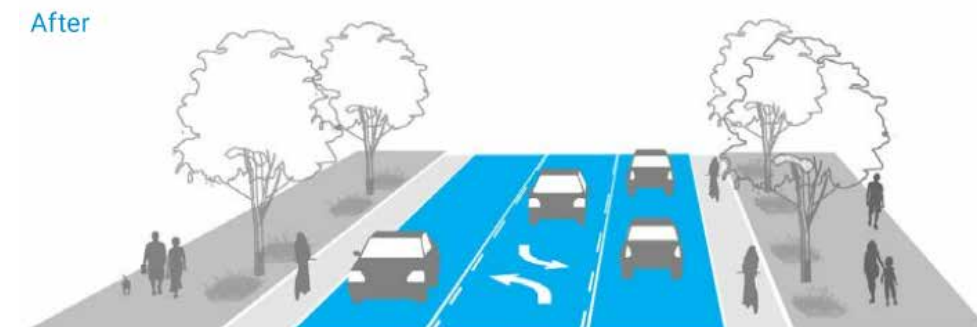
Thermoplastic pavement markings can be used in place of painted pavement markings. The material is retroreflective and can be seen in wet and dark conditions. A Road Diet, or roadway reconfiguration, can improve safety, calm traffic, provide better mobility and access for all road users, and enhance overall quality of life. A Road Diet typically involves converting an existing four-lane undivided roadway to a three-lane roadway consisting of two through lanes and a two way left turn lane (TWLTL).

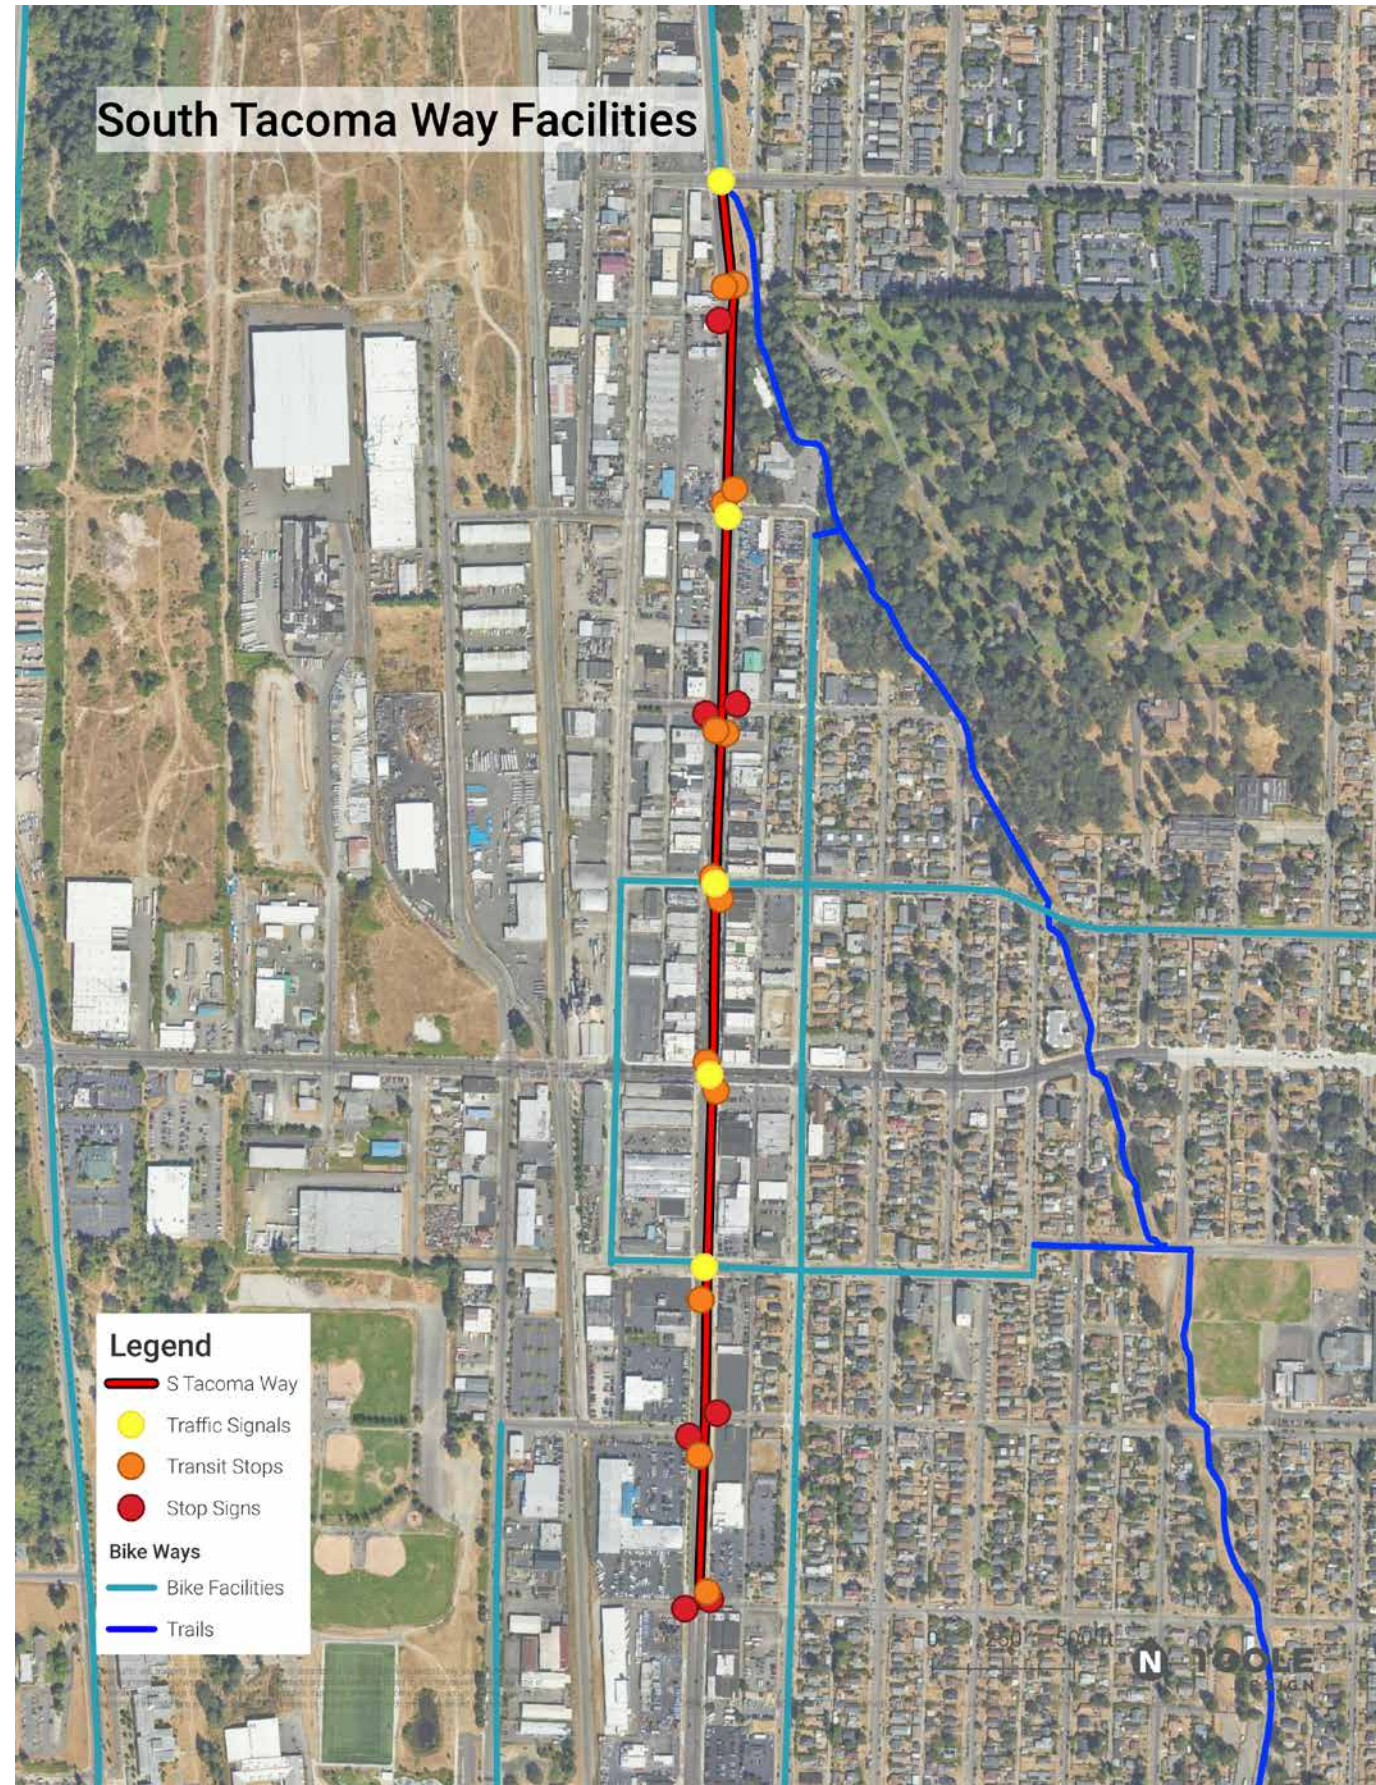
FIGURE 6 South Tacoma Way Facilities

Figure 6 displays facilities along South Tacoma Way. The map includes locations of existing bicycle facilities, traffic signals, stop signs and bus stops.

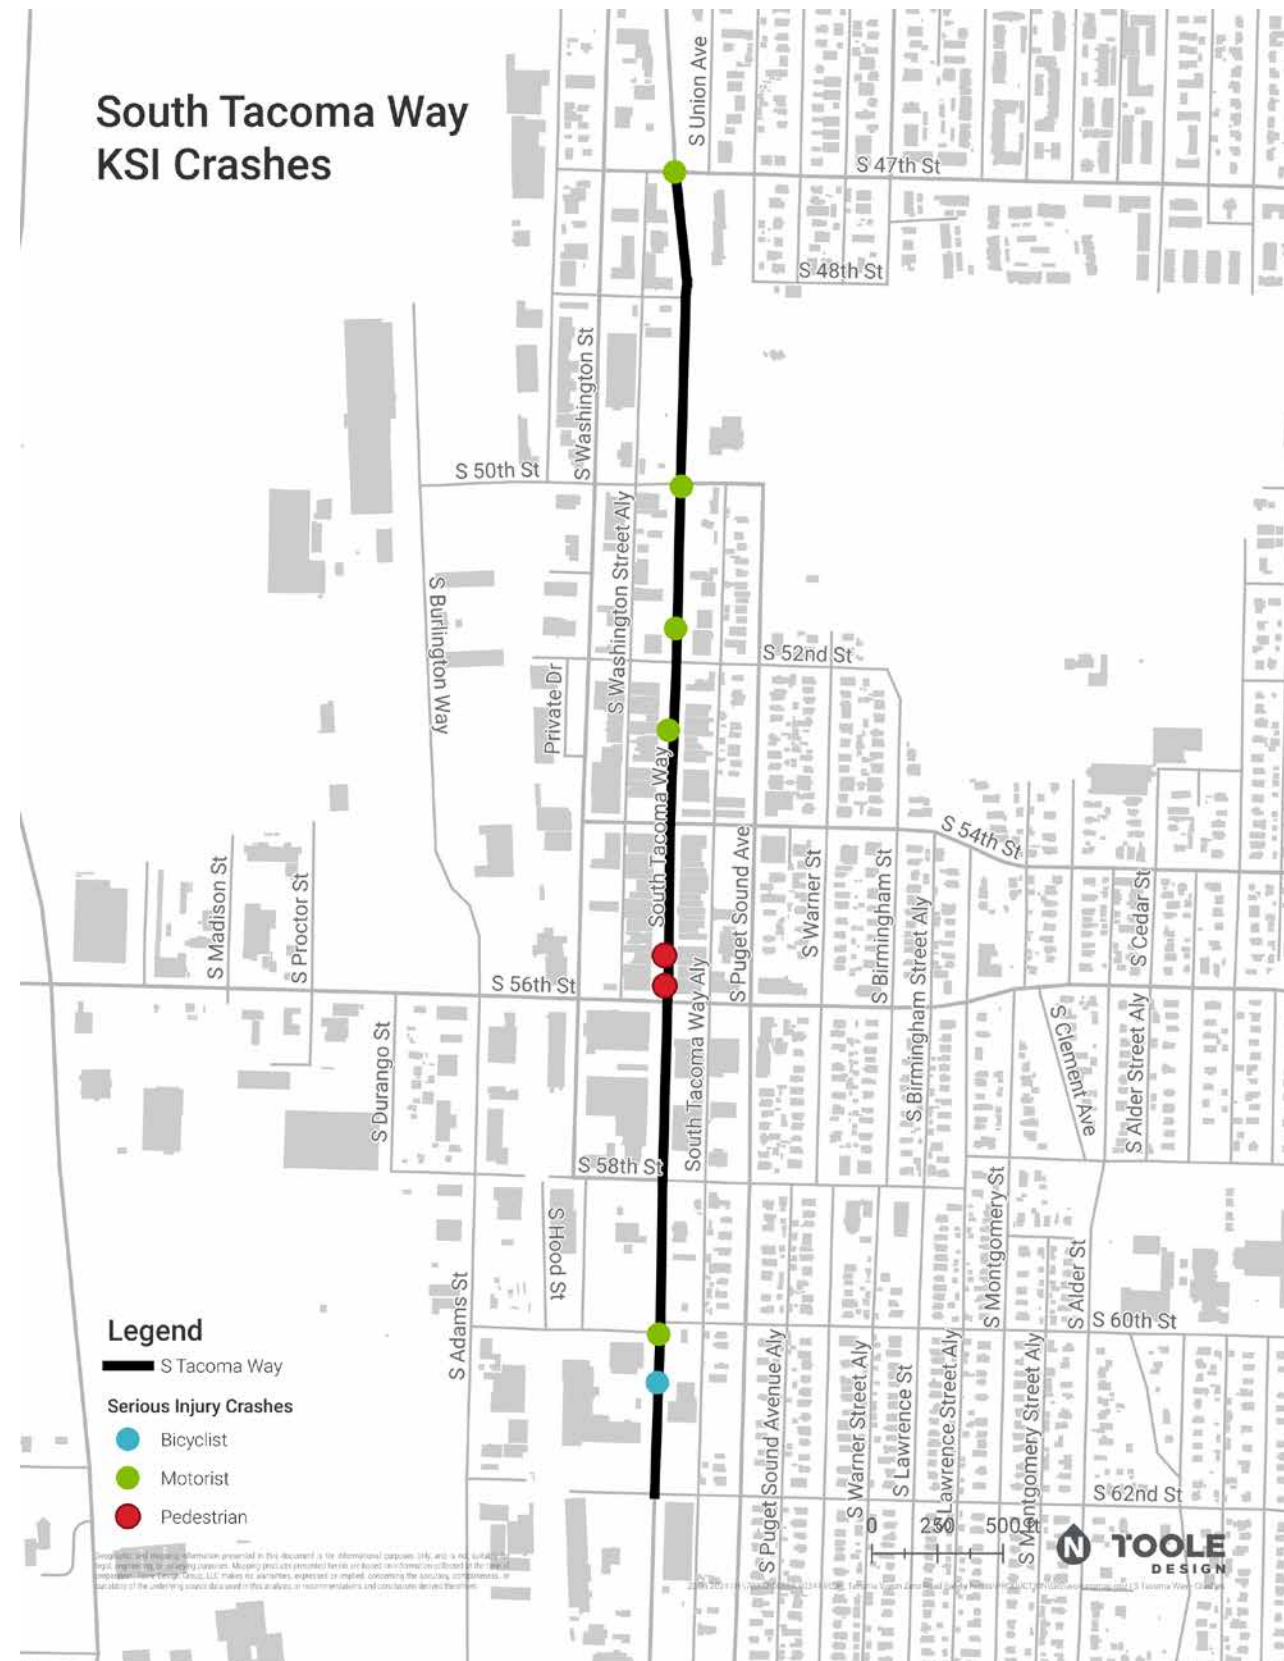
FIGURE 7 S Tacoma Way KSI Crashes Map

2017	2018	2019	2020	2021	2022	2023
SERIOUS INJURY	0	0	1	2	3	2	0
FATAL	0	0	0	0	0	0	0

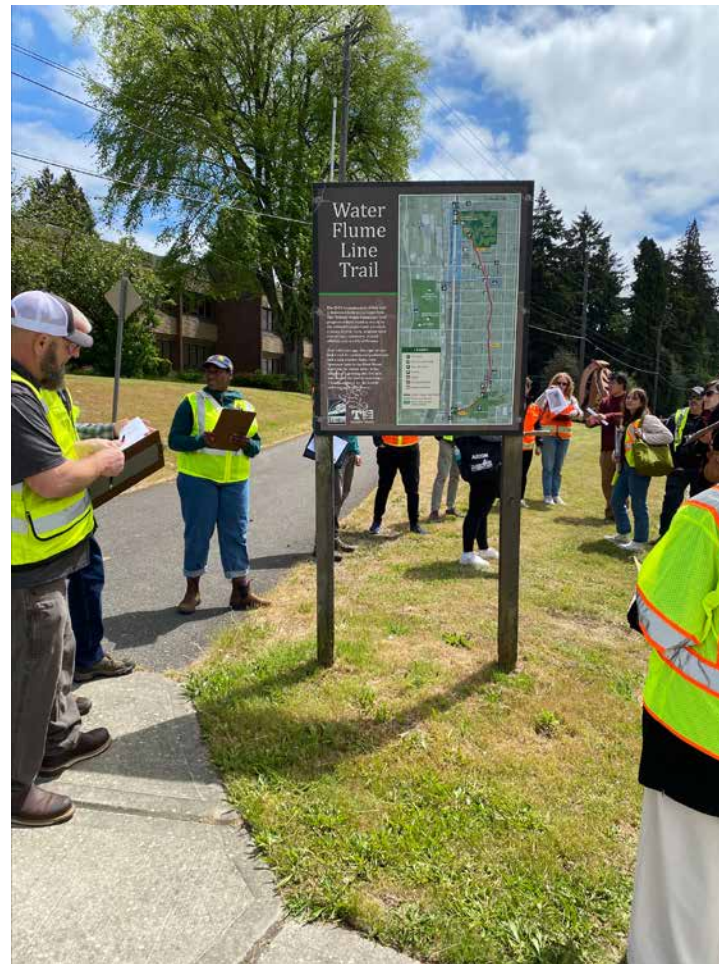
End of Water Plume Lane Trail at S 47th St and S Tacoma Way

- The sidewalk is substandard along frontage. Curb is rolled and fails to protect sidewalk for motorists.
- Add curb along sidewalk on west side.
- Plant trees in landscape zone on east side.

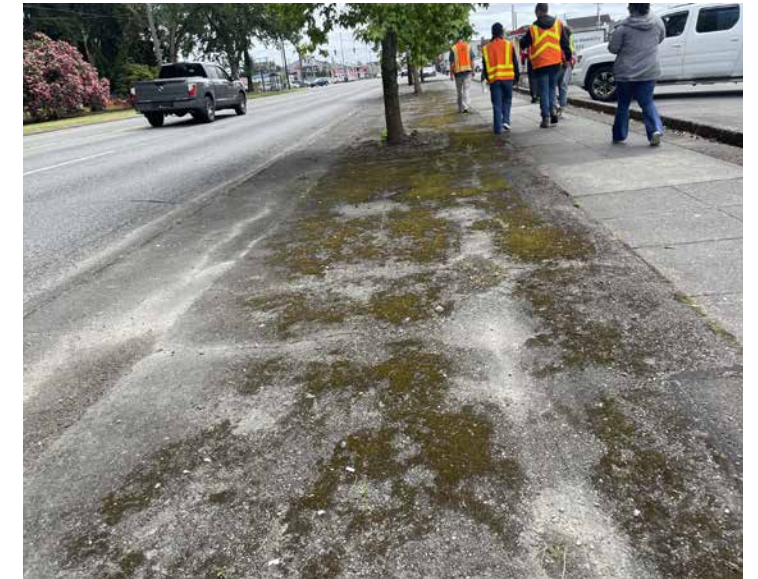
West side of street needs depaving between S 47th and S 50th St

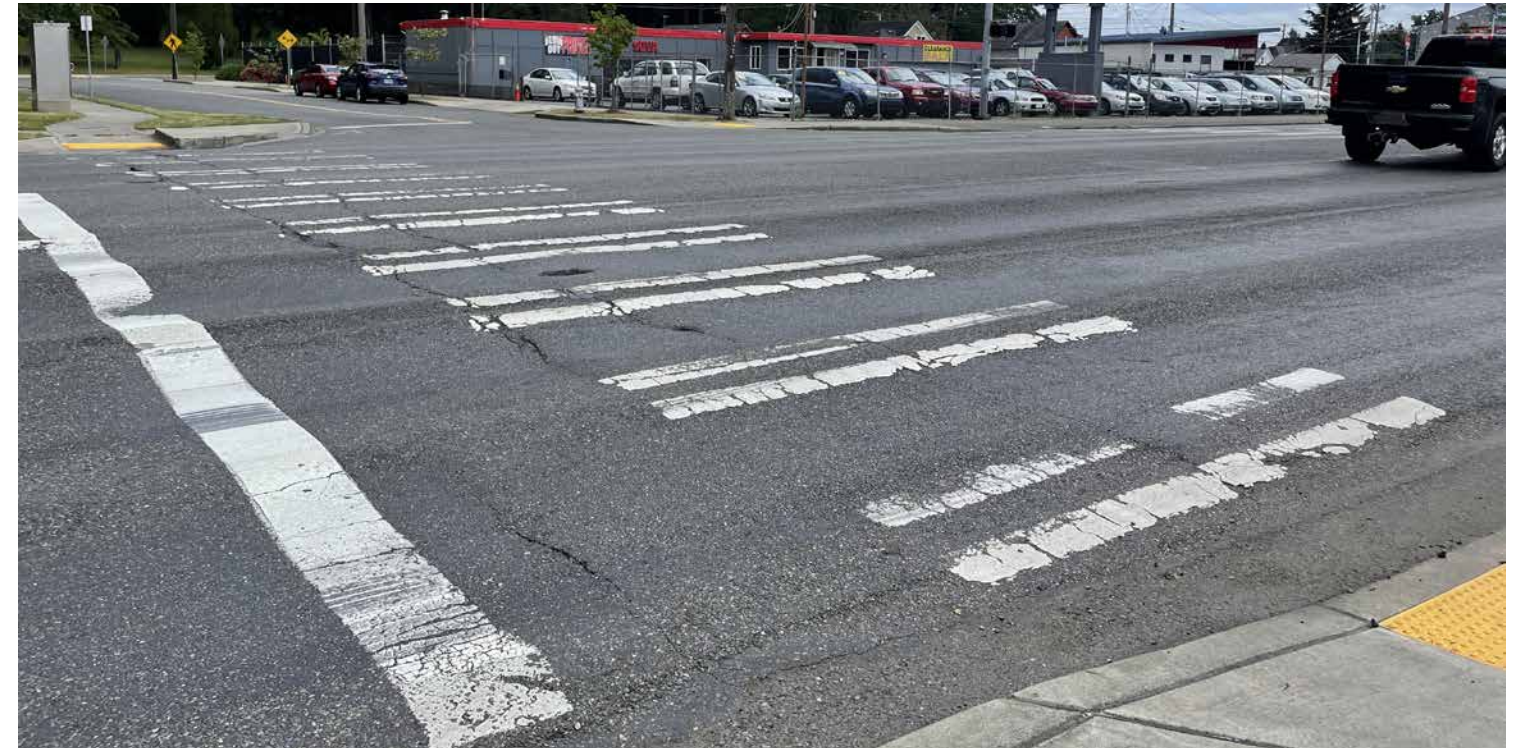
- Pedestrian crossing buttons are confusing. Could be updated.
- Roadway seriously concaved/ damaged. Needs improvement.
- Street parking begins south of here. Needs painted parking strip.
- Substandard ramps on the SW and SE legs of the intersection.
- Increase lighting at crossings and intersections.
- Add Leading Pedestrian Intervals (LPI).
- Install 12" signal heads with reflective backplates.
- Consider protected/permitted left turns.
- Add marked crosswalks.

Concaved roadway in need of improvement

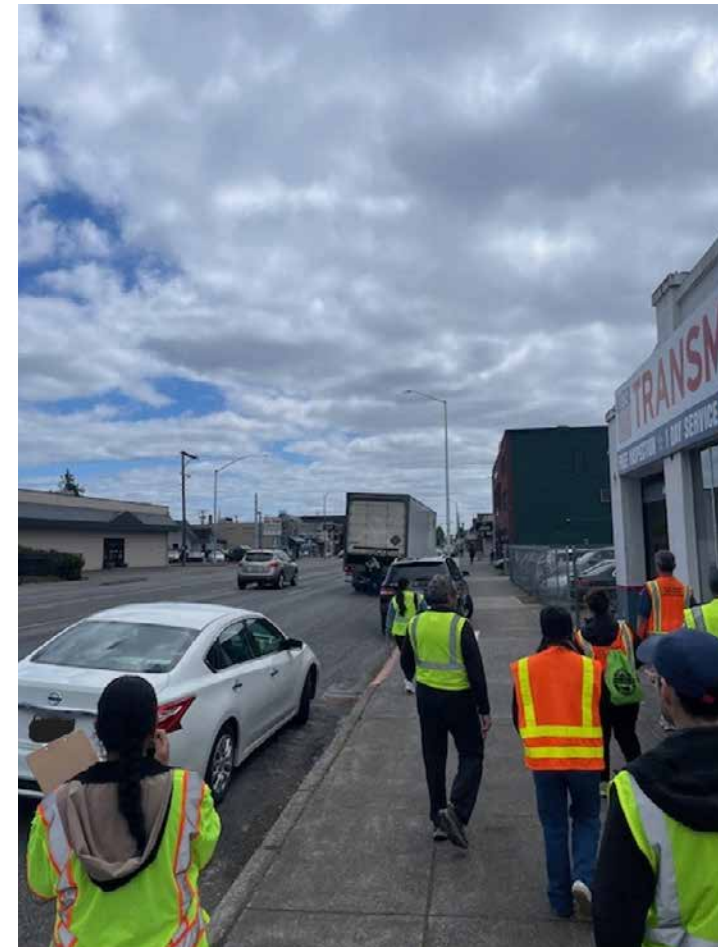
- Convert outer lanes to back in angle parking.
- Preserve mature trees.
- Substandard driveway and damaged sidewalk at multiple locations within this section.
- Bus stops are not in optimal locations or do not allow enough room for pedestrians.
- Freight loading and unloading happening in the ROW but should happen in alley.

Freight loading/unloading happening in travel lane

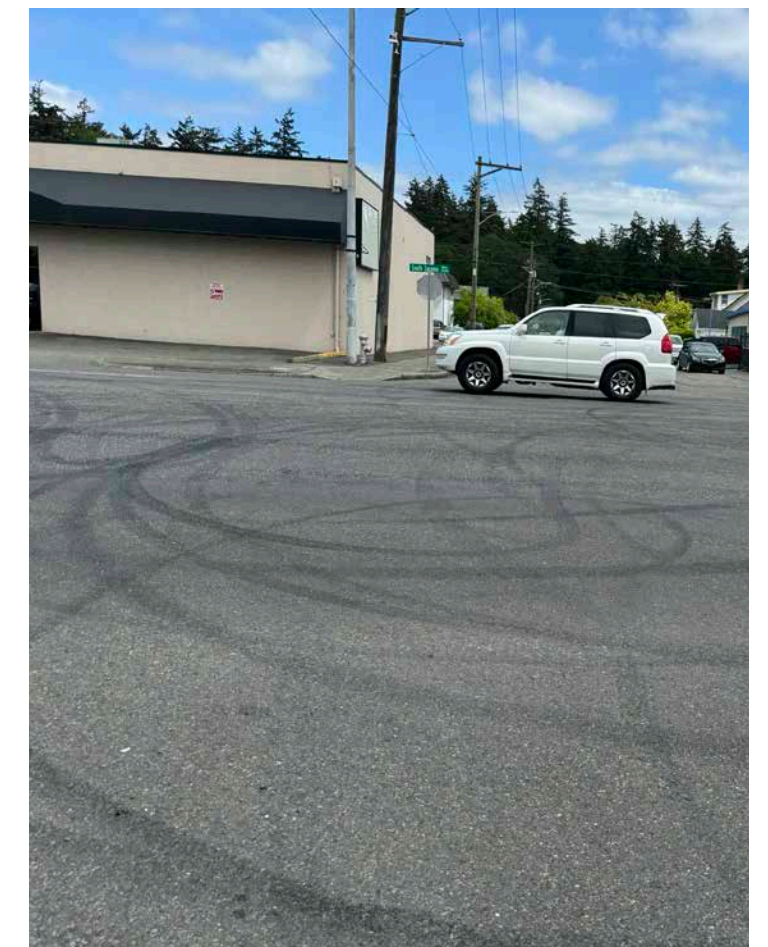
- Pedestrians need to cross approx. 68 ft.
- Crosswalk in unmarked and substandard ramps.
- Update pedestrian crossing.
- Suggestion to close off access to S Tacoma Way from driveway immediately south of intersection.
- Cars do donuts in this intersection.
- Add truncated domes.

Skidmarks in intersection showing cars frequently "do donuts" here

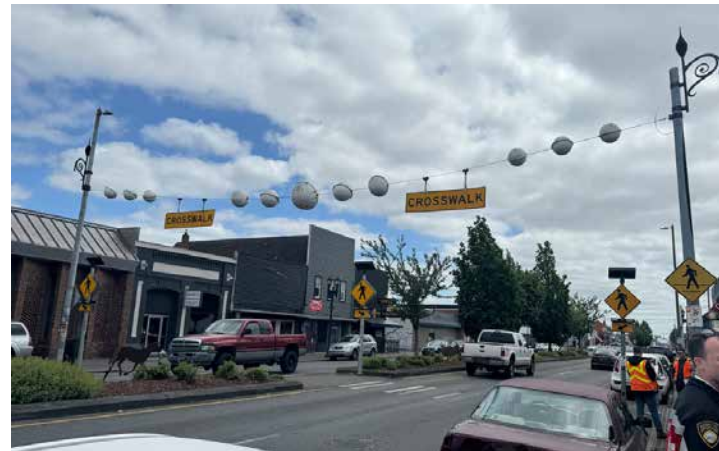
Pedestrian median island between S 52nd and S 54th

- Pedestrian scale lighting begins here.
- Ramps do not meet ADA requirements.
- Inline storm crossing.
- Explore if trees along center median landscape need to be limbed up.
- Add bike corral and parklets at various points of the NBD.
- Driveway access to S Tacoma Way should be closed to protect pedestrians and bus stop users.
- Upgrade midblock crossing with raised crossing.
- Update pedestrian beacon to Rapid Flashing Beacon.

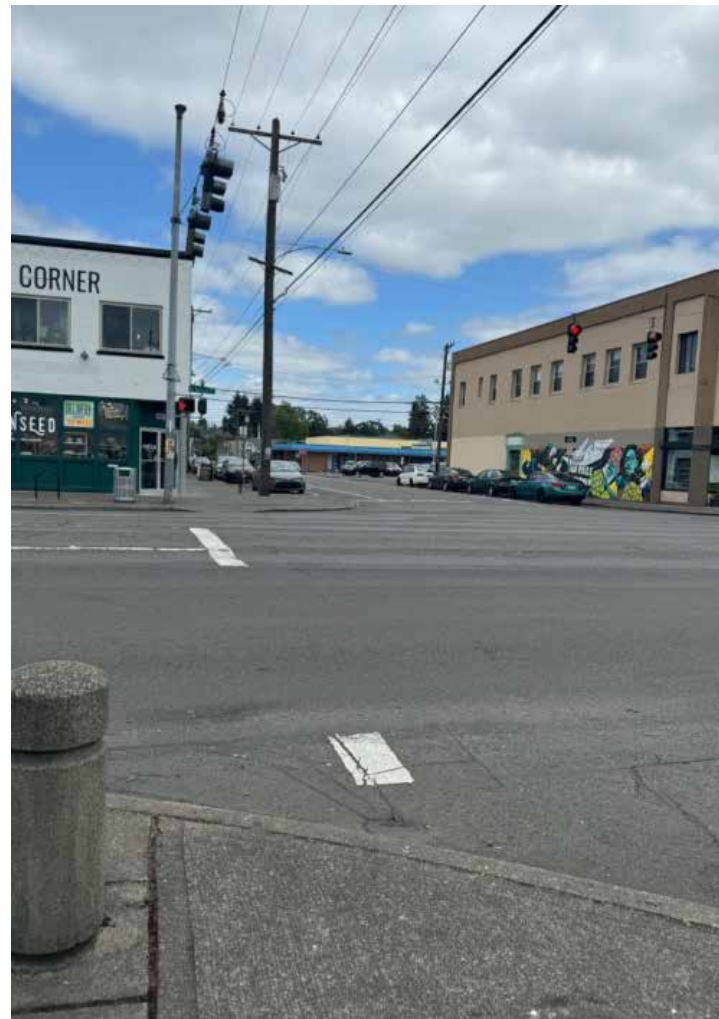
No marked crosswalks at S Tacoma Way-S 54th St intersection

- There is limited lighting near intersection.
- Alighting from the back door bus is difficult and forces people into driveway area.
- There are substandard curb ramps here.
- South side of 54th St sidewalk needs repair.
- There is evidence of cars doing donuts in intersection.
- This is a good intersection for crashworthy art.
- Add temporary or quick build curb bulb outs that don't obstruct bicycle infrastructure.
- Add marked crosswalks.
- Add marked green bicycle crossings.
- Install 12" signal heads with backplates/reflectors.
- Look into Protected/Permitted left turns.

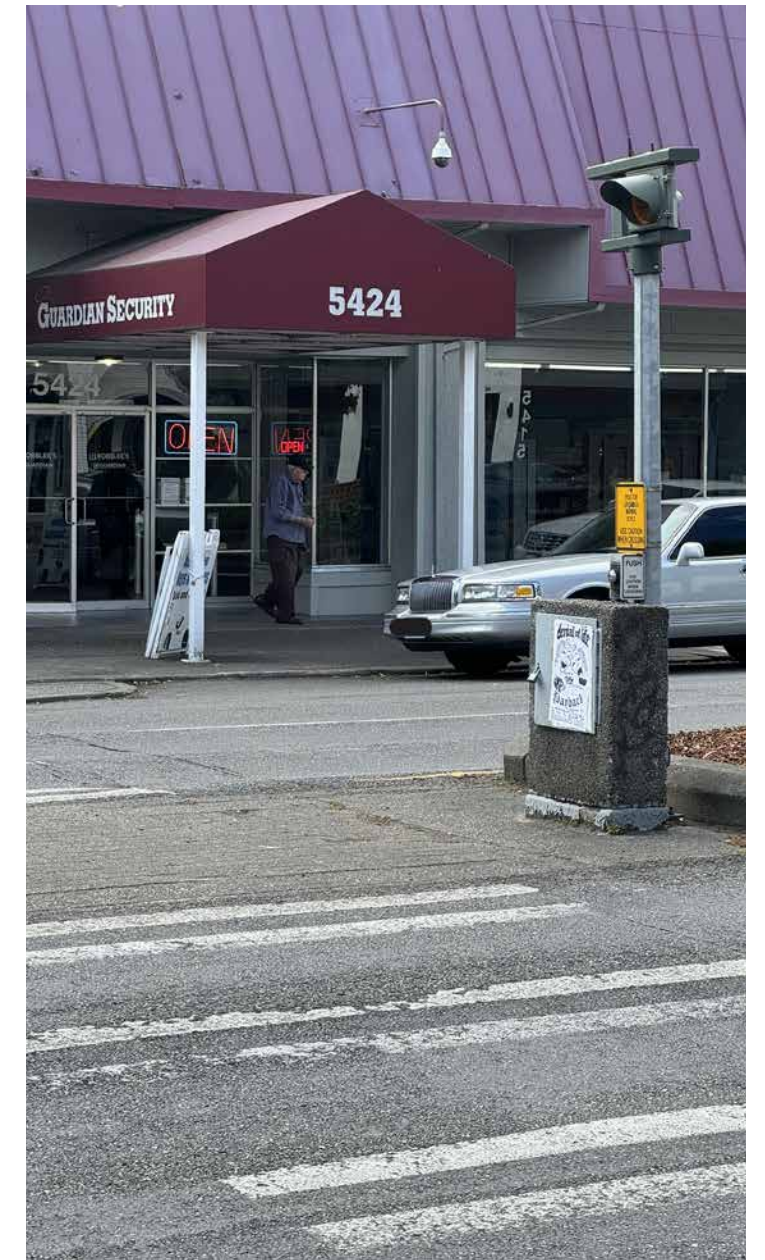
- This intersection is coordinated with the signal at Washington for the trains.
- There's an automated red-light camera at 56th for EB traffic. Try to avoid saturating areas. City gets 22 speed cameras allotted.
- Add pedestrian crossing countdown.

Crossing Island with dated pedestrian crossing beacons between S 54th and S 56th

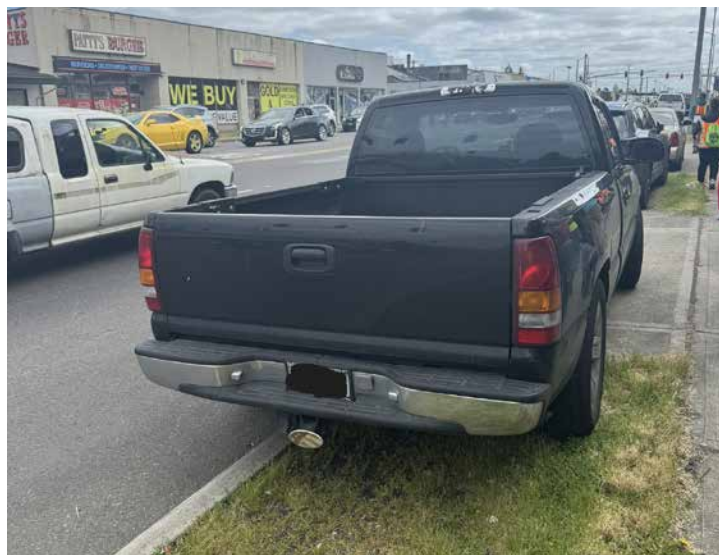
Vehicles parking on strip near sidewalk restricting pedestrian access

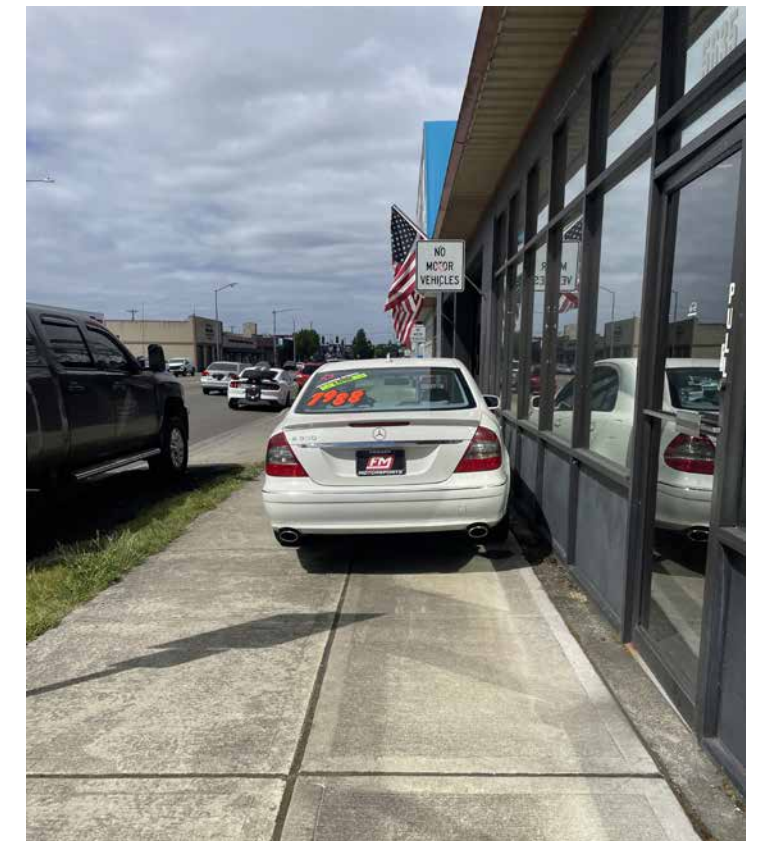
- Need more bus shelters/ benches at bus stops.
- Dealerships parking cars on plantings strips, obstructing sidewalks.
- Replace two-way left turn lane with raised center median.

Dealership cars obstructing sidewalk path

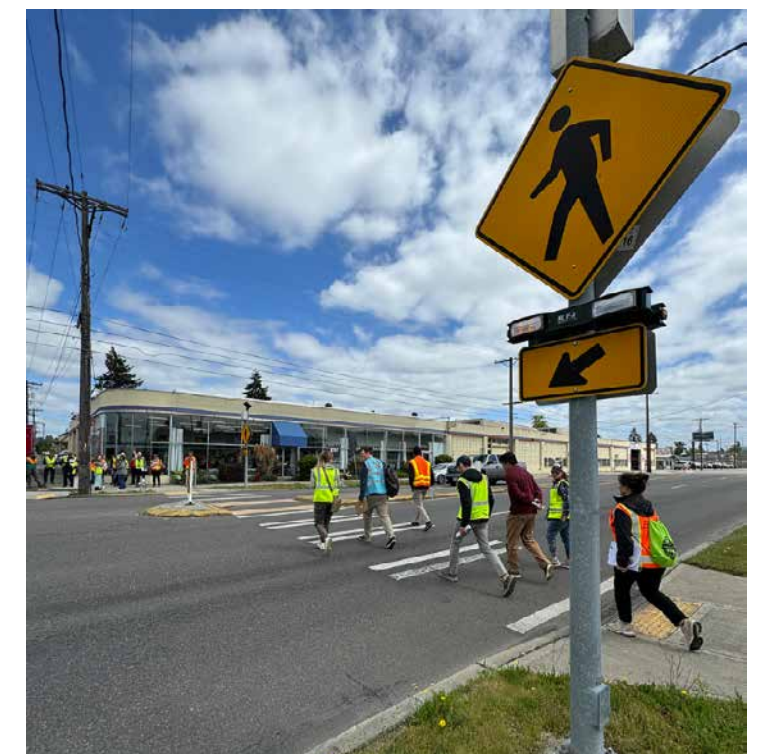
- Crossing is not allowed at the north side of the intersection.
- There's limited visibility to the flashing beacon due to trees.
- Upgrade the ped beacon to newer Rapid Flashing Beacons.
- RRFB is likely not appropriate given the number of lanes and travel speed.
- The median island is struck frequently.
- Improve lighting at intersection.
- Automated enforcement as folks enter the business district.
- Consider adding a median Rectangular Rapid Flashing Beacons.
- Add curb bulb-outs.

RRFB at end of project segment (S 62nd St and S Tacoma Way)

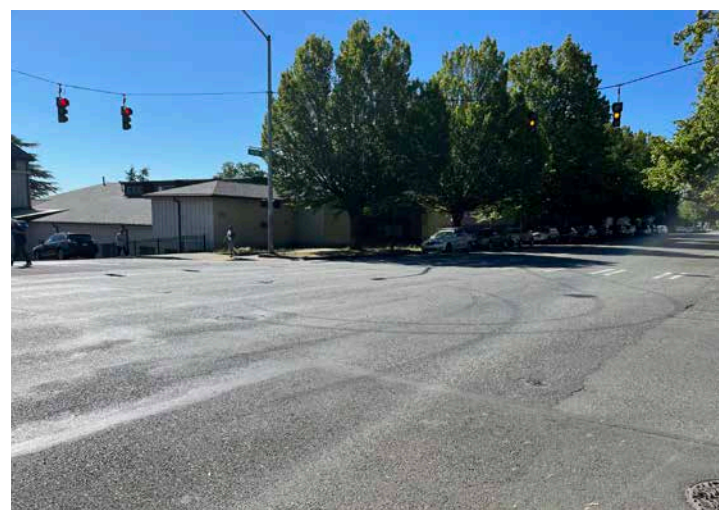
Tire marks from donuts at S 13th St intersection

- S 13th St sign missing on north side of intersection.
- Tire marks from donuts.
- No curb ramp inventory data for southwest and southeast corners. Address tripping hazard at southwest corner. Install bulbouts for pedestrian visibility.
- Very awkward curb, planter strip, sidewalk setup on SW corner of S 13th St.
- To address all signal comments, signal system would need to be completely reconstructed.

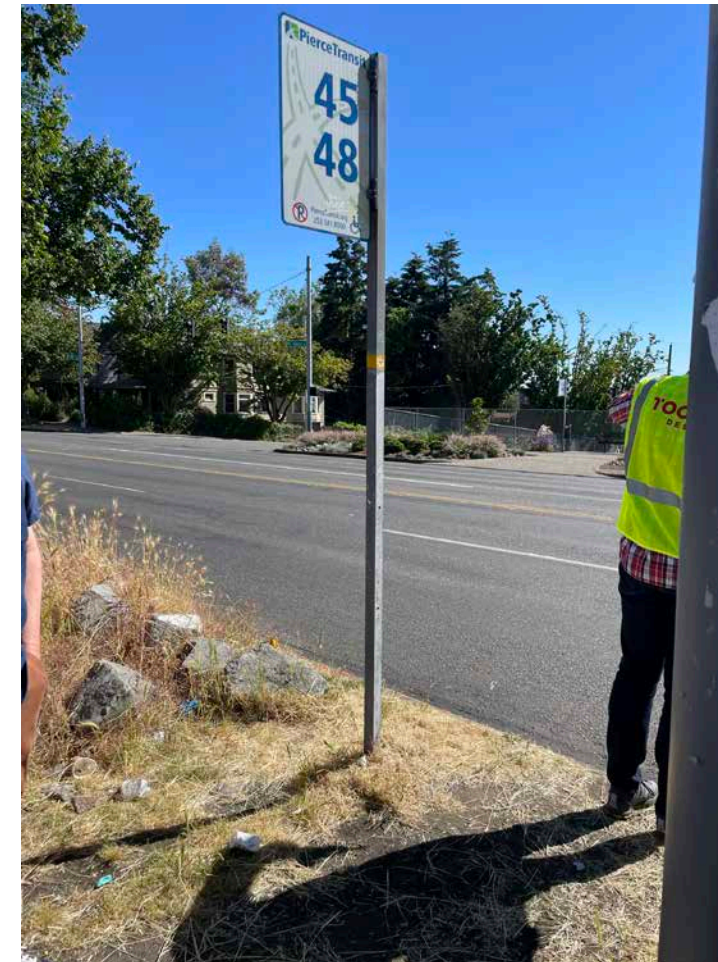
- Ramps not ADA compliant.
- Only 1 streetlight.
- Building foundations c. 2006 but no action since (parcel on Northwest corner).

Bus stop at S 15th doesn't have front or rear pads.

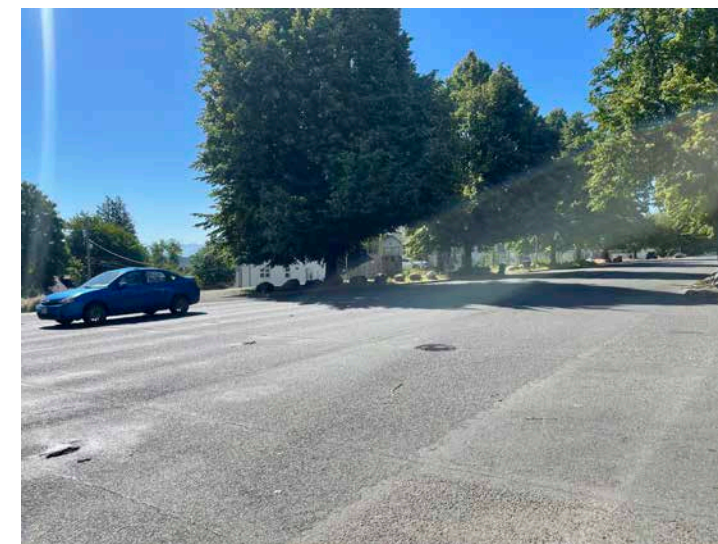
Large uncontrolled and unmarked intersection at S 16th St

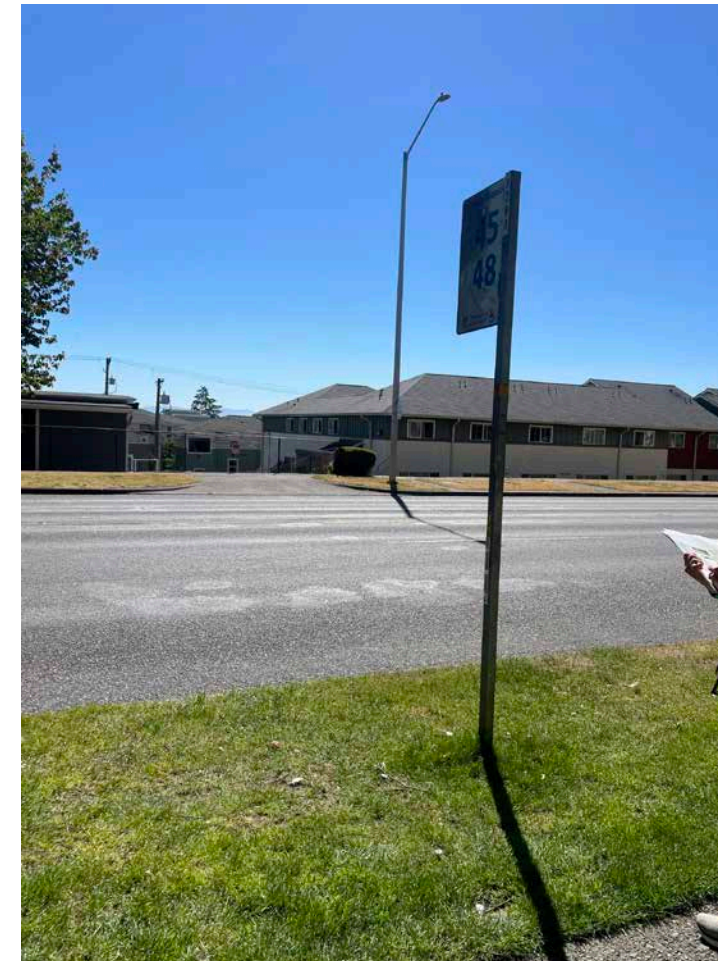
Bus stop without front or rear pads at S 17th St

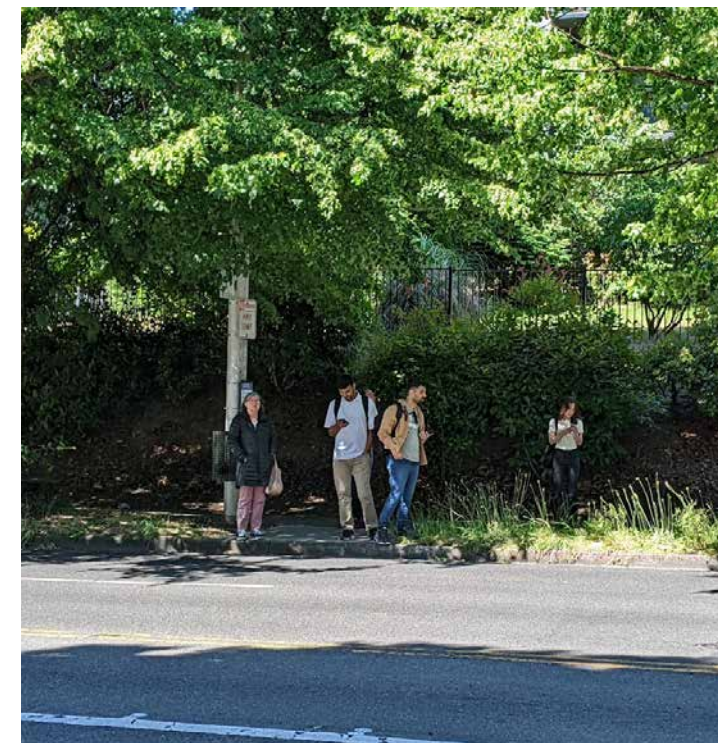
People waiting for bus with no bus shelter or benches.

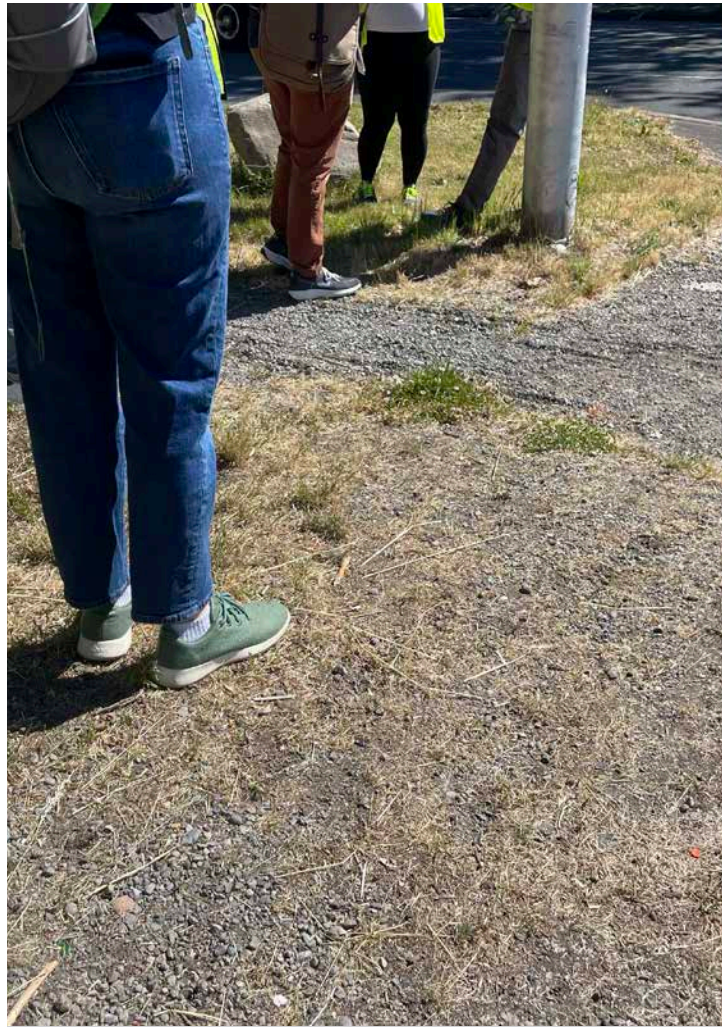
Dirt and gravel covering sidewalk at northwest corner near S 21st St

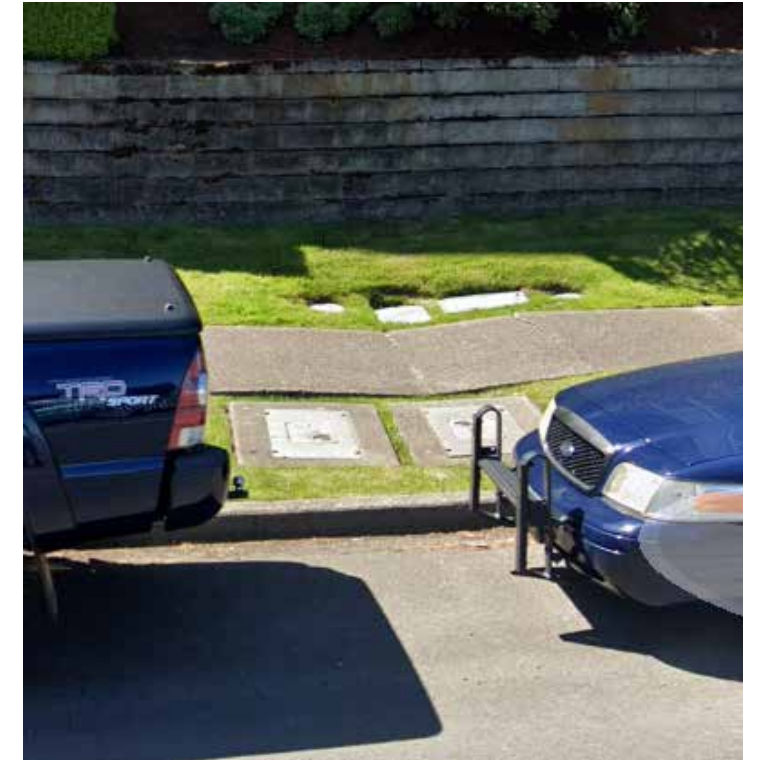
- There are a lot of lifted and cracked sidewalk panels along this whole corridor, due to tree roots.

Sidewalk uneven and caving between S 21st St and S 23rd St

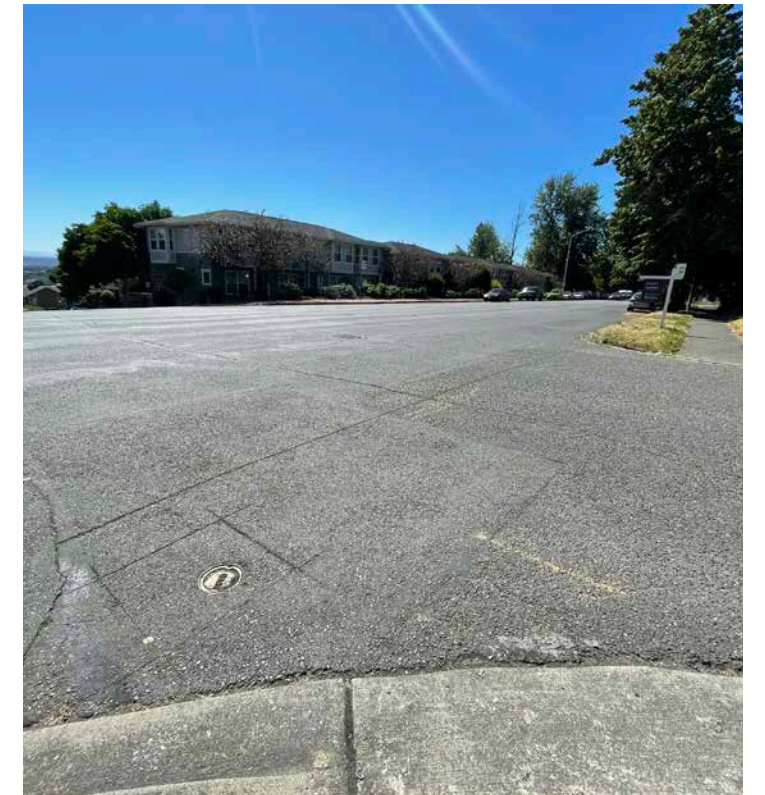
Large, unmarked intersection at S 23rd St

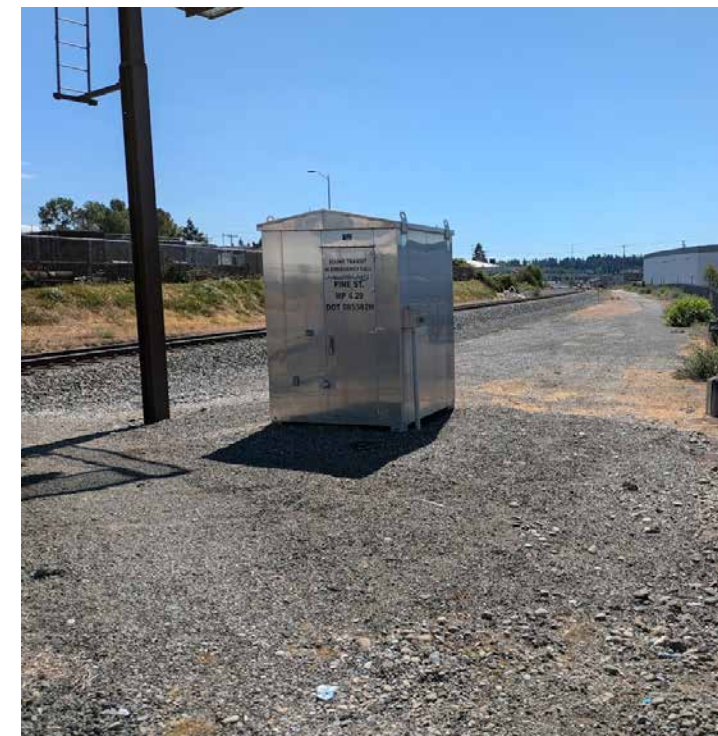
Rail tracks owned by Sound Transit

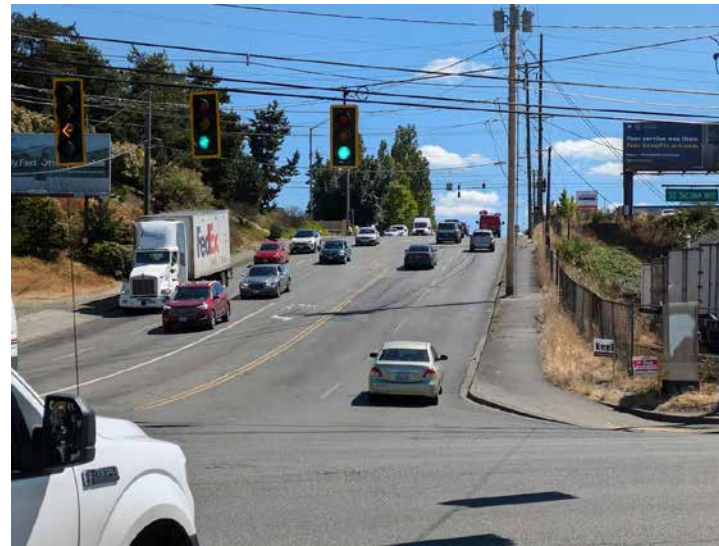
Steep slope south of S Tacoma Way

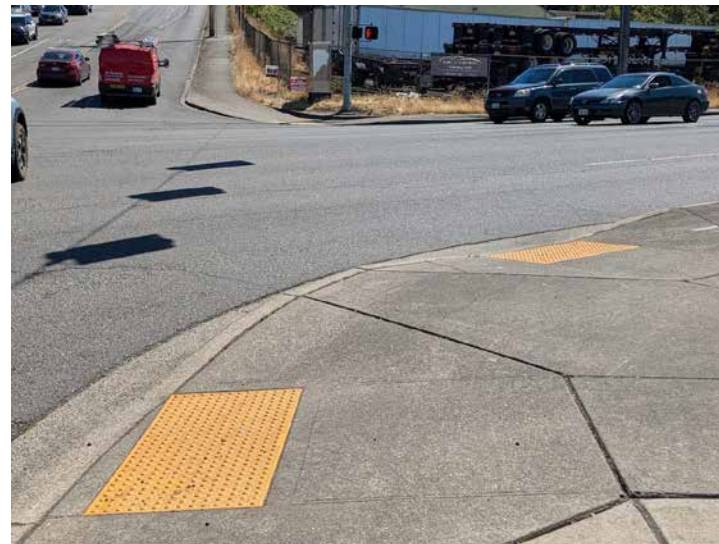
Unmarked crosswalks at South Tacoma Way intersection

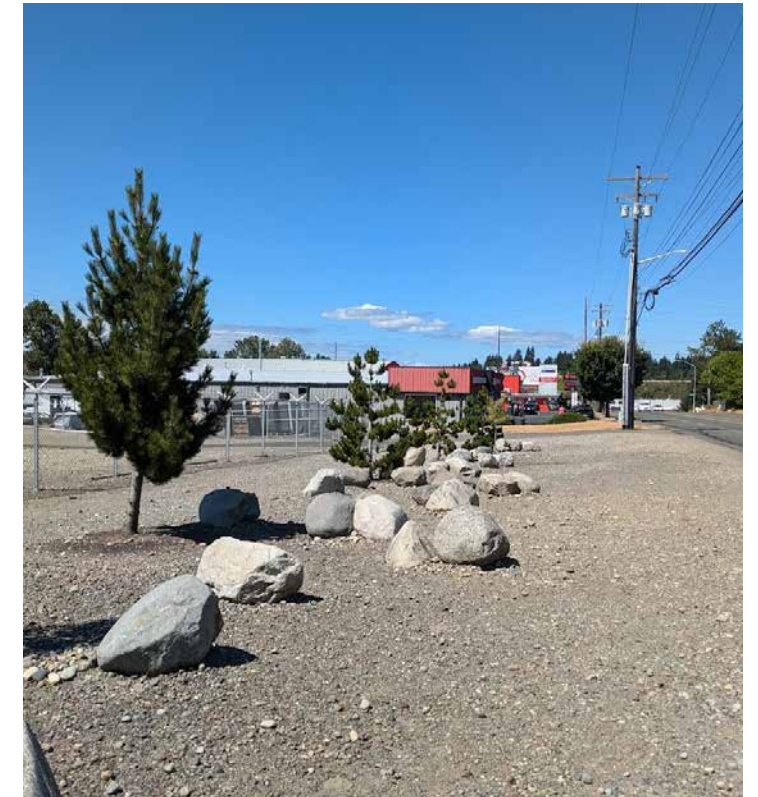
- Narrower sidewalk on west side.
- No sidewalk midblock on east side.
- Rolled driveways here. Not ADA accessible.
- No sidewalk on south end of segment both sides.
- Potential EPA cleanup from this site on NW corner near S 36th St.

Missing sidewalk between S 35th St and S 36th St

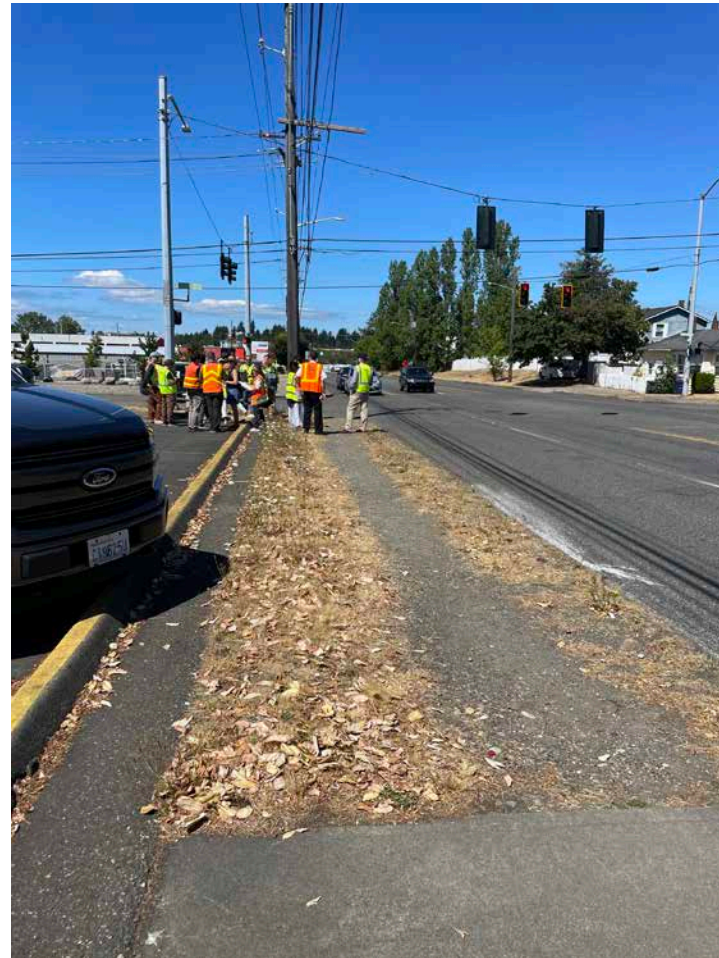
Missing link sidewalk south of S 36th St
