Tacoma Vision Zero Road Safety Audits

September 2024 ■ Year 1 Report

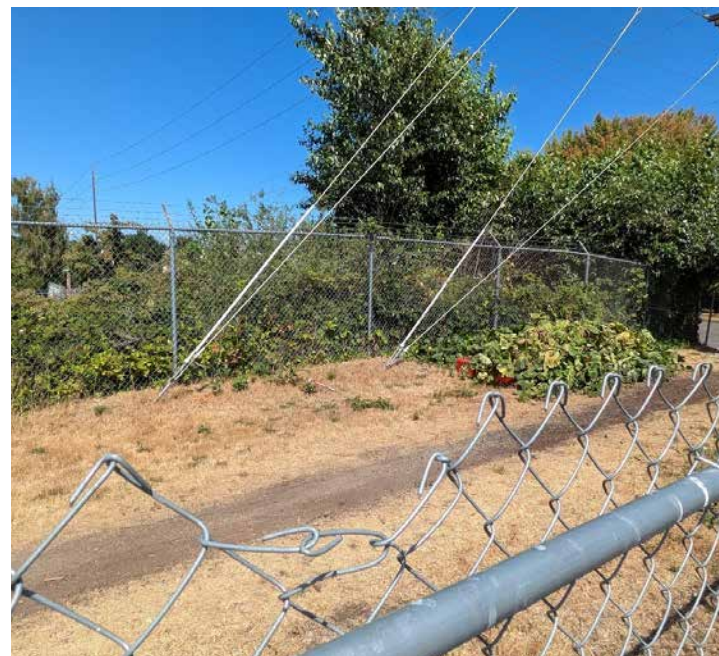
Trail access from S 40th St is not ADA accessible

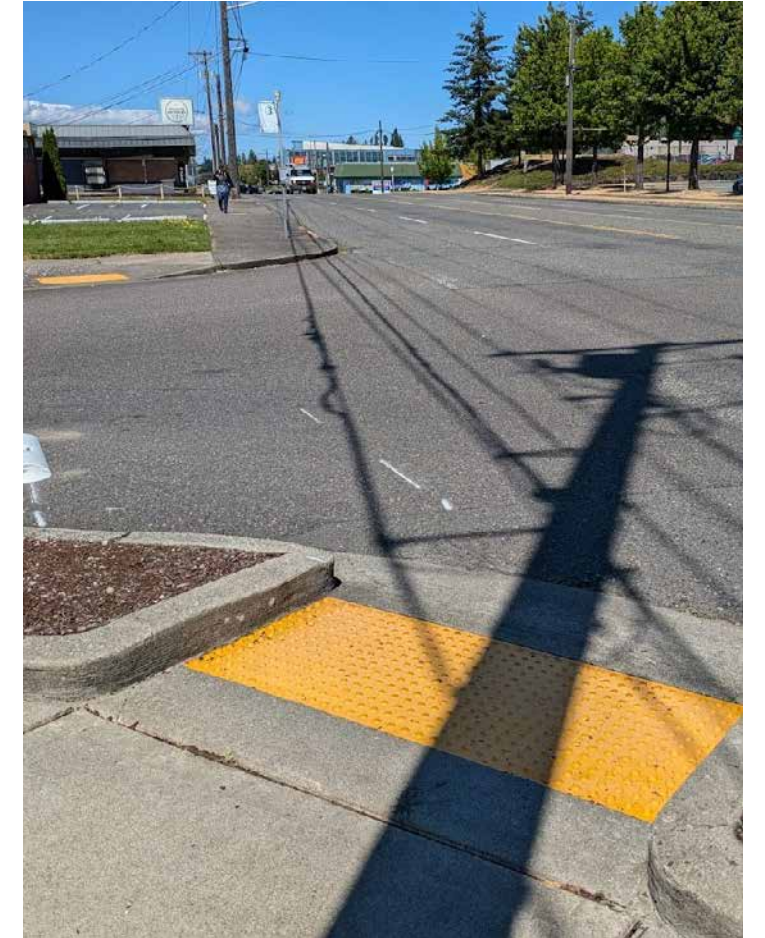
Curb ramps misaligned at S 40th St

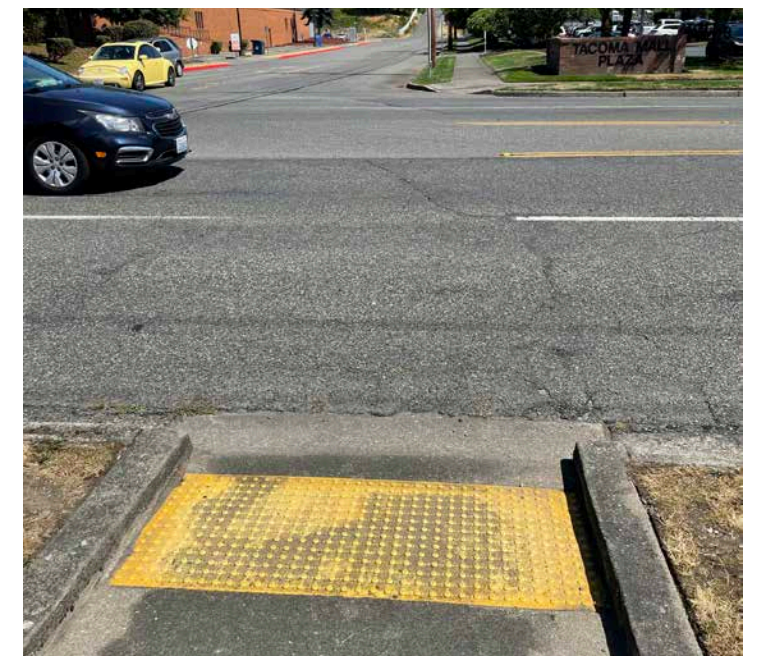
Unmarked crosswalks at S 42nd St

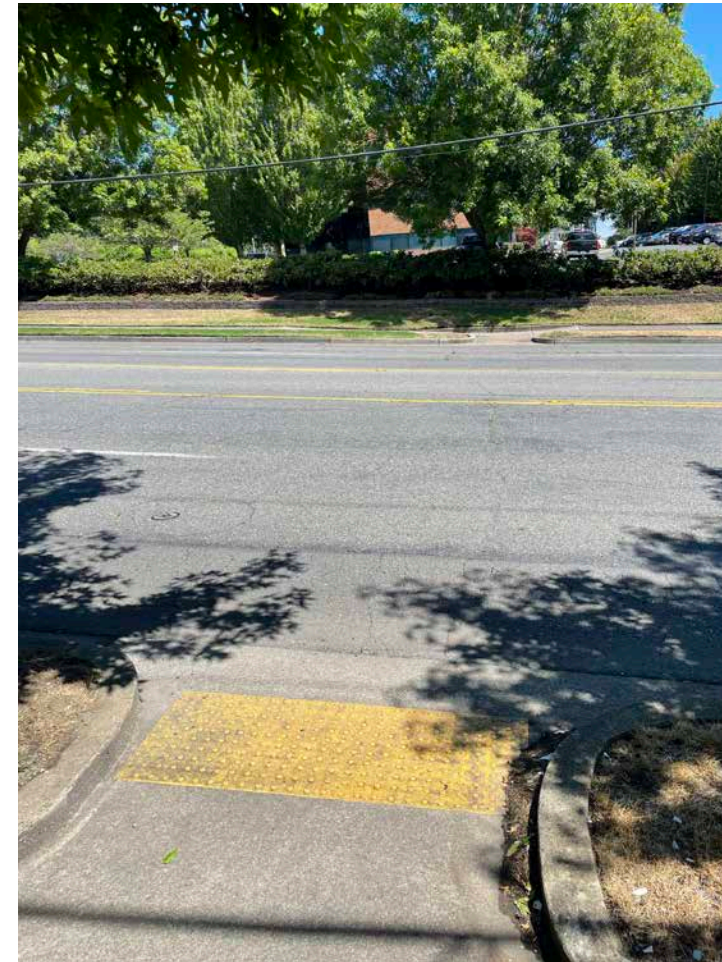
Curb ramp at least 20 feet south of S 43rd St intersection

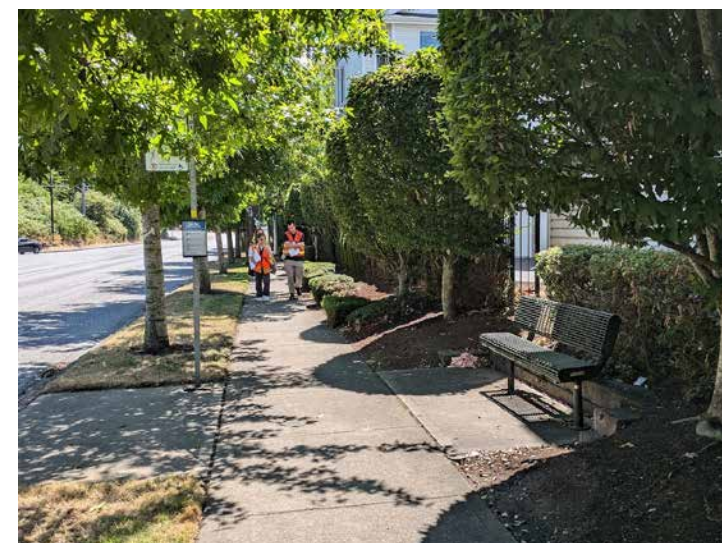
Nice buffered sidewalk and bus stop between S 43rd St and S 45th St

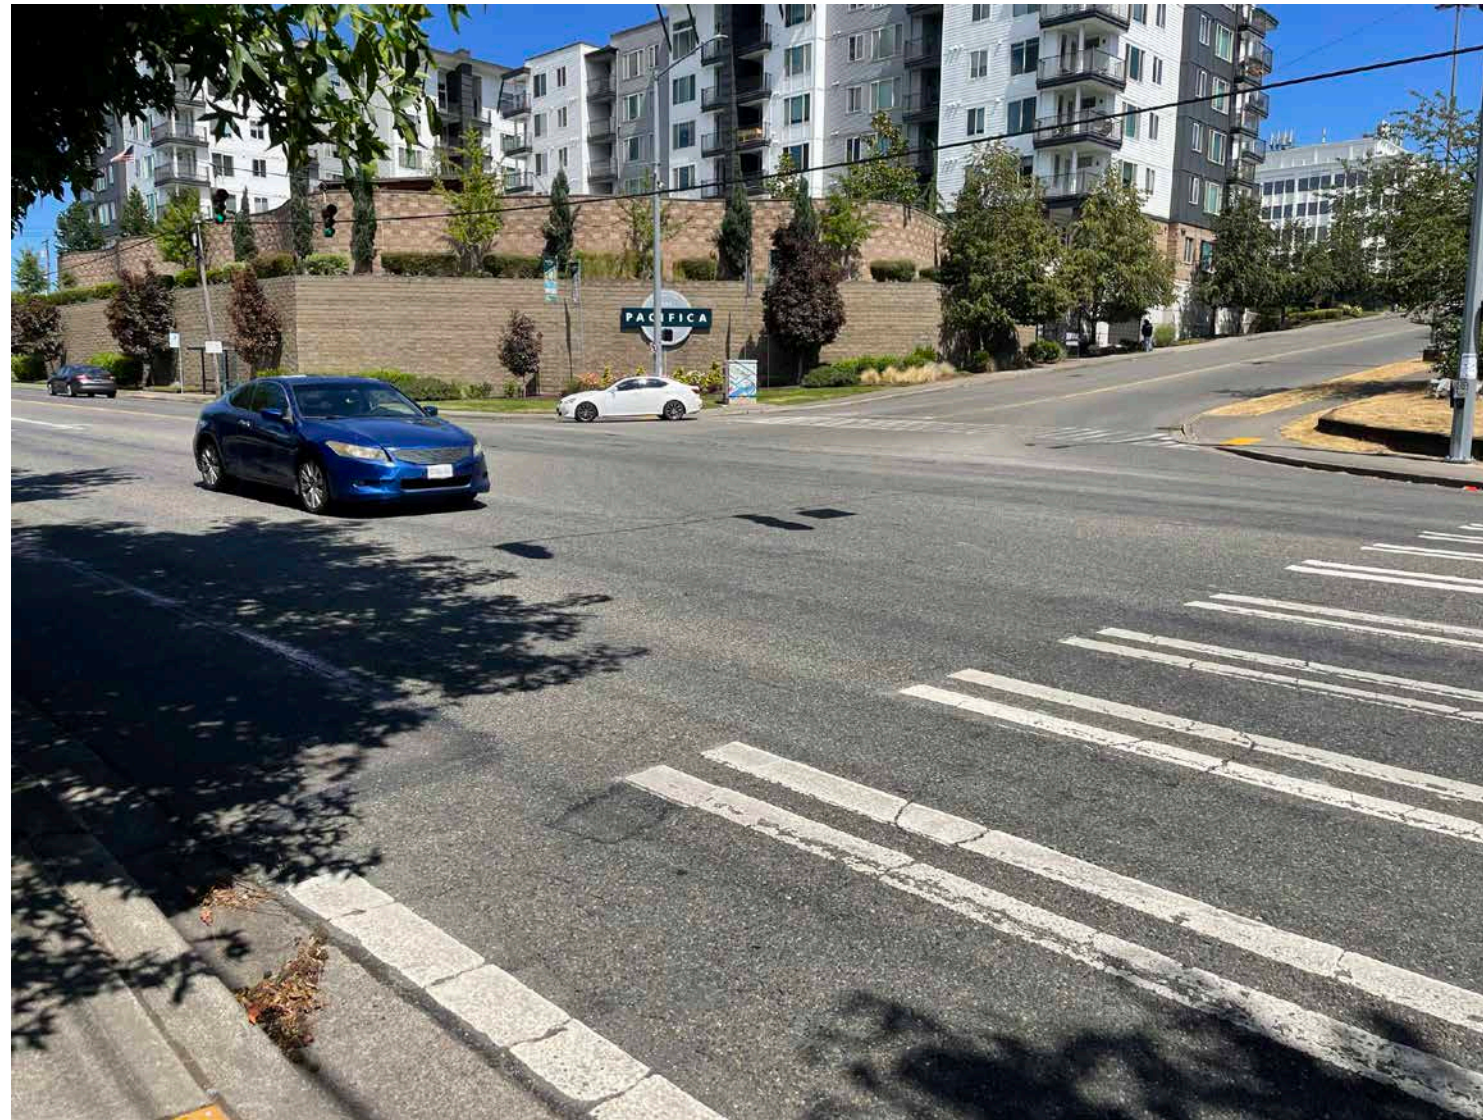
Large intersection and with only N-S eastside and E-W southside marked crossings
