# Schuster Slope Activities and Monitoring Report 2016/2017

**Prepared by City of Tacoma**

**Passive Open Space Program**

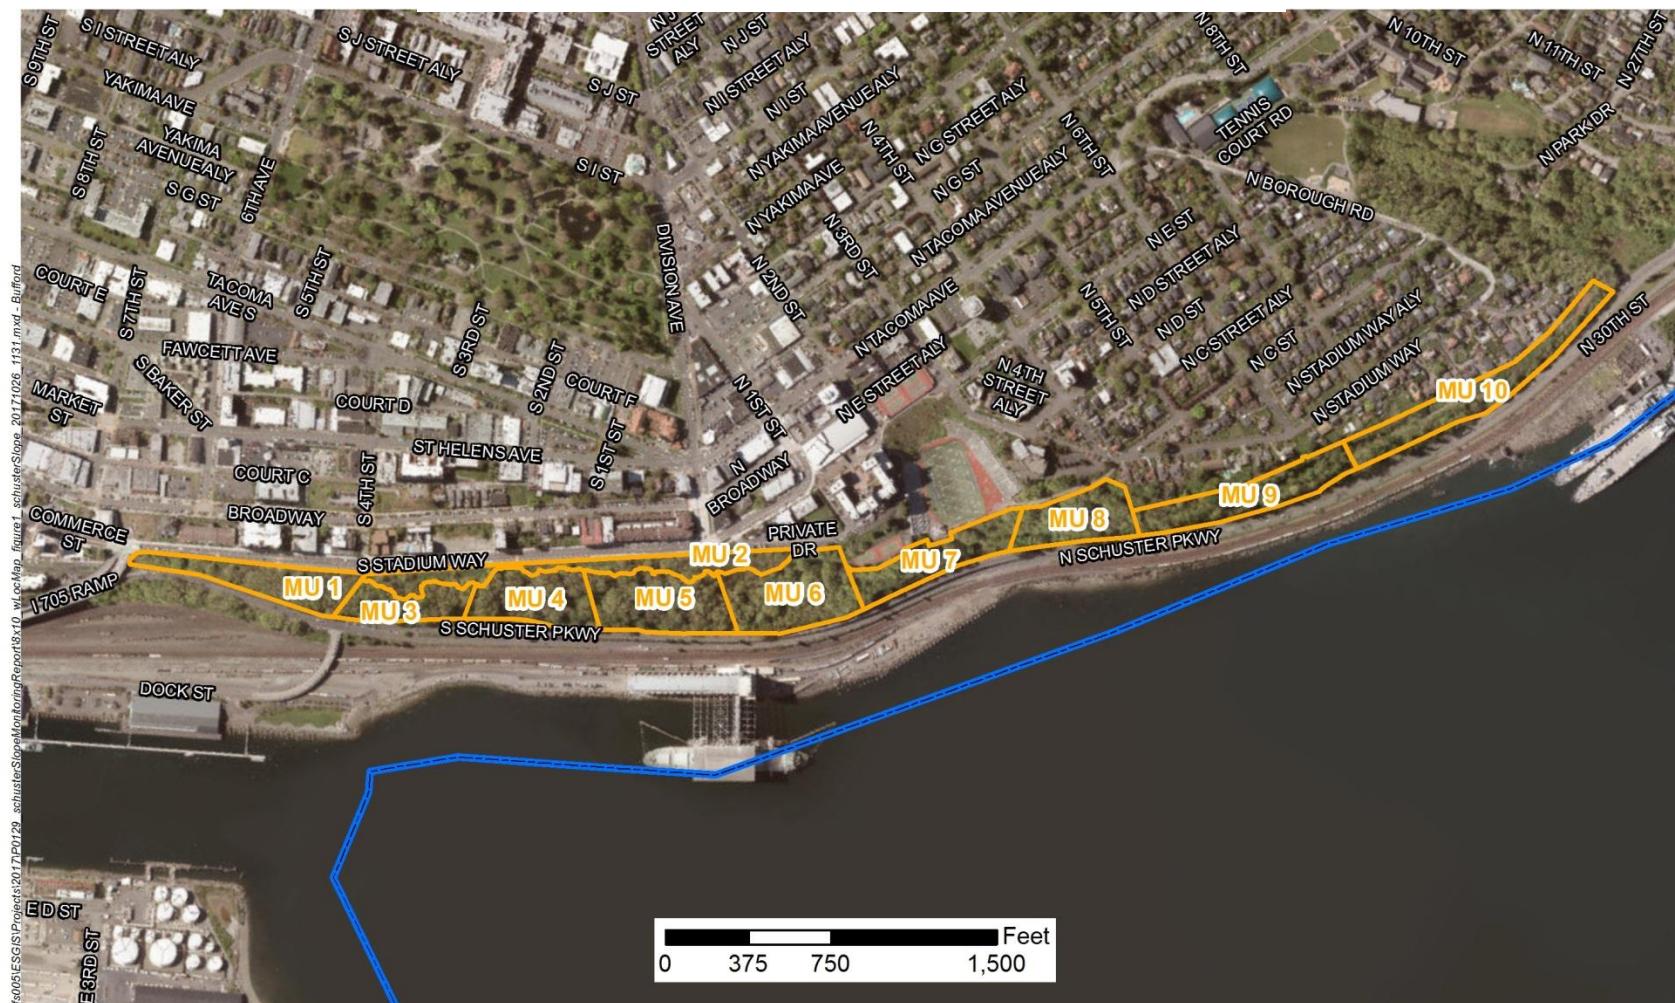
## **Figure 1. Schuster Slope Management Units**

Schuster Slope is made up of 10 management units (Figure 1), totaling 31.2 acres. Restoration began in 2015 and survival rings were cut around trees across the entire site. Slope stabilization efforts, including the installation of erosion control best management practices (BMPs) and planting native vegetation, occurred on Management Unit 1 (MU1) in 2016. Management Unit 1 is located at the southern end of the slope and is 2.8 acres in size. Habitat restoration area monitoring was performed for MU1 in 2017, and will take place for a total of five consecutive growing seasons to determine vegetation survivability and coverage as they pertain to the LMP permit requirements for the City of Tacoma. Monitoring outcomes will ultimately be used to assess if standards related to slope stability, forest health, public safety, and other objectives are being met, as described in Section 4 of the LMP (See Table 1). Qualitative observations concerning human induced actions will also be considered.

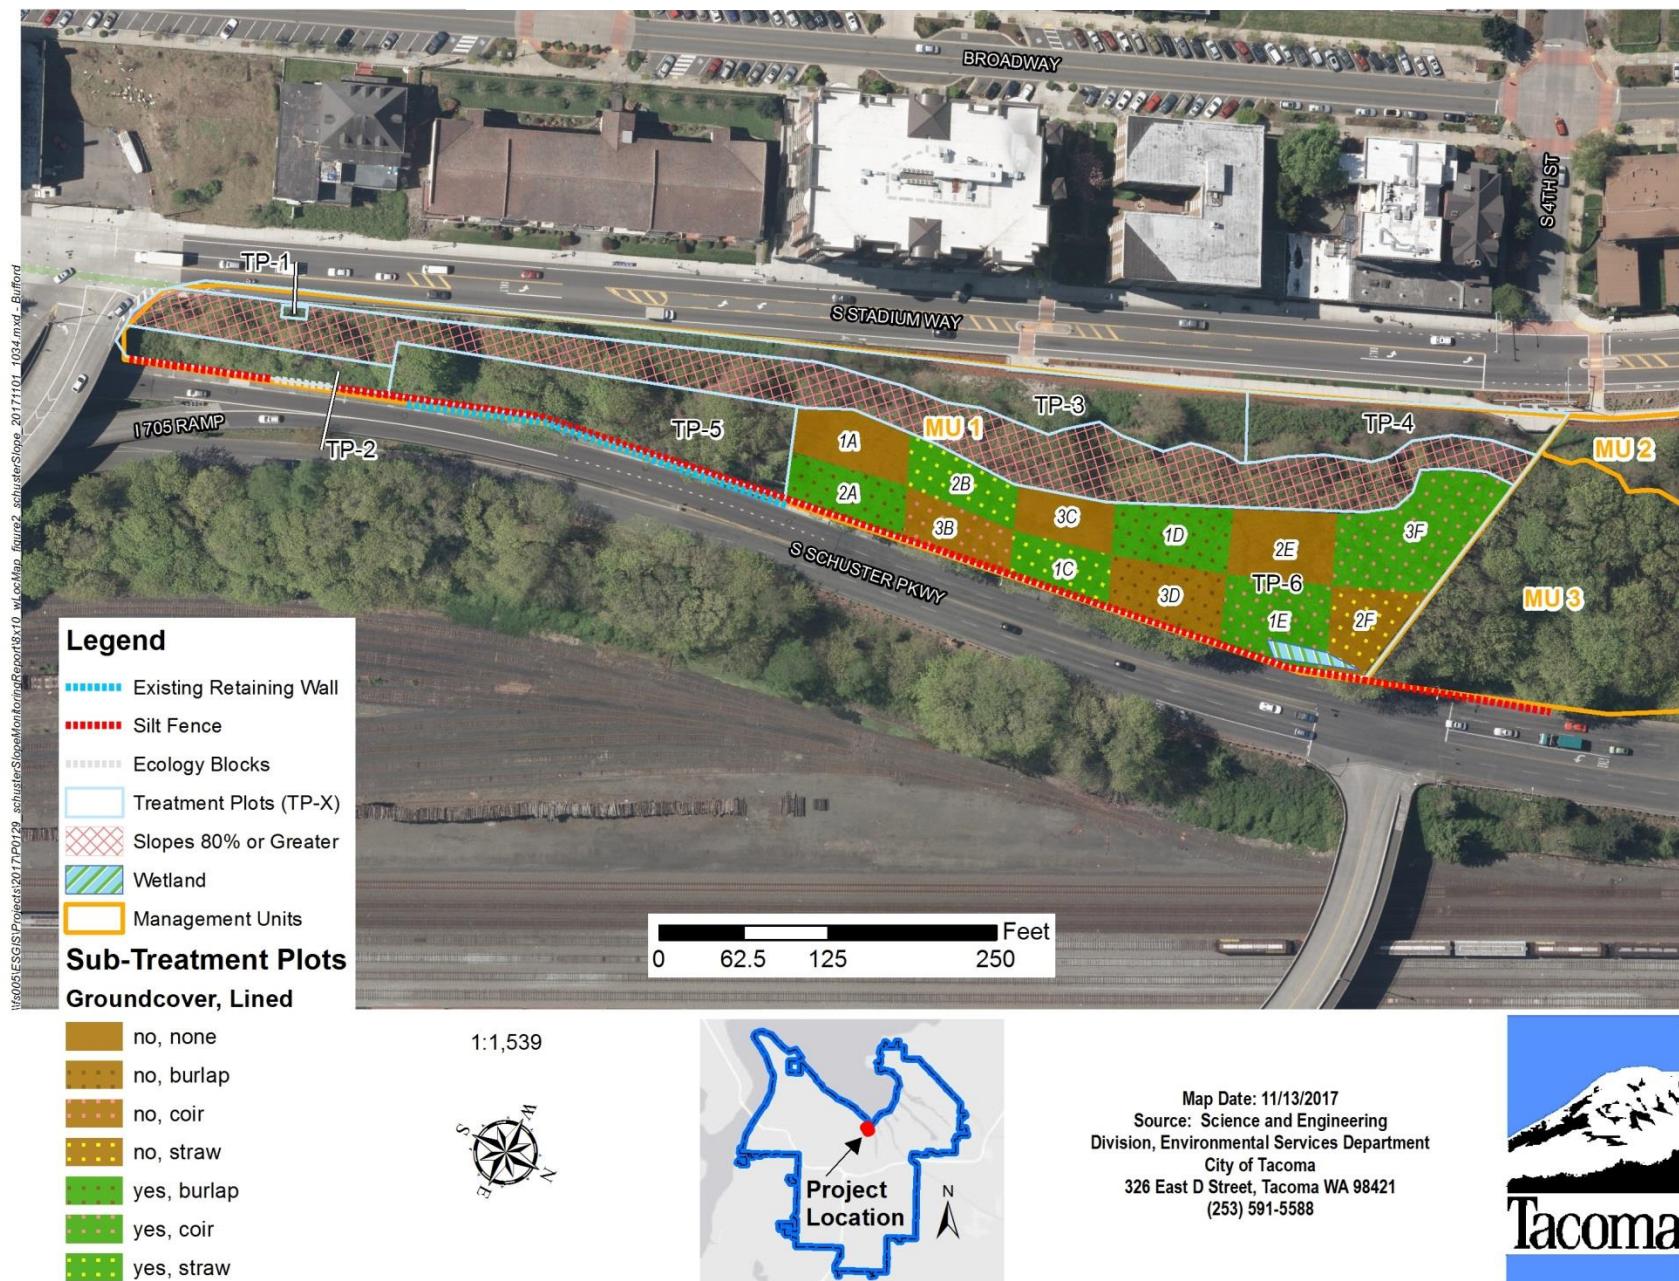
**Figure 2. Schuster Slope Management Unit 1**

Management Unit 1 is divided into six treatment plots (Figure 2) based upon differences in soil composition, sunlight, slope and vegetation.

Treatment plots located at the top of the slope (TPs 3 and 4) are separated from those at the bottom of the slope (TPs 2, 5 and 6) by a “no touch” area, where slopes are 80% or greater (red hatched area in Figure 2). Treatment Plot 1 is located in this region.

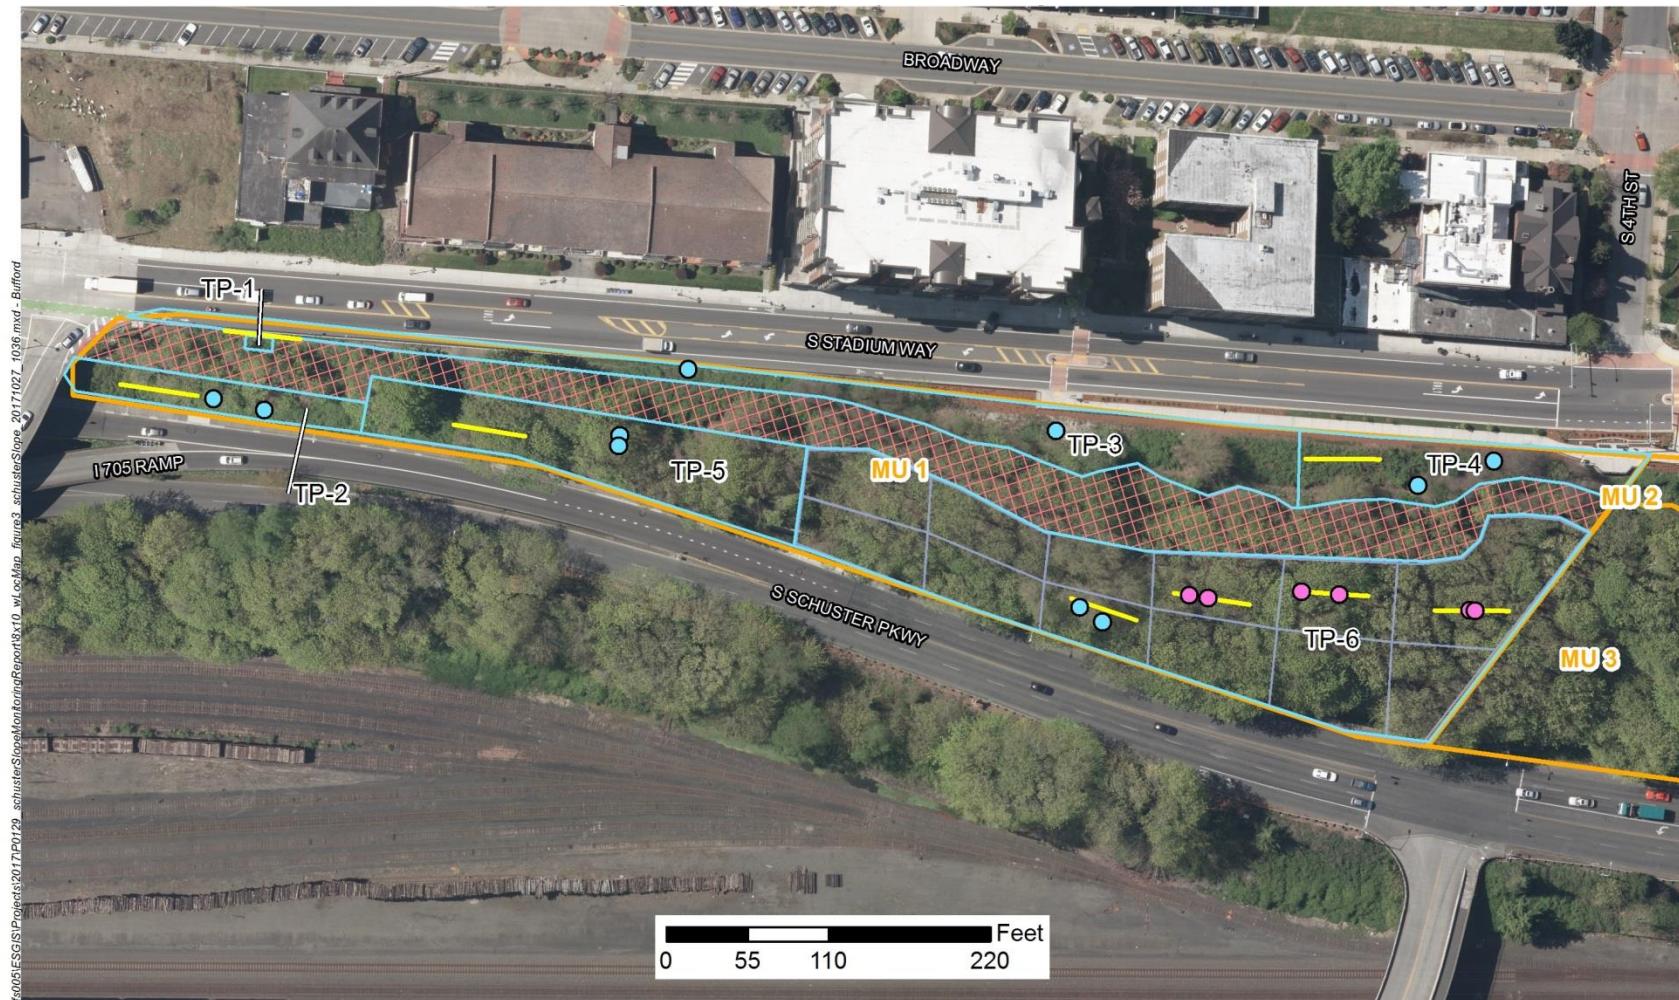
**Figure 3. Schuster Slope Monitoring 2017**

sub-TPs with no groundcover and no fabric lined holes when there should have been only one. The only sub-TPs planted in 2016 include: 1A, 2A, 2B, 3B, 3C, and 1C (Figure 3). Sub-treatment plots planted in 2017 include: 1D, 2E, and 3F. The remainder of the sub-TPs, 1E and 2F, will be planted during 2018.
