Section S8.F.7 – Best Management Practice Evaluation Pervious Pavement Flow Reduction

March 2012

Purpose. Section S8.F.7 of the 2007 National Pollution Discharge and Elimination System (NPDES) permit requires monitoring of a flow reduction hydraulic Best Management Practice (BMP). This condition requires the City to continuously monitor rainfall and runoff from one flow reduction strategy and to annually report these results. This report summarizes the methods and results of flow monitoring data from the Tacoma Landfill Employee Parking Lot Expansion and Pervious Pavement Demonstration Project (Project).

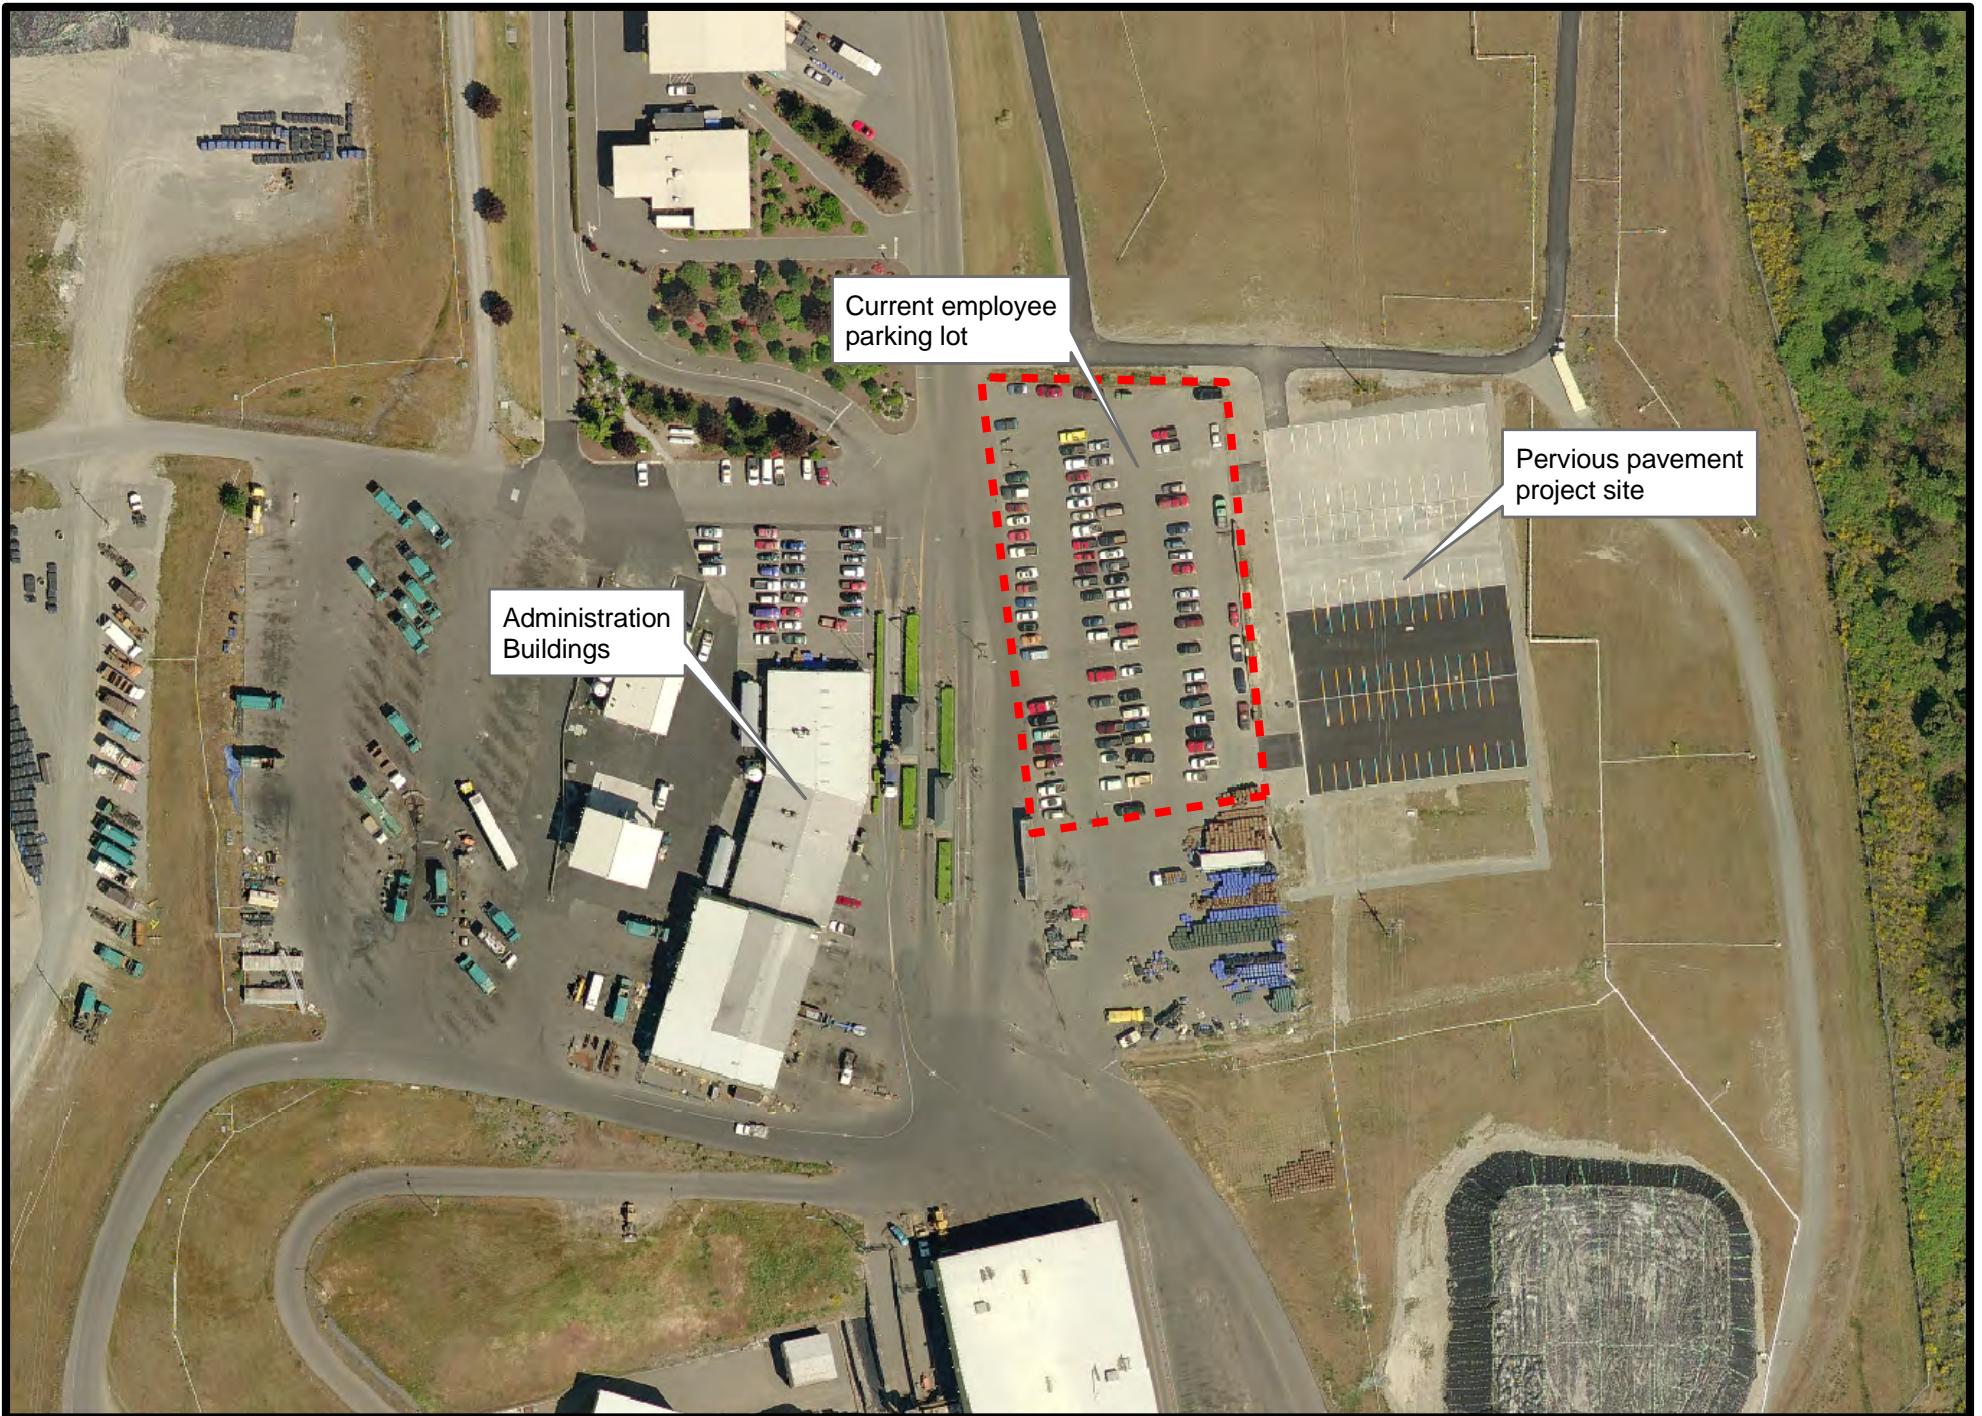
**Figure 3-5 Location of Pervious Pavement Site,
Tacoma Landfill**

BMP No. 3 – Pervious Pavements. At the Tacoma Landfill, a demonstration project, a 36,100 square foot paved area, was constructed using 3 types of pervious pavement systems and a control, standard asphalt (see Figure 3-5). There are several national studies on the effectiveness of pervious pavement. Tacoma is monitoring the effectiveness of this BMP for both water quality and flow reduction. Tacoma will continue to monitor flow reduction effectiveness at this facility.

The five projects are located within Tacoma (Figure 3-1). Tables 4-1 through 4-3 summarize the geographic information for the selected projects. Figures 4-1 through 4-4 and Figure 3-5 show the geographic drainage area for each project.

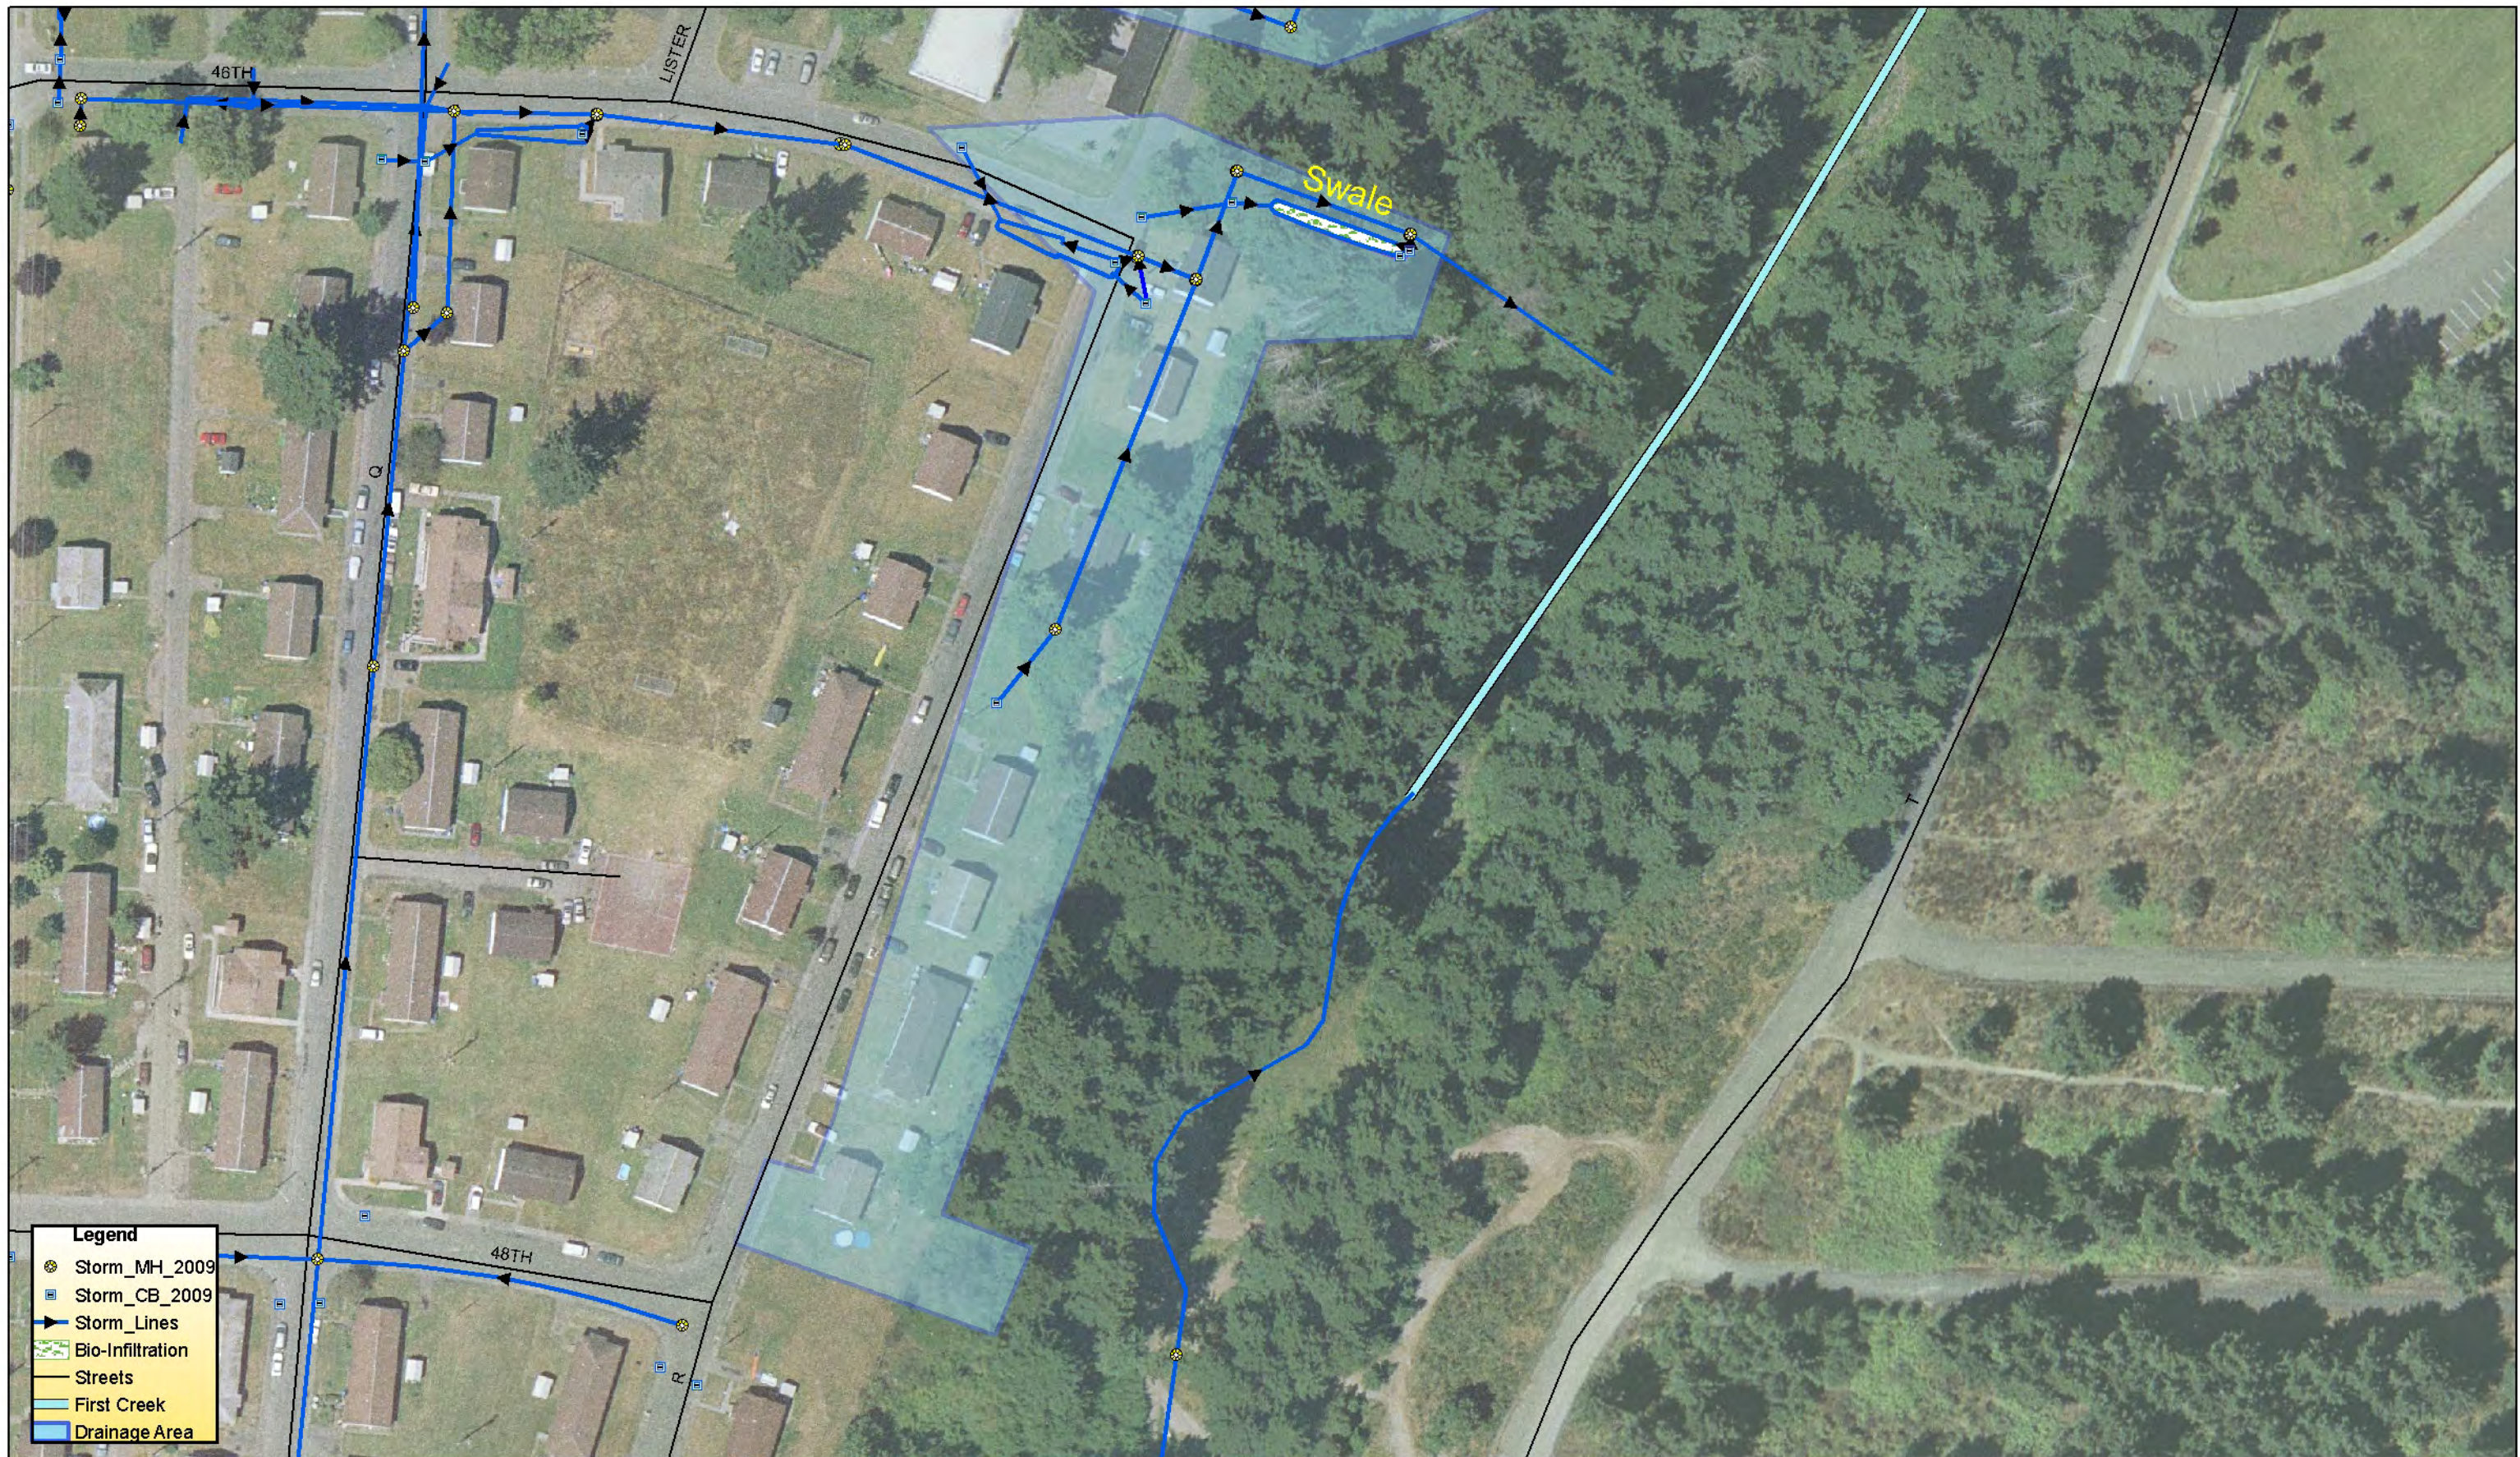
Fig. 4.1

East 46th and R-Street Bio-Infiltration Facility Drainage Area

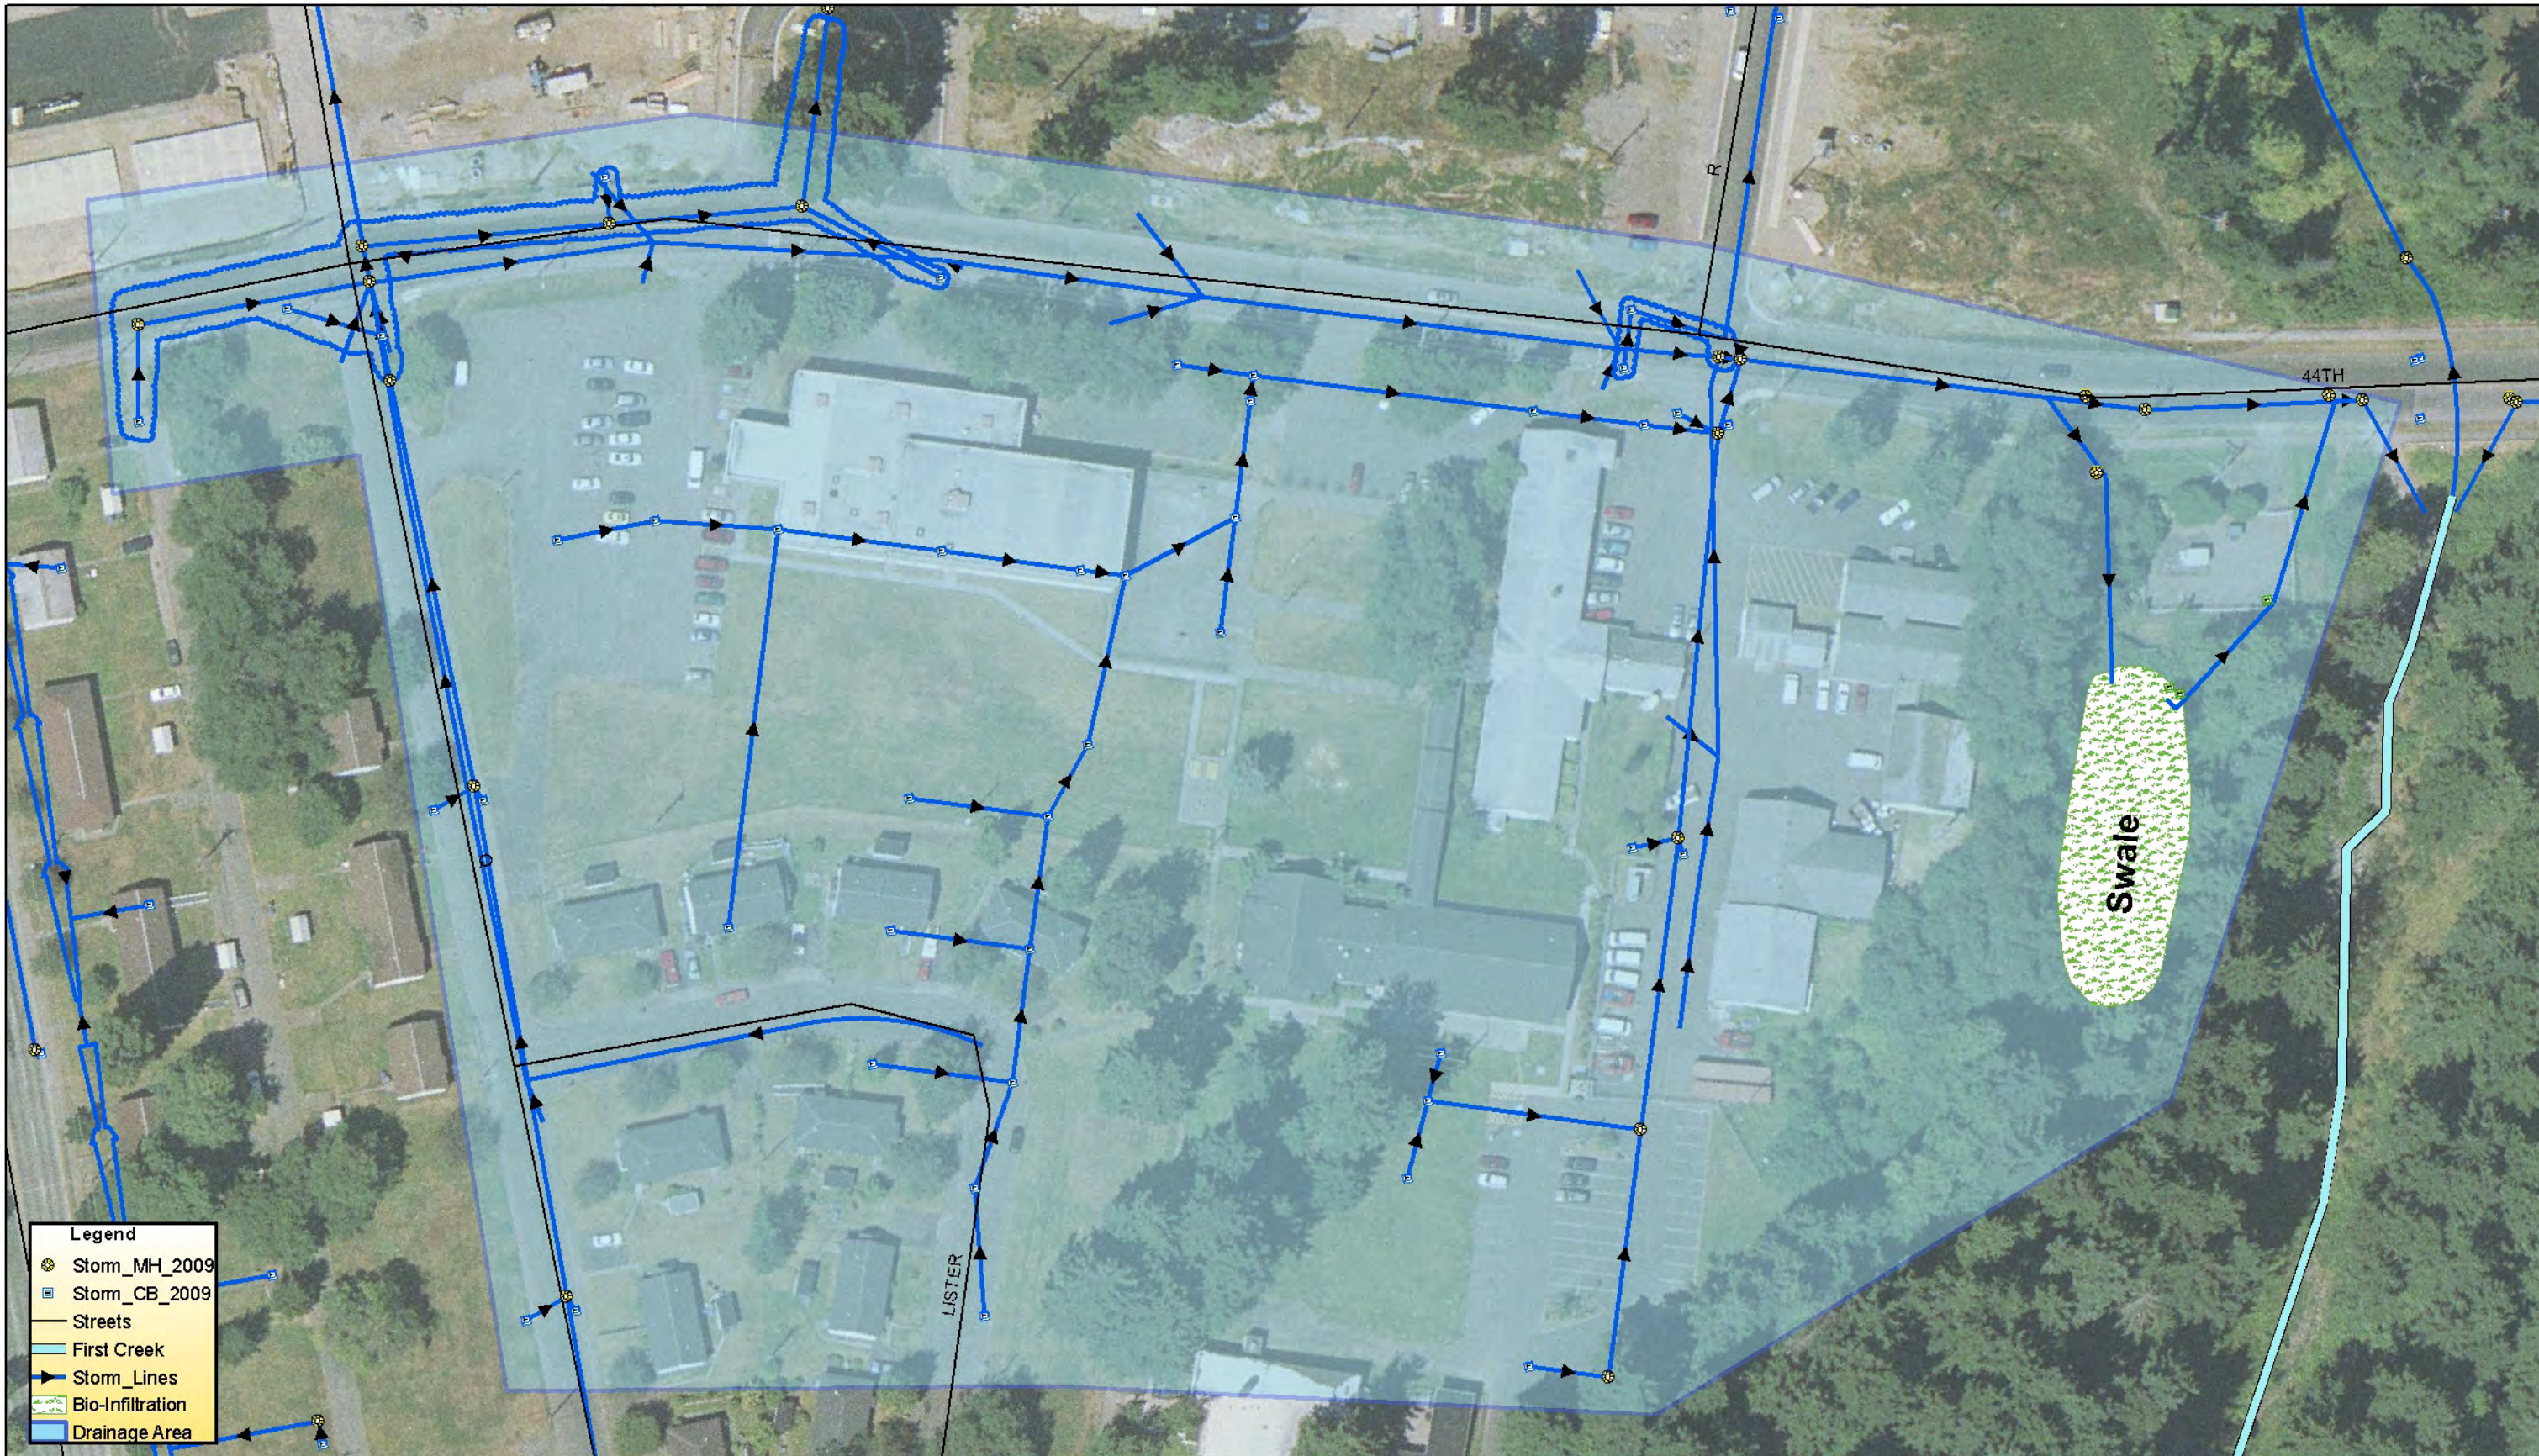
Fig. 4.2

East 44th and T-Street Bio-Infiltration Facility Drainage Area

2005 Ortho-Photo Does not reflect current site conditions
Drainage includes street runoff from Salishan Hope IV development

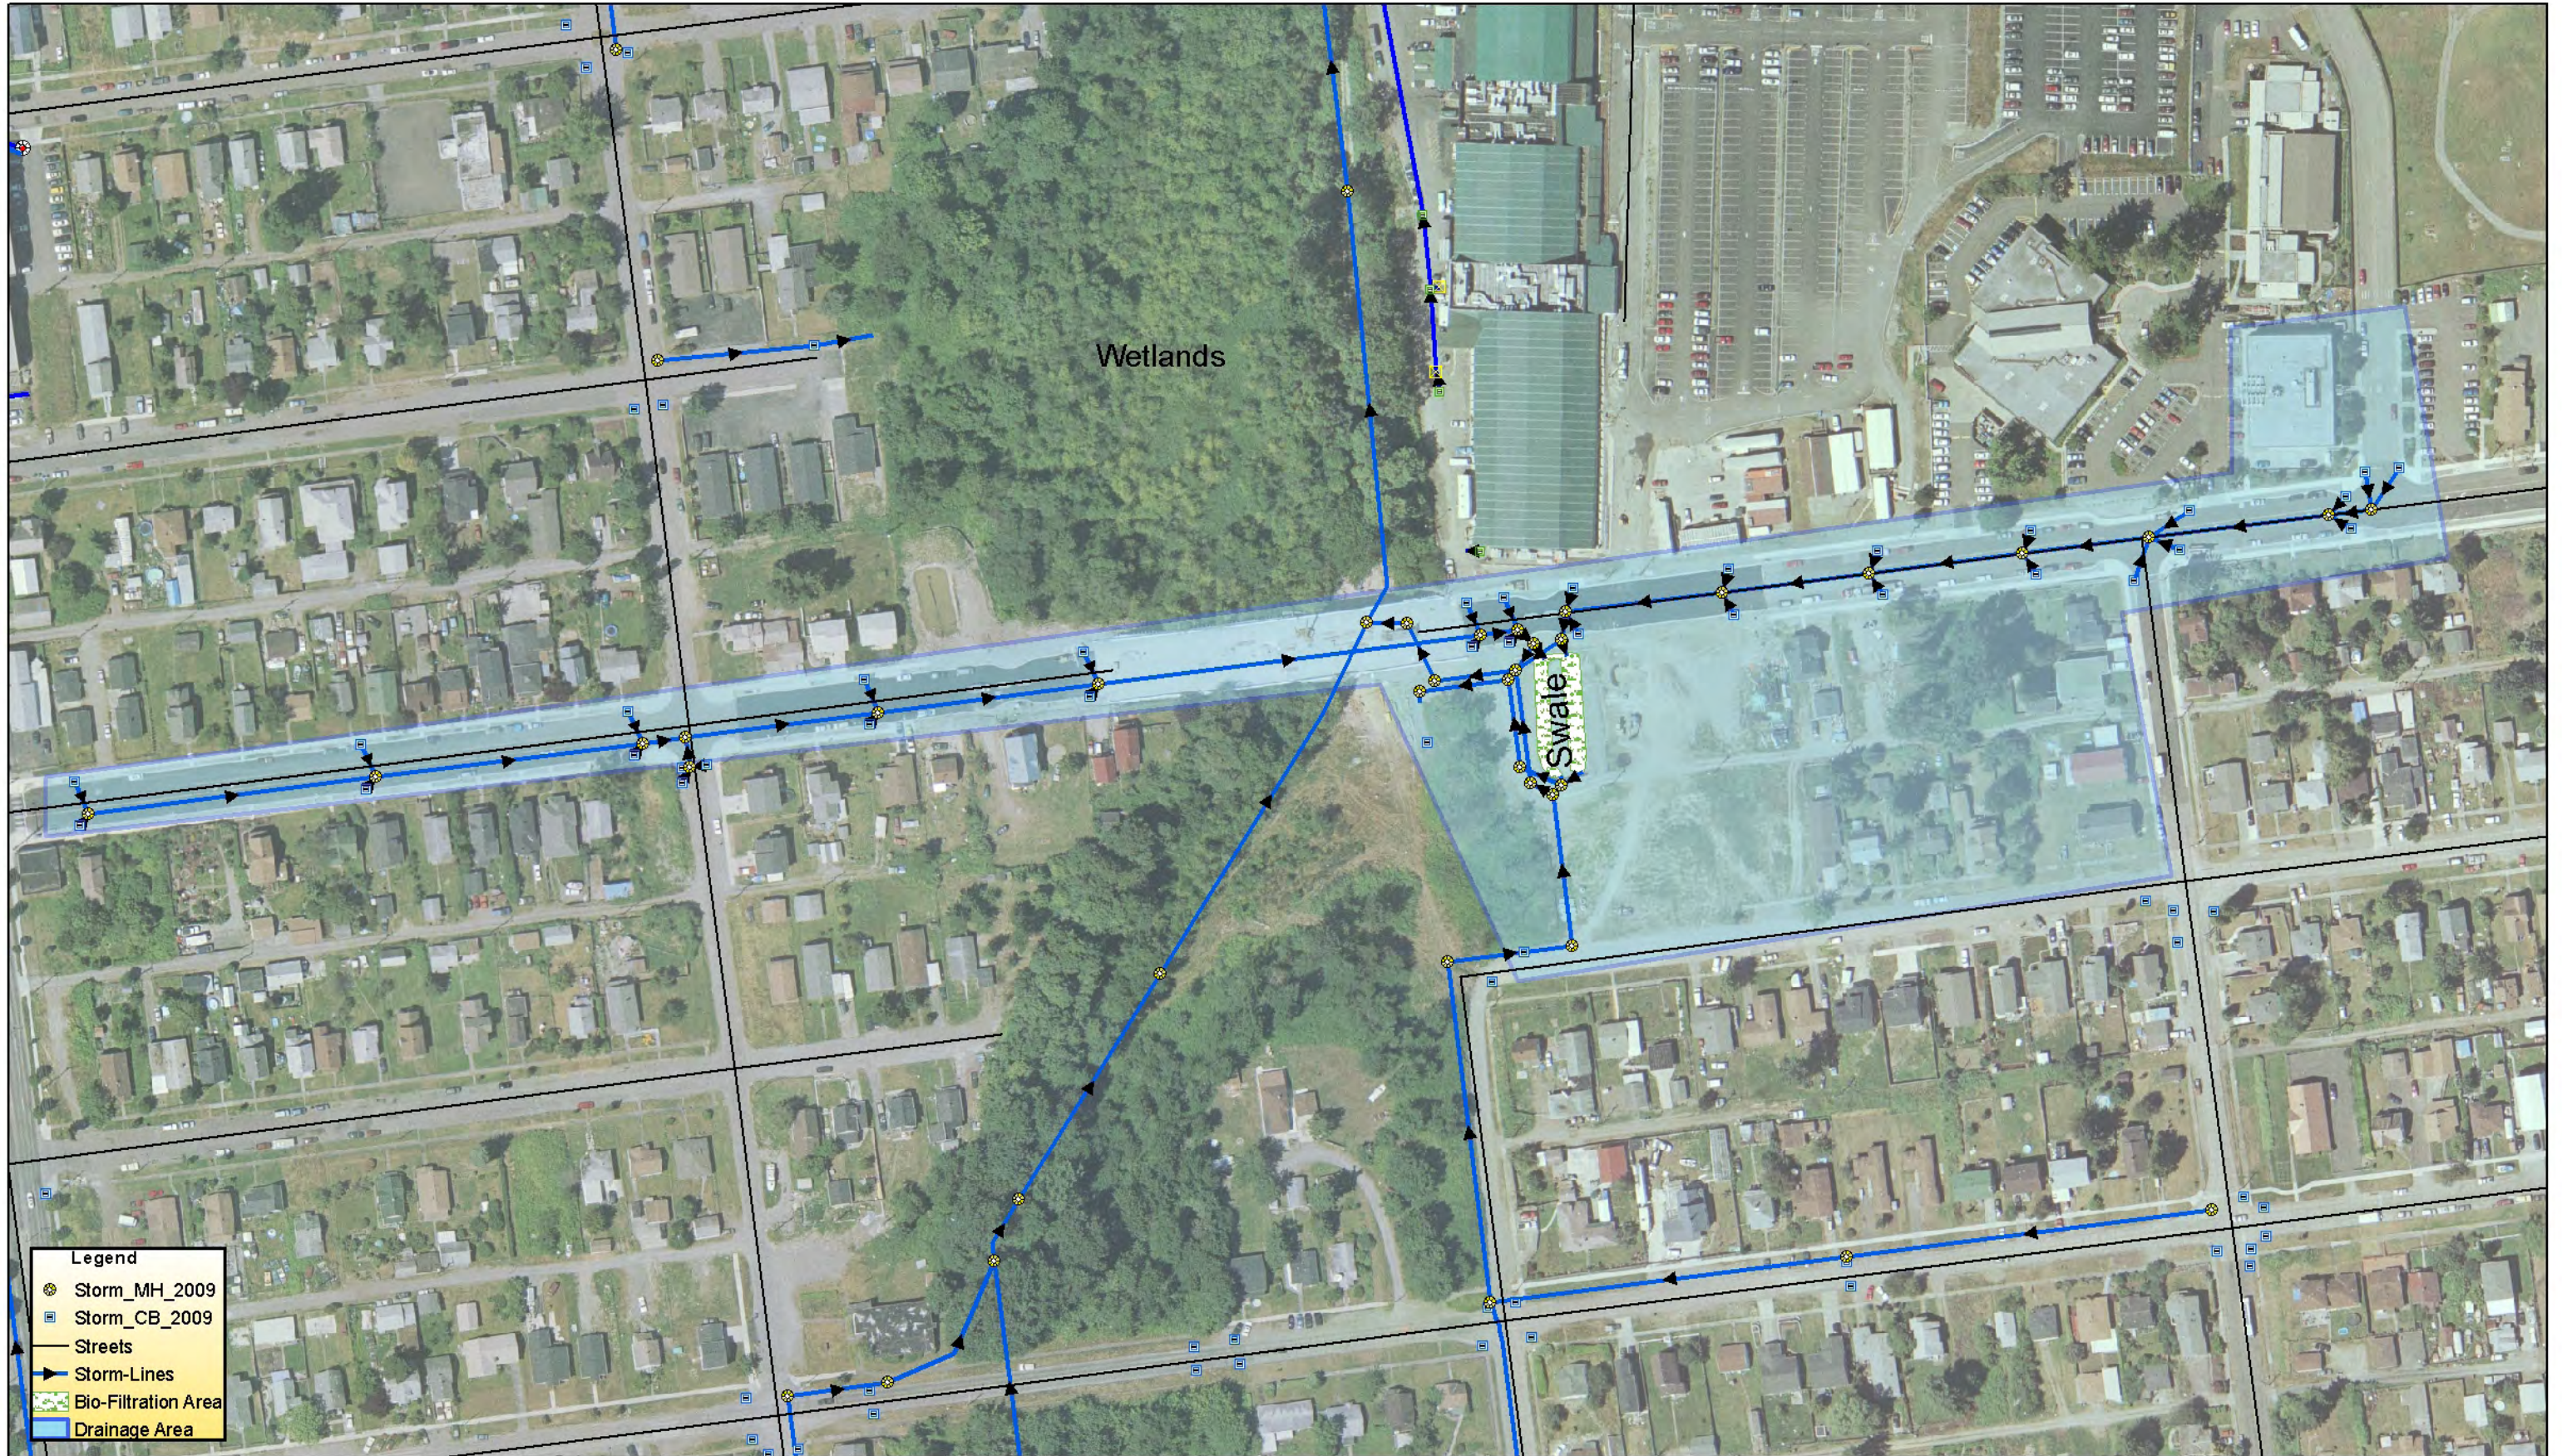
Fig. 4.3

East 32nd St. Bio-Filtration Facility Drainage Area

2005 Ortho-Photo Does not reflect current site conditions

The East 32nd Street Facility has two parallel swales that are approximately 120 feet long and run south of East 32nd Street parallel to T-Street Gulch (see Figures 4-3 and 7-3a). The second biofiltration facility, Trolley Court Swale, is approximately 186 feet long and is south of 17th at the intersection of State Street (see Figures 4-4 and 7-4a). The biofiltration facilities comprise of an inlet pipe, grass-lined channel, and an outlet structure (see Appendix A for details, Table A-3: Trolley Court and Table A-6: East 32nd Street Facility). During operation, stormwater runoff from the surrounding drainage basin enters a grass-lined channel via an inlet pipe where it disperses across the width of the channel and flows down the length of the channel to allow filtration via the grasses.

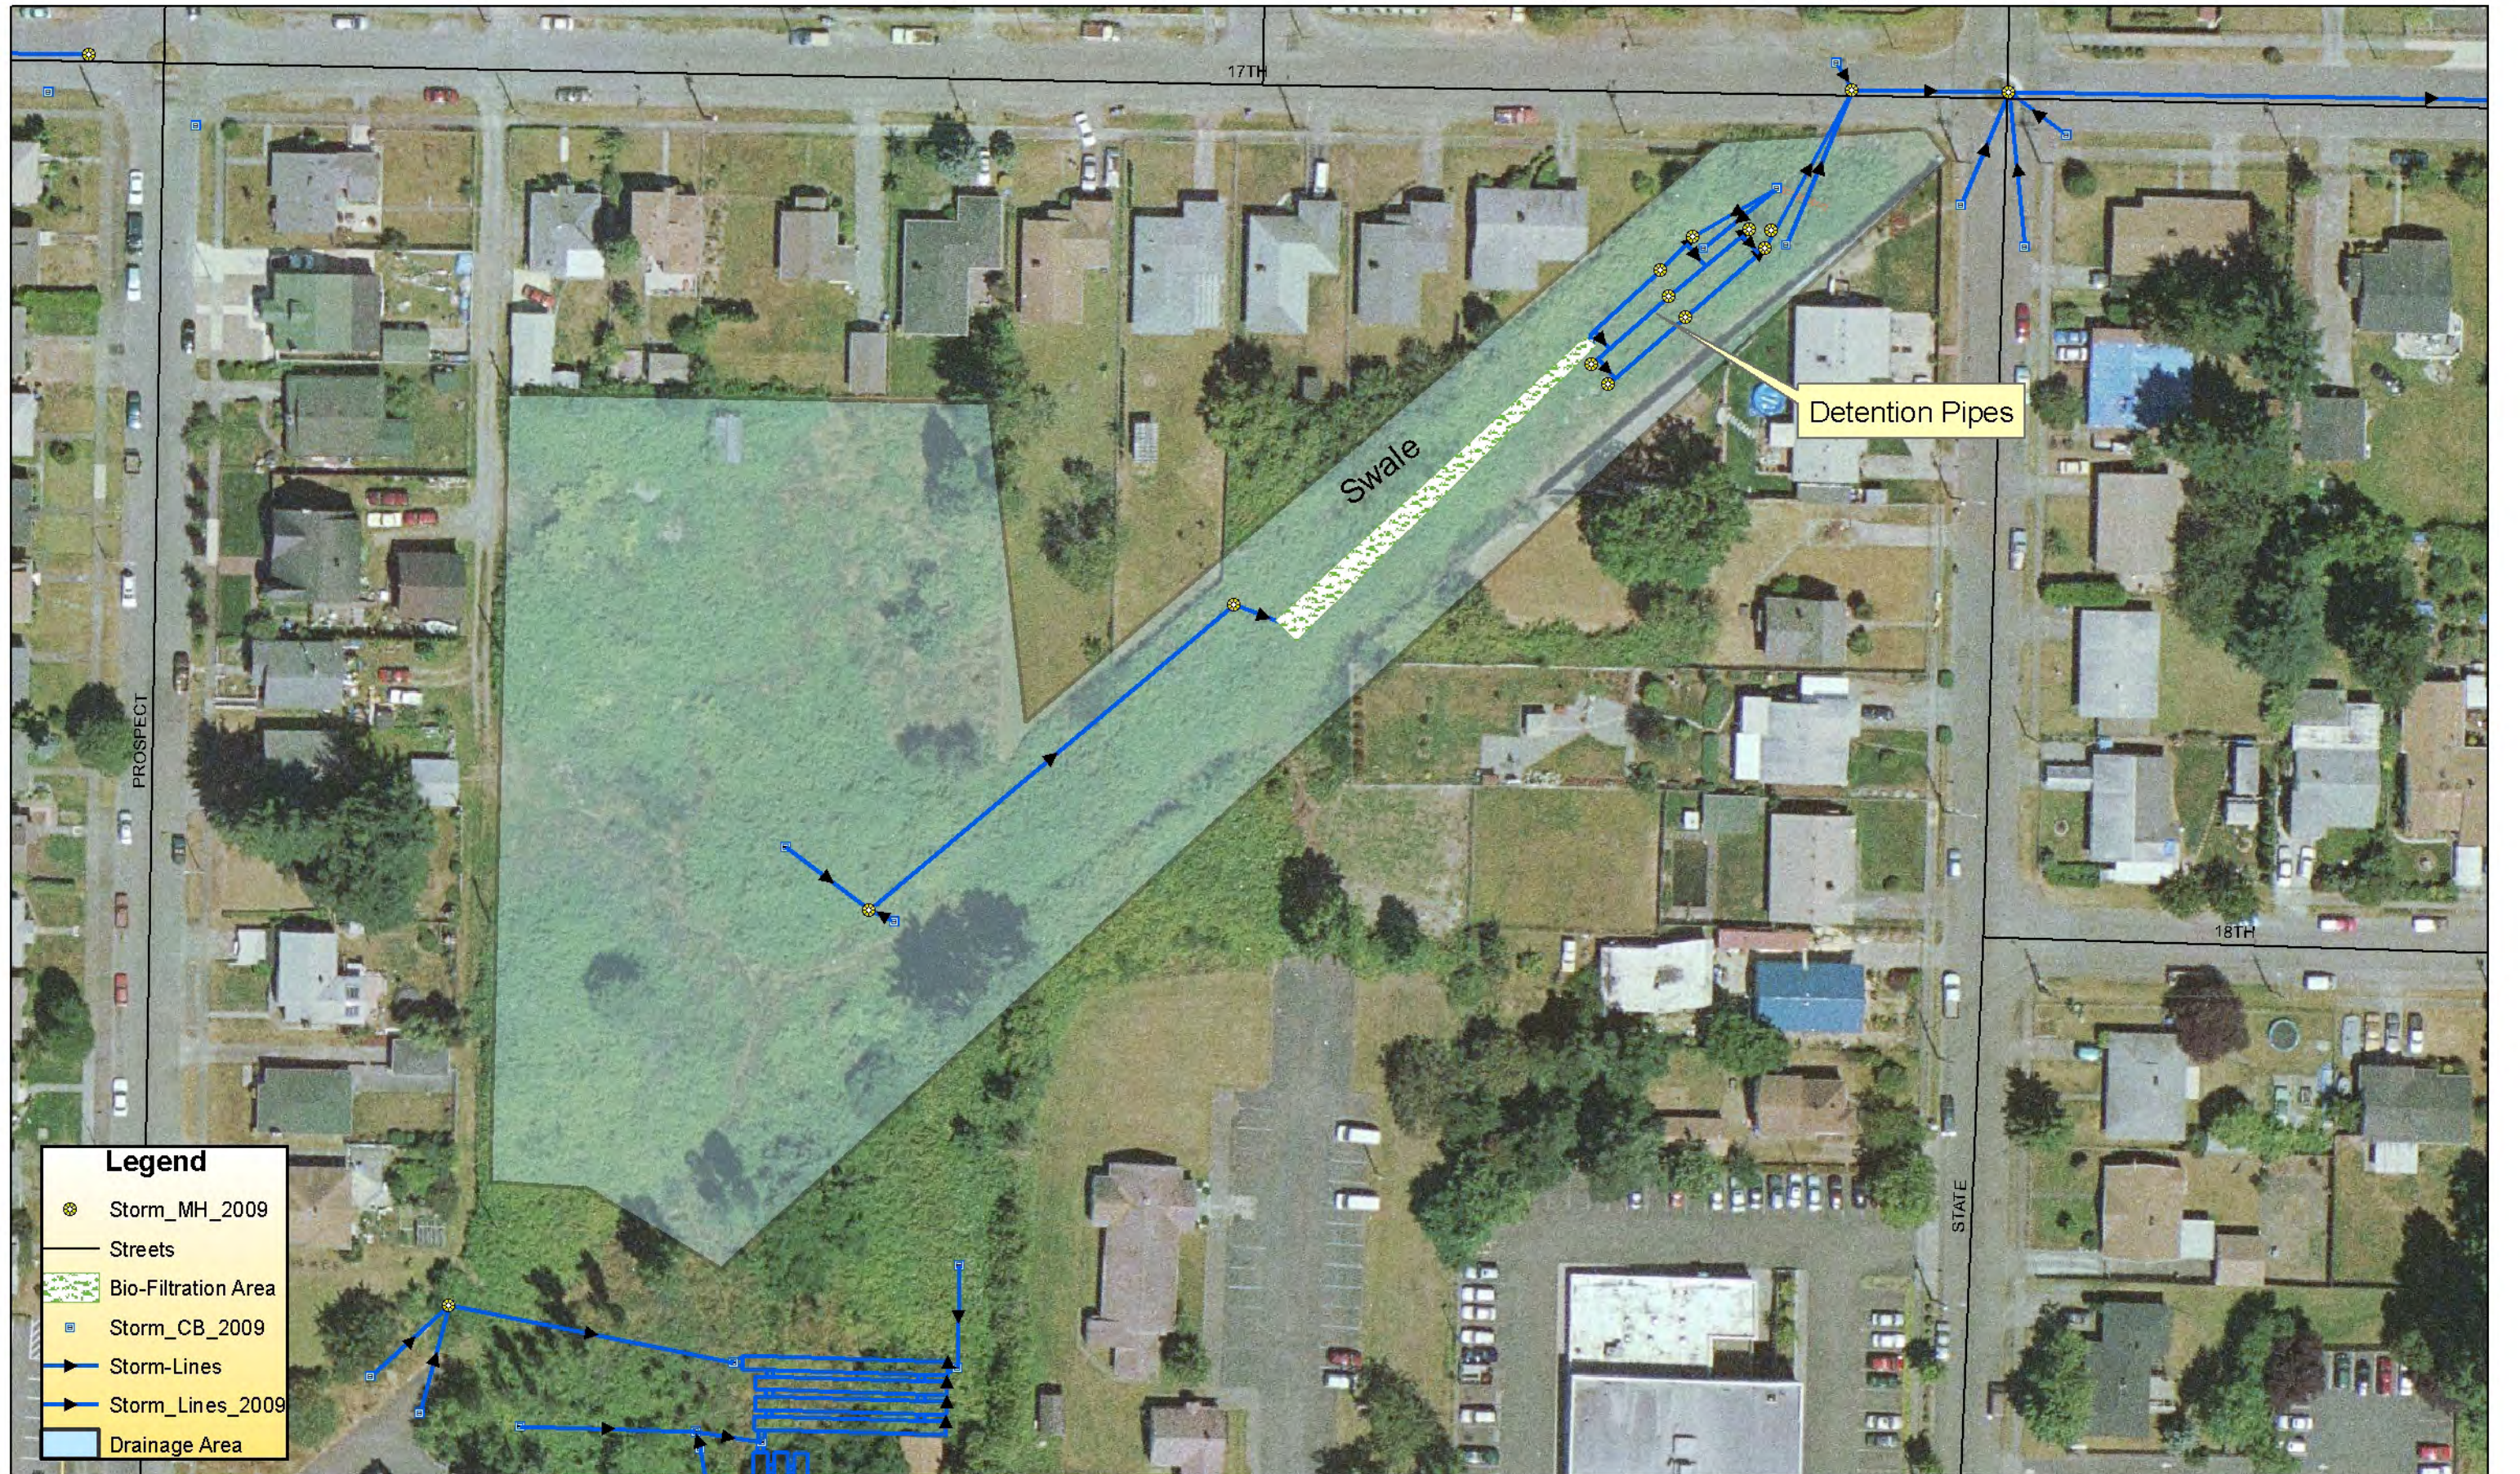
Fig. 4-4

Trolley Court Bio-Filtration Facility Drainage Area

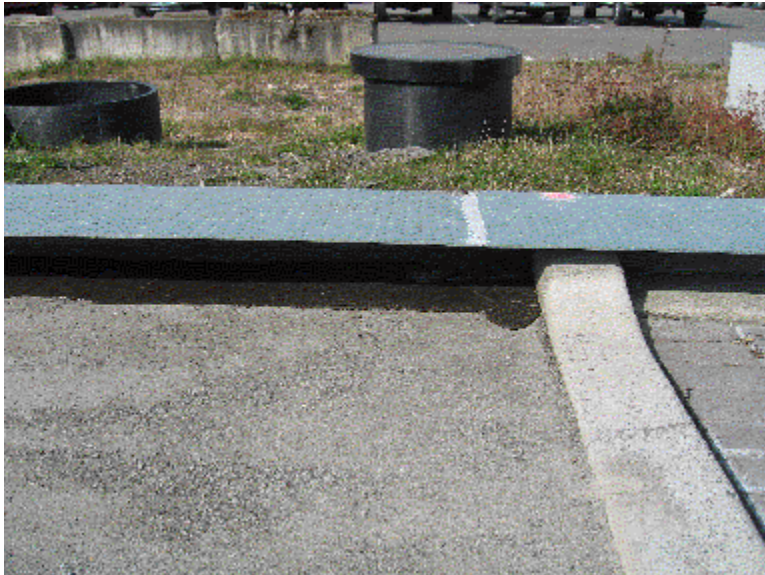
Figure 7-5b –Sampling Manholes and Curbing

Water that infiltrates through the pervious pavement sections moves through the underlying gravel base and cover soil until it reaches the top HDPE liner. Water then travels along the HDPE liner west until it reaches a perforated pipe which collects these flows. The pipe discharges into the monitoring manhole immediately west of each of the sections (Figure 7-5a and b).

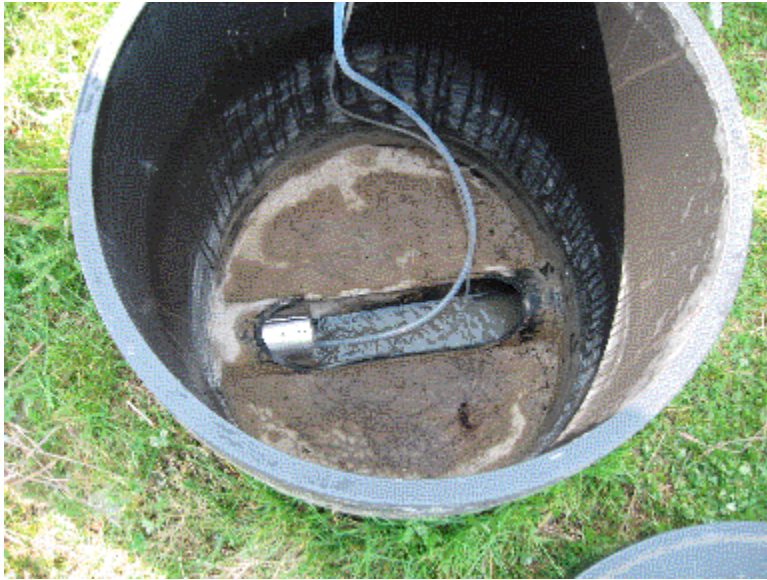
Figure 7-5c Flow Monitoring setup for Pervious Pavement and Standard Asphalt Sites

Water levels from both the pervious pavement sections (infiltrated flows designated as Perv. Pavers, Perv. Concrete, and Perv. Asphalt) and standard asphalt (surface runoff designated as Std. Asphalt) are measured using a portable ISCO 730 bubbler flow module (see Figure 7-5c). The bubbler flow module measures water depth and this data is converted to flow using Manning's equation (see Figure 7-5c).

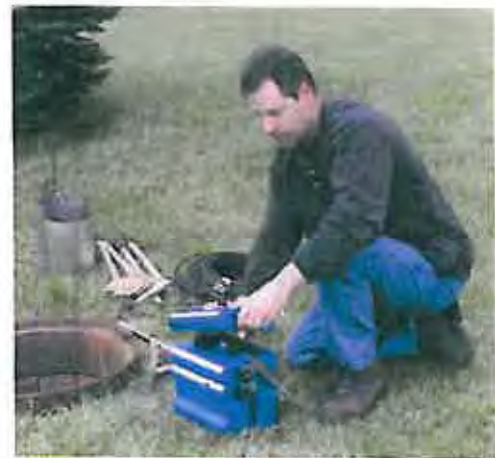
Above left: Additional modules can be added for redundant or multi-stream measuring (Isco 2110 Ultrasonic Module shown). Right: Optional mounting rings provide quick, secure sensor installation in round pipes from 6 to 80 inches (150 to 2000 mm).

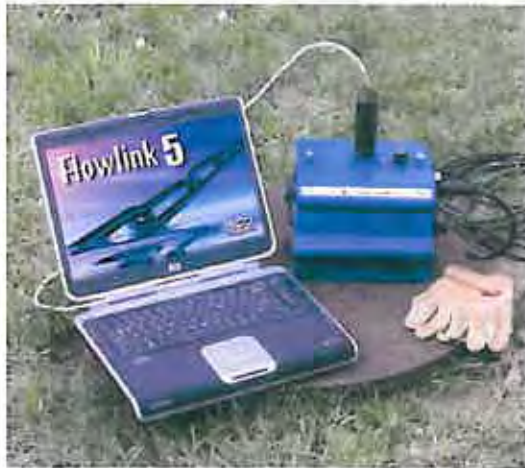
The Flowlink screen shown above gives a comparison of dry and wet weather flows, plus rainfall typical of an inflow & infiltration study

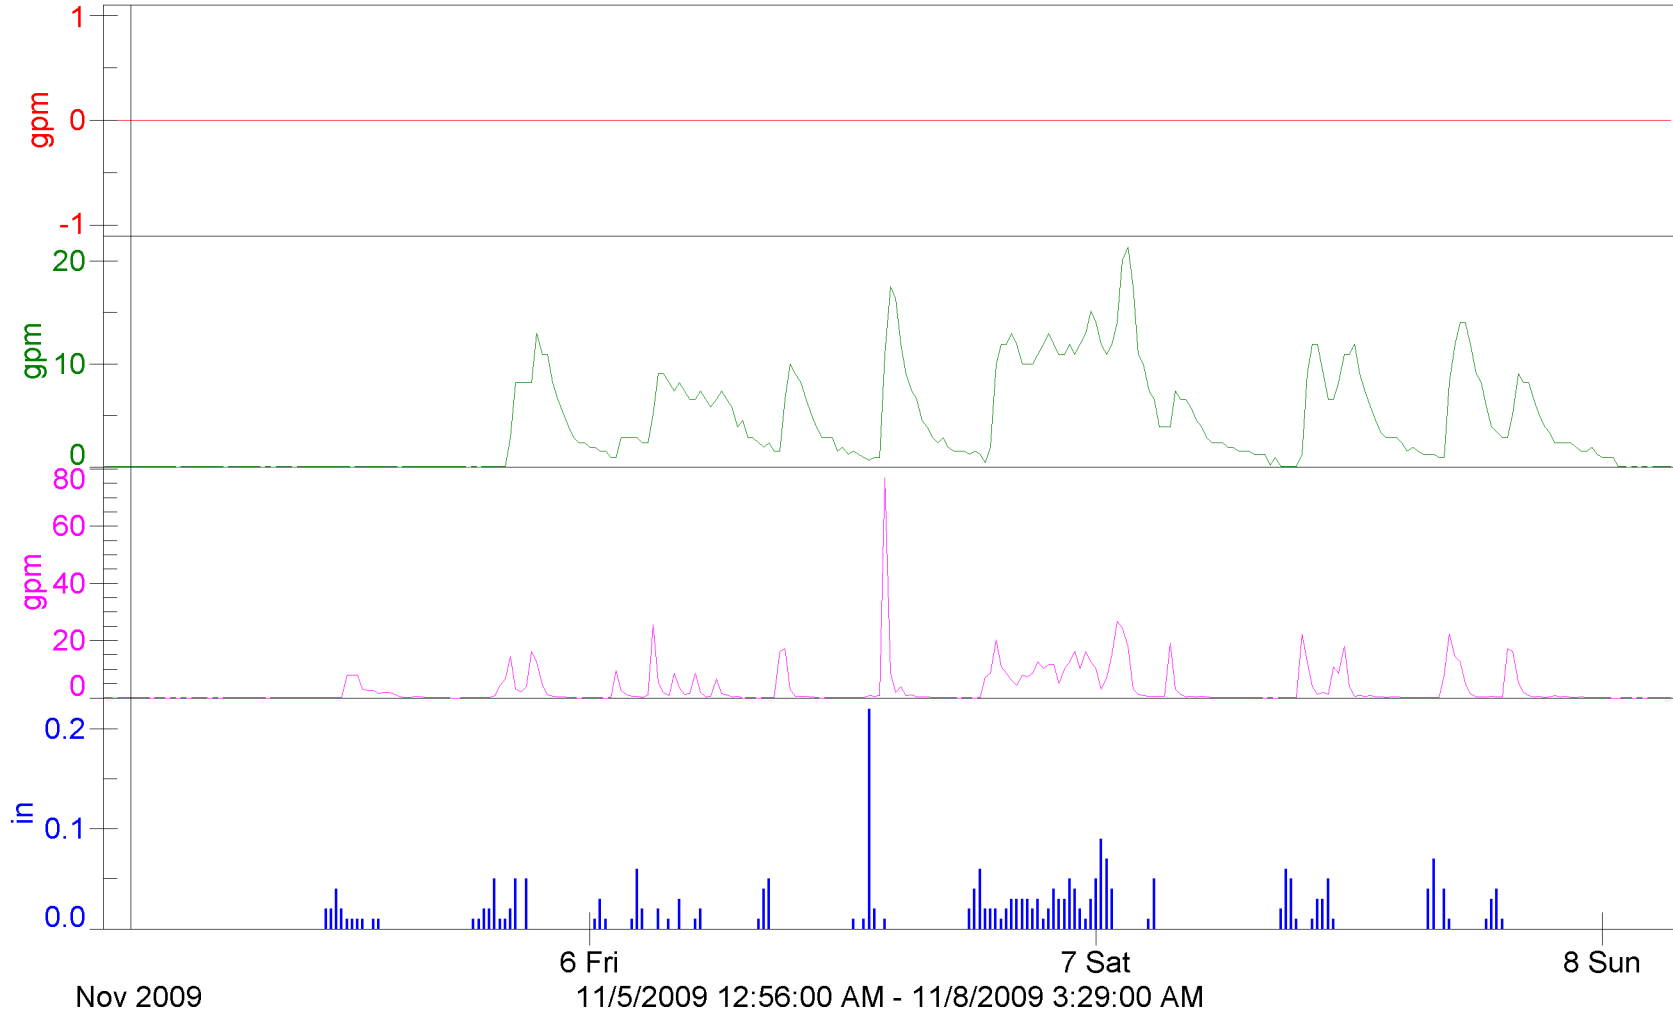
Perv Pavers Flow (0.000 gal):0.00
Std Asphalt Flow (13427.4 gal):0.01

Perv Asphalt Flow (18050.1 gal):0.01
Rainfall - Landfill (2.500 in):0.00
