Section S8.F.7 – Best Management Practice Evaluation Pervious Pavement Flow Reduction

March 2012

Purpose. Section S8.F.7 of the 2007 National Pollution Discharge and Elimination System (NPDES) permit requires monitoring of a flow reduction hydraulic Best Management Practice (BMP). This condition requires the City to continuously monitor rainfall and runoff from one flow reduction strategy and to annually report these results. This report summarizes the methods and results of flow monitoring data from the Tacoma Landfill Employee Parking Lot Expansion and Pervious Pavement Demonstration Project (Project).

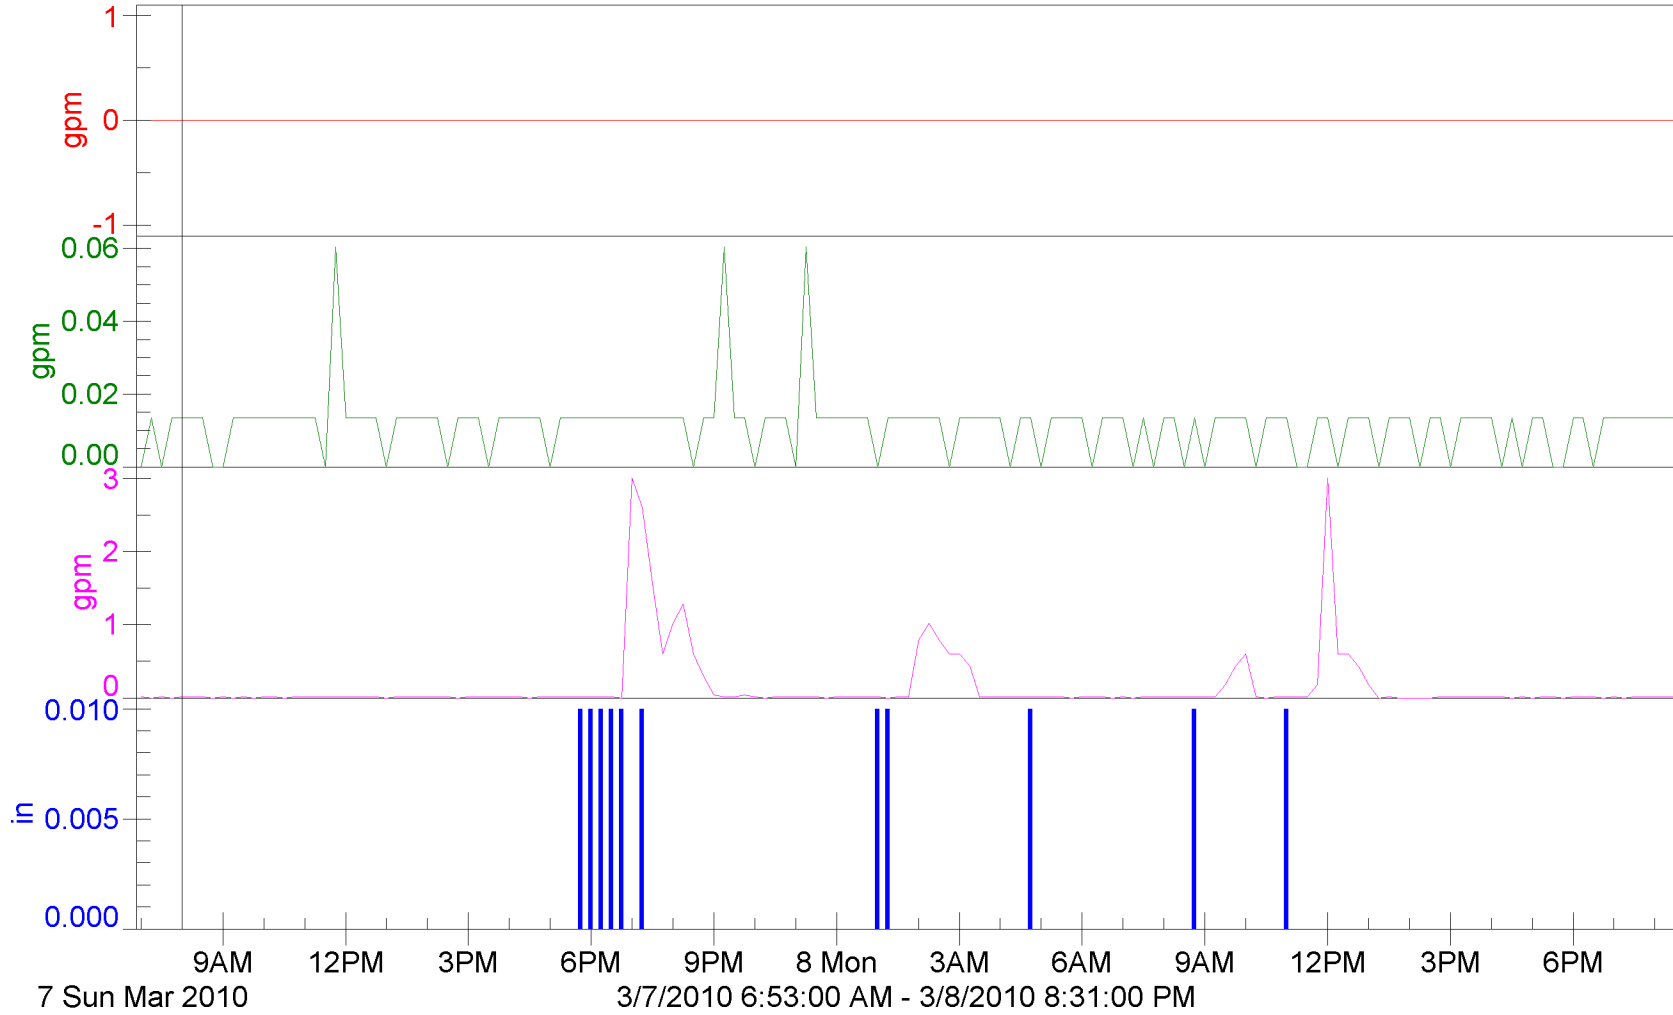
Storm #61

Std Asphalt Flow (336.122 gal):0.01

Rainfall - Landfill (0.110 in):0.00

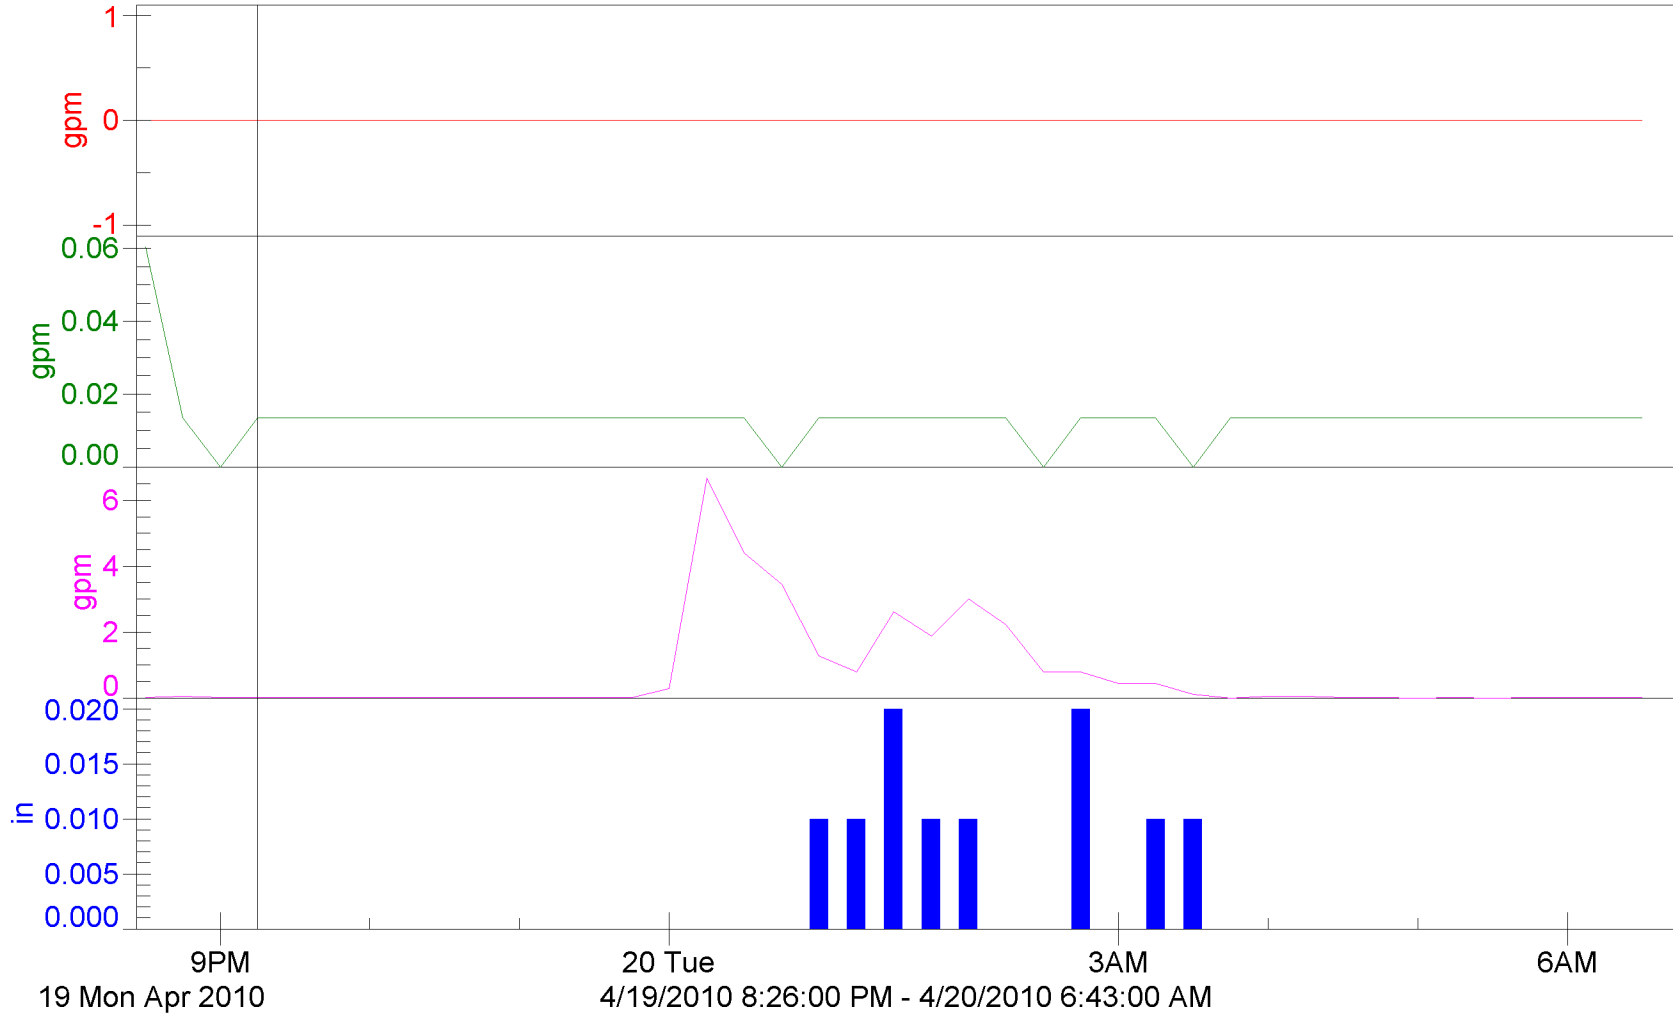
Storm #80

Std Asphalt Flow (442.351 gal):0.01

Rainfall - Landfill (0.100 in):0.00

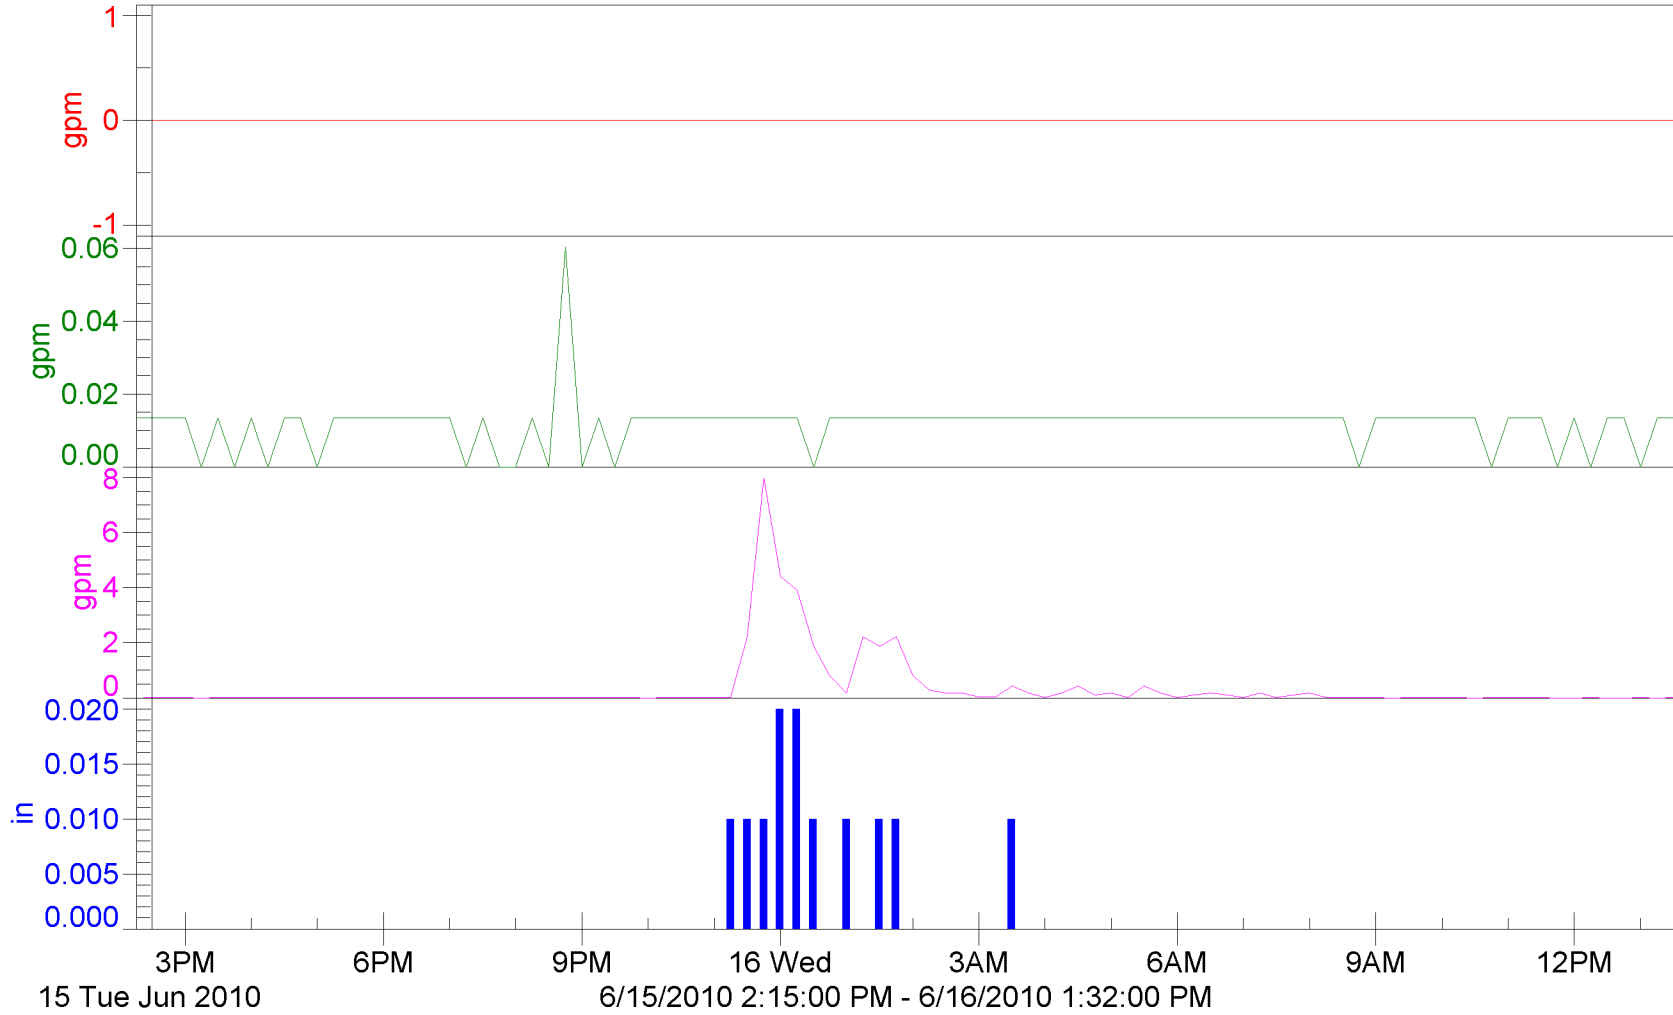
Std Asphalt Flow (490.772 gal):0.01

Rainfall - Landfill (0.120 in):0.00
