Landmarks Preservation Commission Planning and Development Services Department

A. Stadium High School <i>Exterior masonry repairs</i>	Brian Rich	3	15 m
-----------------------------------------------------------	------------	---	------

STADIUM HIGH SCHOOL EXTERIOR MASONRY RESTORATION PHASE 1 PROJECT

**STADIUM HIGH SCHOOL
MASONRY RESTORATION DEMONSTRATION**

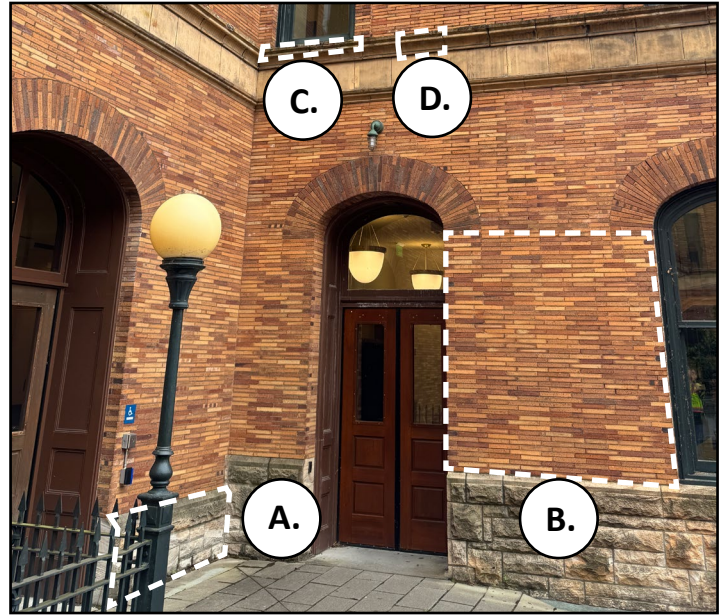
A. Stone Repointing Area (15 sq ft), B. Brick Repointing Area (50 sq ft), C. Terra Cotta Patch Area, D. Terra Cotta Removal - Full Unit

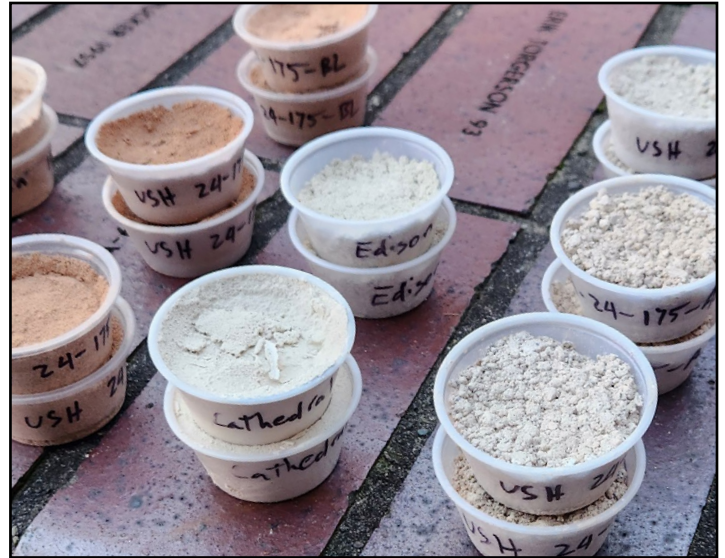
Due to the abbreviated nature of this demonstration, the mortar did not have sufficient curing time to evaluate the coloring, and this will need to be conducted at a later date.

Mortar samples on-site prior to being cleaned and rinsed concurrent with the masonry. Two samples were prepared for each mortar type; only one sample was cleaned.

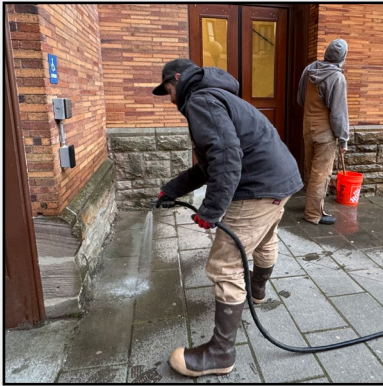
8:15 AM Low-pressure, water rinse using spray nozzle.

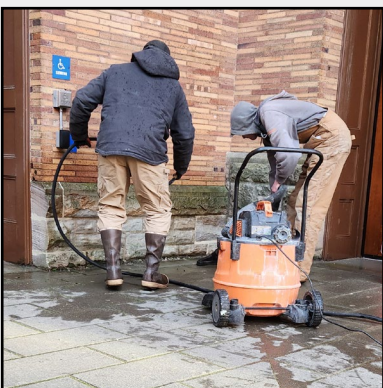
8:57 AM Low-pressure, water rinse using spray nozzle.

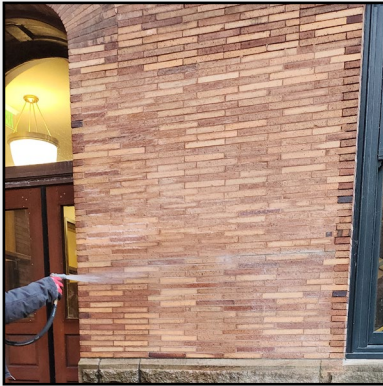
8:15 AM Low-pressure, water rinse using spray nozzle.

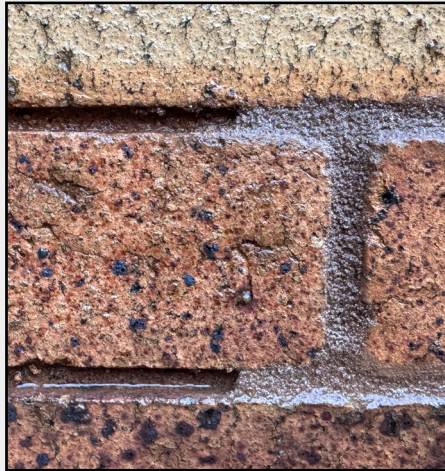
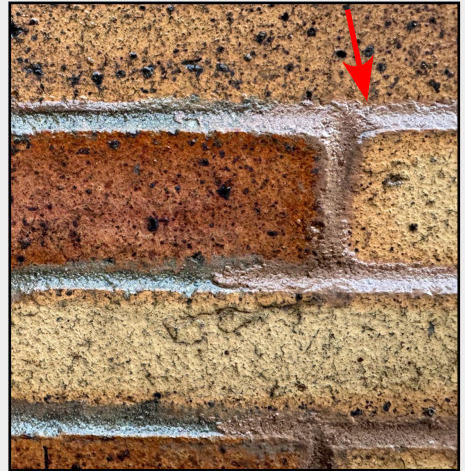
8:20 AM Vana Trol application using natural bristle brush. Approximately 20 minute dwell time.

The historic mortar is visible in the recessed joint on the left, in comparison to the restoration mortar on the right. The excess mortar on the brick face has not been fully removed.

The excess mortar on the brick face has not been fully removed. Further development of a masonry cleaning protocol is recommended.

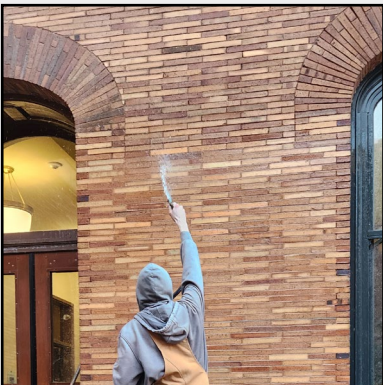
8:40 AM Low-pressure, water rinse using spray nozzle.

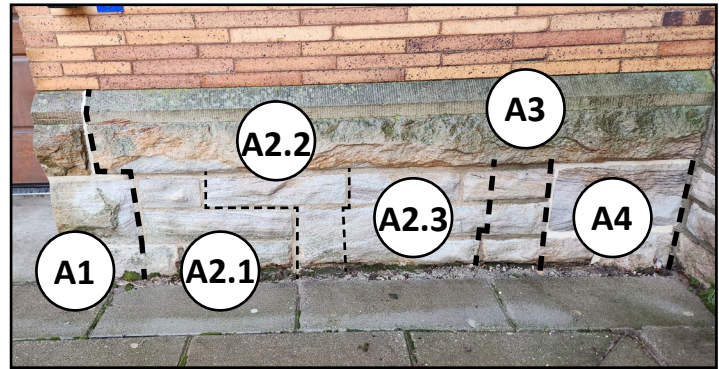
AREA A - MORTAR INSTALLATION MAP

A2.1 - USHG (BASE)
Sample appears dry and not easily workable. All USHG stone mortars share this characteristic as well as visible salt crystallization.

In general, cleaning procedures should be modified to allow for consistent aggregate exposure. The formation of salt crystals will continue to be monitored. Mortar color will be examined at a later date as the mixtures dry.

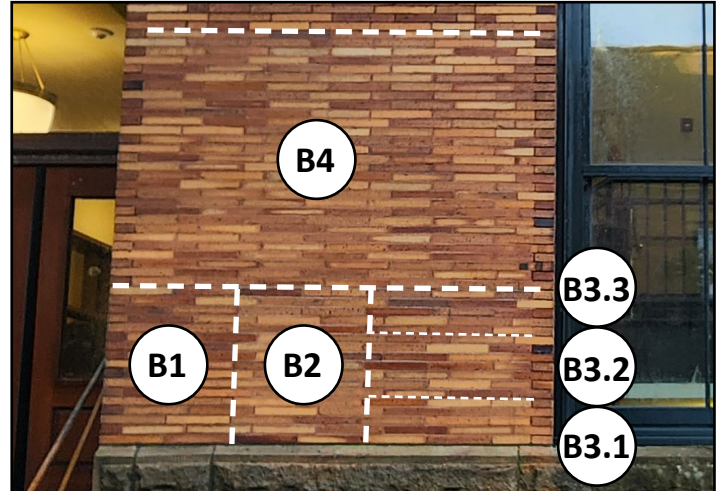
MICROSCOPIC MORTAR PHOTOS
AREA B - MORTAR INSTALLATION MAP

B1 - CATHEDRAL STONE
Aggregate very difficult to see through mortar cream. Shrinkage cracks throughout.

In general, cleaning procedures should be modified to allow for consistent aggregate exposure. The formation of salt crystals will continue to be monitored. Mortar color will be examined at a later date as the mixtures dry.
