**Request for Proposals Specification No. PW24-0192F  
Facility Condition Assessment**

2023 Facility Condition Assessment

# Facility Detail Report

Greater Tacoma Convention Center  
Greater Tacoma Convention Center

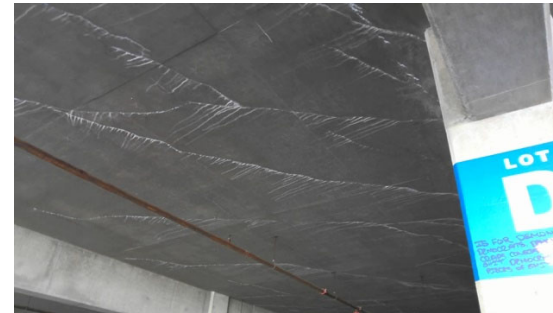
**Deficient Material:** Concrete Deck

Significant areas of parking structure effervescence and cracking is showing up on two floors of the post-tension slabs below decks exposed to weather. Evidence of efflorescence observed at what appear to be post-tension end cap plugs. There are areas of known corrosion of topping slab reinforcing mesh (see also G2020 Parking Lots). Based on observed moisture exposure, there are concerns about post-tension cable corrosion.

Have special testing company investigate and test post-tension cabling for potential corrosion. (Estimate is only a placeholder for investigation and testing only, not including any repair work if issues are found.)

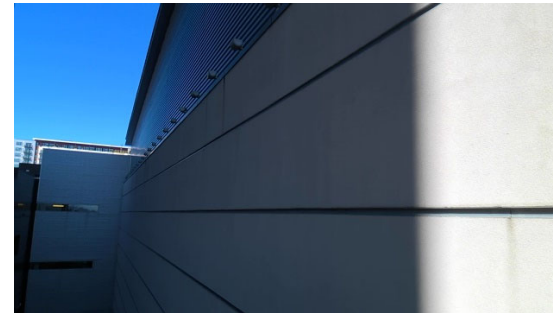
**Deficient Material:** Exterior Wall

South wall at the "Canyon," cement stucco showing water intrusion, and reportedly leaks into Ballroom D in wind-driven rain events. It was reportedly constructed as a temporary seven-year wall with no insulation and vapor barrier (intended to have the hotel built up against the convention center and was not constructed as a permanent wall).

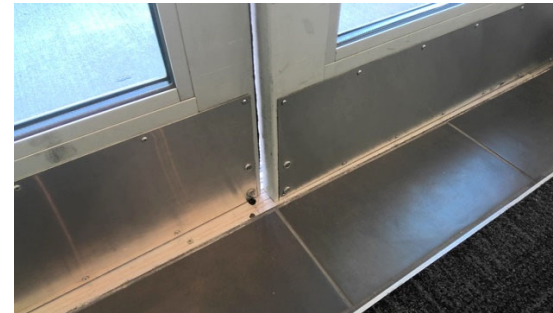
**Deficient Material:** Door Hardware

Entry hardware is at end of life issues on public entry doors (locking pins failing to engage and secure doors panic hardware issues, primarily on third floor).

Replace hardware and adjust operations.

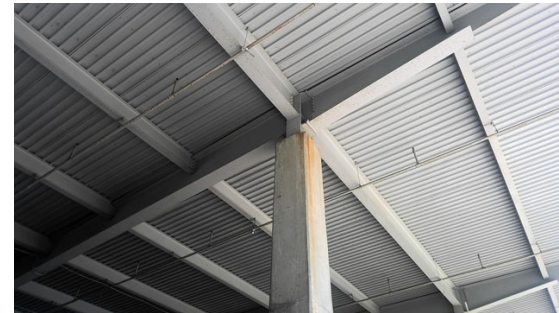
**Deficient Material:** Canopy

Corrosion of loading dock steel components beginning to bloom.

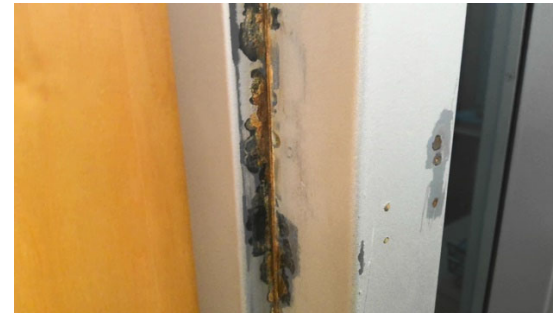
**Deficient Material:** Door Frames

14 door frames corroding from the inside at the admin offices, likely due to chemical reaction with frame fireproofing filler.

Remove and replace frames.

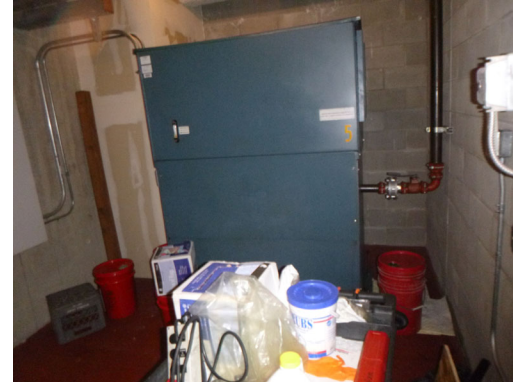
**Deficient Material:** Elevator  
Reported hydraulic leak at Freight Elevator No. 5.

**Remedial Action:**  
Repair leak.

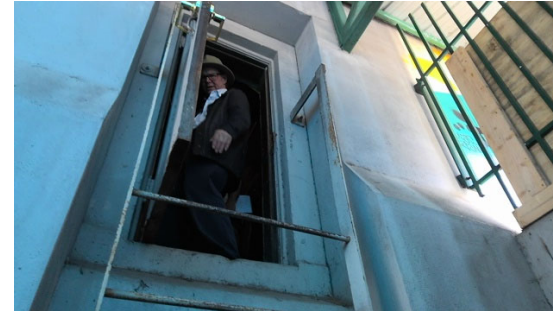
**Deficient Material:** Catwalk Access

Access to catwalk is hazardous, with a wall-mounted ladder behind a grab bar, and an outswinging door that blocks the left side ladder handrail.

Revise attic access to meet OSHA requirements, or at least replace door with inswinging door.

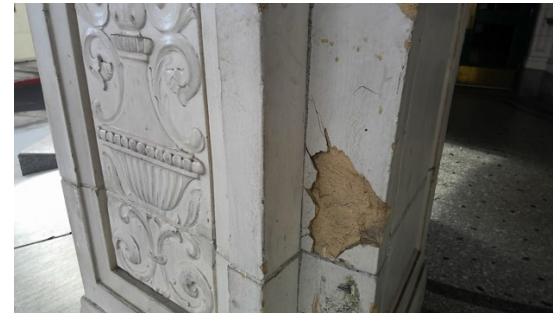
**Deficient Material:** Architectural Ornamentation

Parapet terra cotta missing (reported stored at City of Tacoma Streets and Grounds). Other ornamental plaster and terra cotta finishes and details degrading with hairline cracking of glazed surfaces, and other pieces broken. Rotunda parapet top ornamentation pieces in various states of degradation. Other detail plaster and terra cotta around the facade beginning to degrade.

Have architectural historic preservation specialist investigate and have repairs made to systems to repair and resecure per historic preservation standards by a qualified contractor.

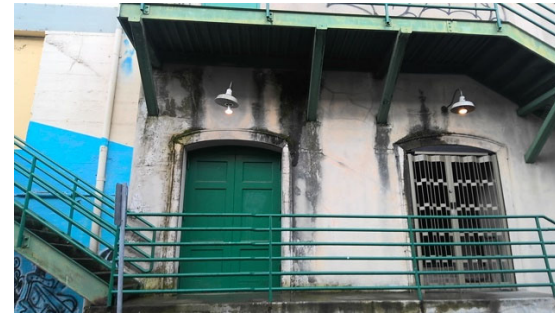
**Deficient Material:** Cement Plaster

Stucco showing decay, cracking, and areas of moisture intrusion.

Clean, repair, seal, and refinish plaster finishes.

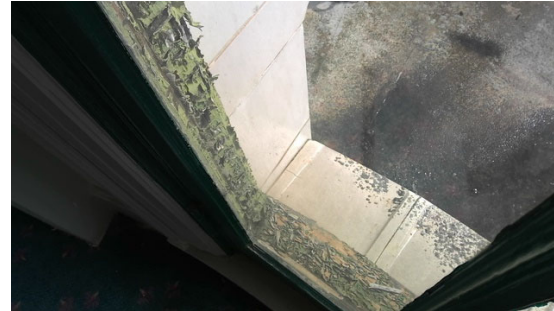
**Deficient Material:** Exterior Windows

Single-pane wood windows leak water and air. They are thermally inefficient, paint is peeling (very significantly on many), and lead-based paint is likely present based on age.

Replace with historically appropriate thermally insulated windows to match the historic character.

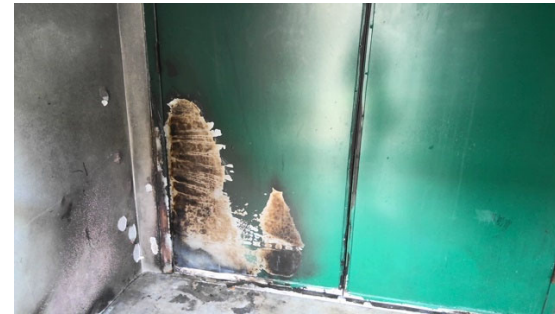
**Deficient Material:** Hollow Metal Doors & Frames  
Exterior pair of egress doors and frame damaged by fires and break-in attempt.

**Remedial Action:**  
Replace door and frame. Install security grille at vestibule to match others.

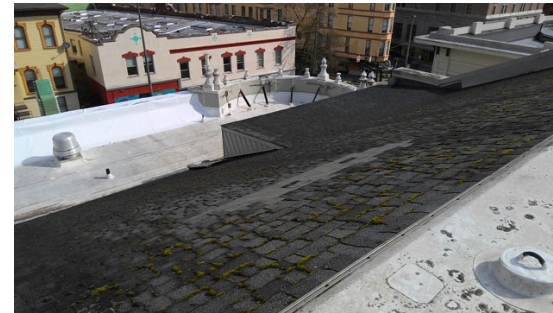
**Deficient Material:** Roof Coverings

Remove all layers of existing roofing. It should be assumed that roof insulation at past leak areas is damaged and needs to be removed (especially along the entire east and south parapet lines). Inspect and evaluate the top layer condition of the roof decking. It is advisable to have a contingency plan in place with unit costs to selectively cut away portions of rotten or compromised decking, treat, and infill layers with structural material per the direction of a structural engineer. For this estimate, we have assumed a premium has been included in the price to cover a contingency. Upgrade rigid insulation to meet or exceed current code above deck. Install new roofing and flashings integrated into parapet conditions, transitions, and flexible movable flashings (like a seismic joint) at the intersection at the garage wall. Include additional fall restraint system tie-offs secured to structure.

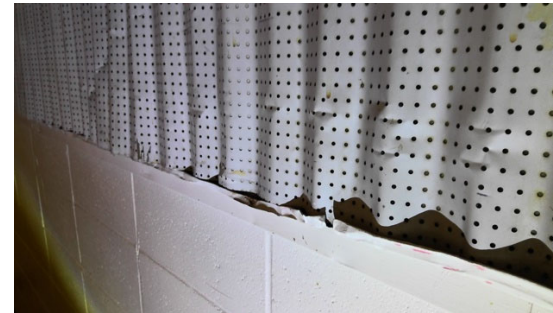
**Deficient Material:** Acoustic Paneling

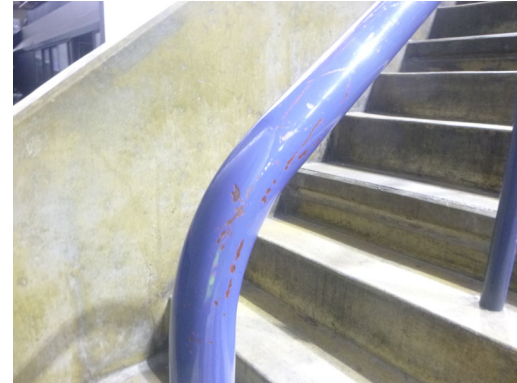
**Deficient Material:** Balusters & Handrails

All railings and hand rails in public seating and circulation areas with worn and chipping paint,

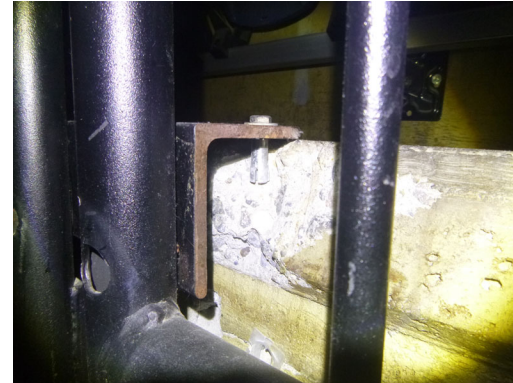
**Deficient Material:** Guard Rails

2018 replacement guardrails were improperly installed, with bolts shot into the edge of concrete, causing concrete edge to break away. Entire system is loose and seems unsafe, and further concrete damage is likely to occur as remaining anchors fail.

Remove system, repair concrete, install edge angle iron properly secured into concrete with drilled epoxy anchors into face of concrete and reanchor guardrail system to new angle iron.

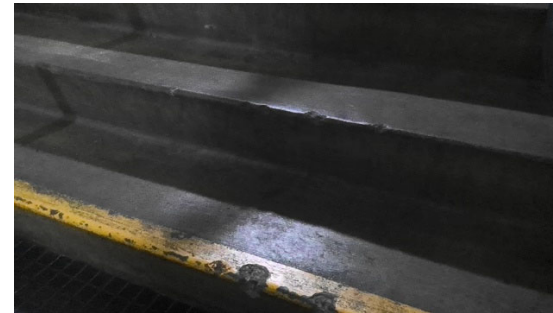
**Deficient Material:** Stair Finish

Concrete stairs from stands to concourse level with painted or applied safety nosing faded and chipped. Surfaces stained with 40 years of event traffic.

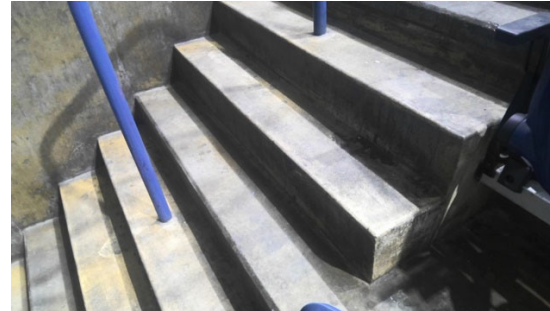
**Deficient Material:** Stair Finishes

Concrete stairs in stands were once painted and now faded. Surfaces stained with 40 years of event traffic.

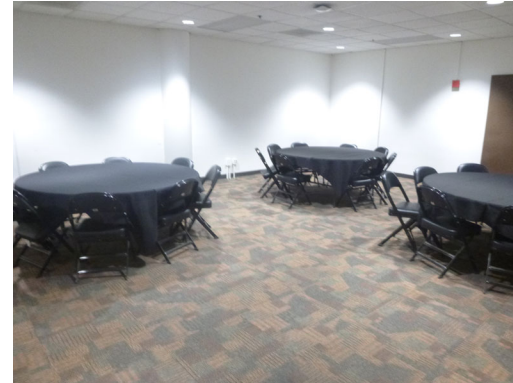
**Deficient Material:** **Carpeting**

Remove and replace carpet.

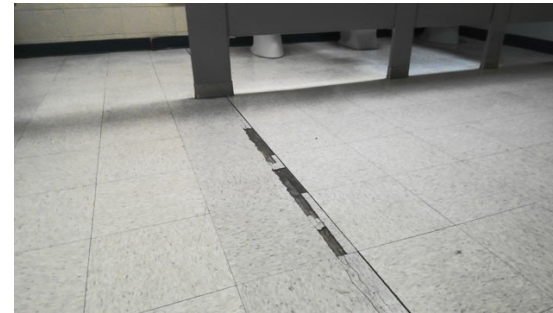
**Deficient Material:** VCT

VCT in concourse level toilet rooms at end of life with failing seams and chips.

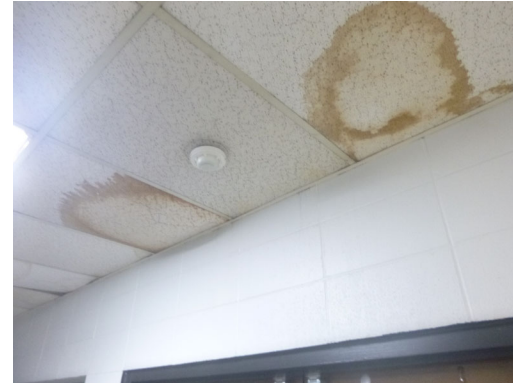
**Deficient Material:** Acoustic Ceiling Tile

Suspended acoustic tile at end of life with significant areas of water-stained tiles and sagging tiles. Based on age, existing ceiling suspension grid is also assumed to not meet modern seismic requirements.

Remove and replace ceiling grid and tile systems.

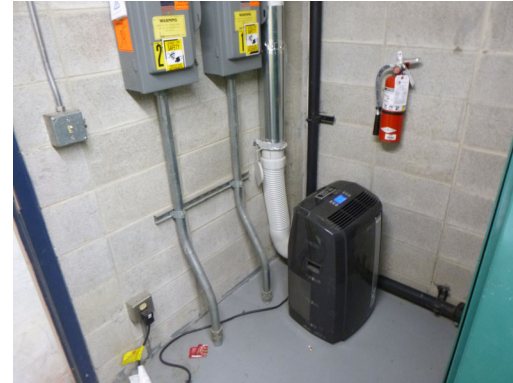
**Deficient Material:** EMR cooling

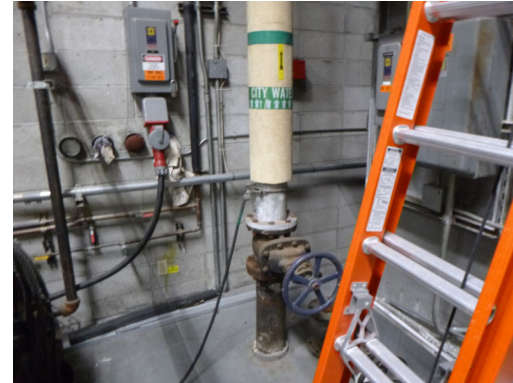
**Deficient Material:** Galvanized pipe

Failing original galvanized piping, damaging new plumbing fixture trim, and leaking throughout the building. Some corroding copper piping as well.

Replace with copper and/or PEX.

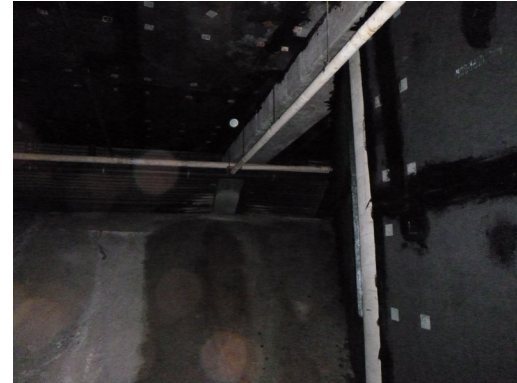
**Deficient Material:** Waste piping

Waste piping in unheated spaces subject to freeze and subsequent failure.

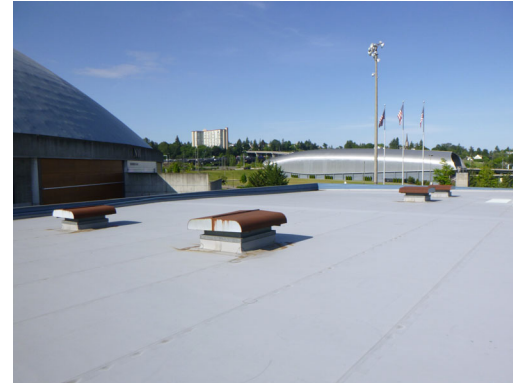
**Deficient Material:** Overflow roof drains

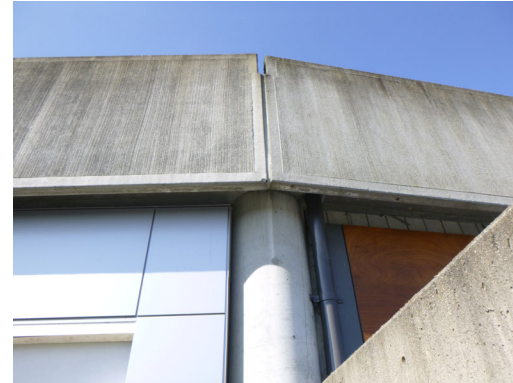
**Deficient Material:** Roof drain system

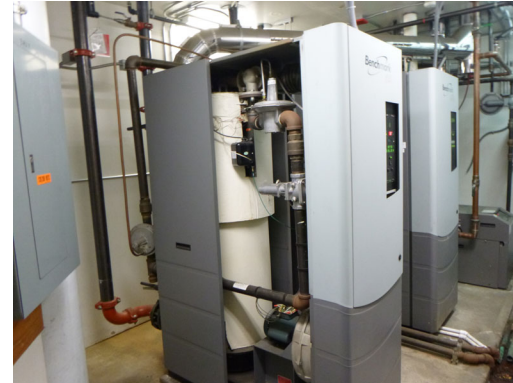
**Deficient Material:** Boilers  
Aging Aerco heating hot water boilers.

**Remedial Action:**  
Budget to replace upon failure.

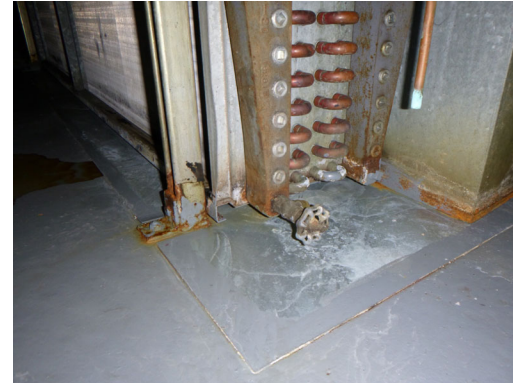
**Deficient Material:** Cooling coil

The central station cooling coils are missing drain pans and condensate piping in two quadrants and are damaged or dysfunctional in the other two. Slab slopes cause the condensate to drain away from, instead of toward the floor drains. Overflowing condensate passes through structural floor slab cracks and gaps and floods into spaces below.

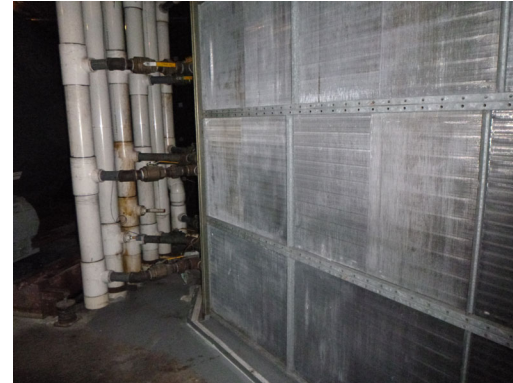
**Deficient Material:** Condenser water piping

Aged and failing PVC condenser water piping; piping also restricts heating hot water temperature to 90 deg F, limiting dome heating capability.

Replace with more robust pipping, such as Aquatherm.

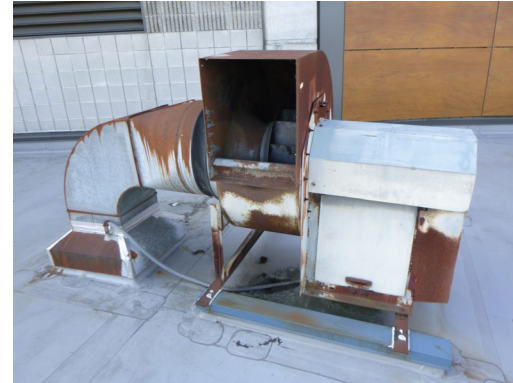
**Deficient Material:** HVAC Equipment

HVAC rooftop equipment and duct between dome and exhibition hall is rusted, corroded, damaged, or failed.

Repair or replace equipment and ductwork between dome and exhibition hall.

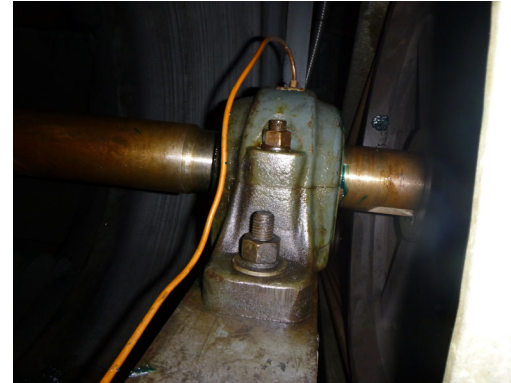
**Deficient Material:** Supply fans

Dome arena supply fan bearings are aging, requiring increasing grease, which in turns leaks.

Rebuild or replace supply fan bearings. Fully clean fan housings and fan wheels, align shafts, test and adjust to reduce vibration.

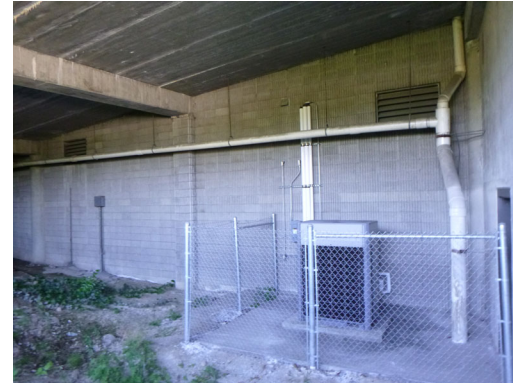
**Deficient Material:** VIP VRF System

Repair VRF system controls. Add capacity as needed to provide VIP guest comfort.

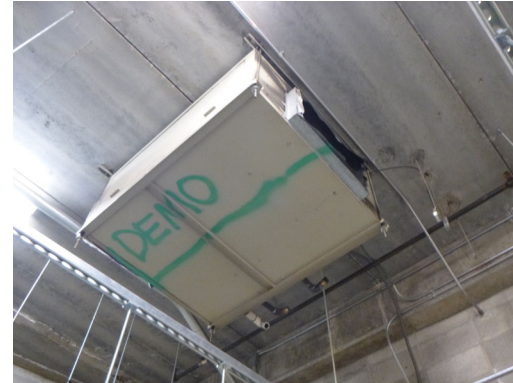
**Deficient Material:** Heat pumps  
Failing water-to-air heat pumps.

**Remedial Action:**  
Replace.

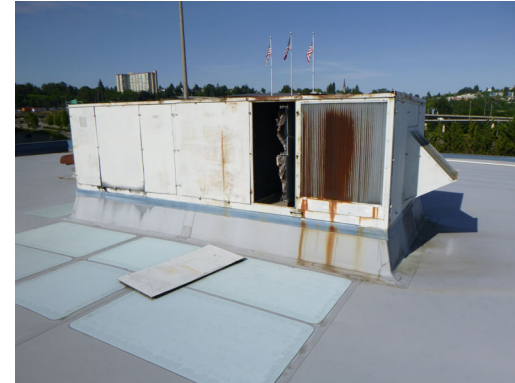
**Deficient Material:** Rooftop units

Three rooftop heat pump air handling units serving the exhibition hall are failed.

Replace with standalone all-electric air-source heat pumps.

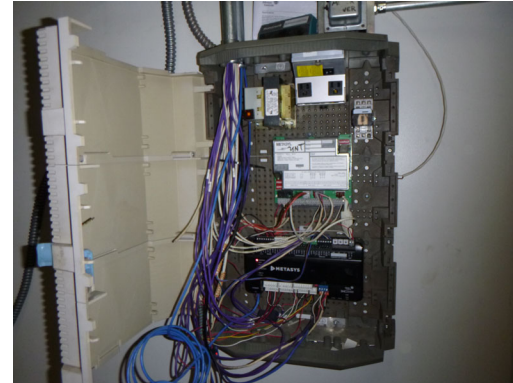
**Deficient Material:** Controls  
Aged and failing pneumatic controls.

**Remedial Action:**  
Upgrade pneumatic to motor-operated controls and upgrade DDC controls to new, where aged, and optimize programming.

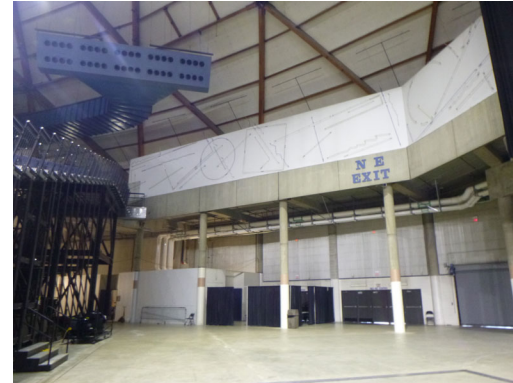
**Deficient Material:** Bolts

Threaded rod anchor bolts and/or lock nuts are loosening from acoustic vibrations during concerts, weakening fire sprinkler and potential other mechanical and electrical support systems.

Inspect and tighten all suspended mechanical and electrical system supports, bolts, lock nuts, and other fasteners subject to concert vibration and loosening.

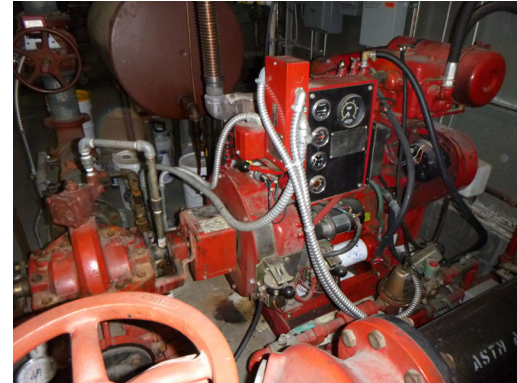
**Deficient Material:** Fire pump engine

Replace fire pump prior to complete failure.

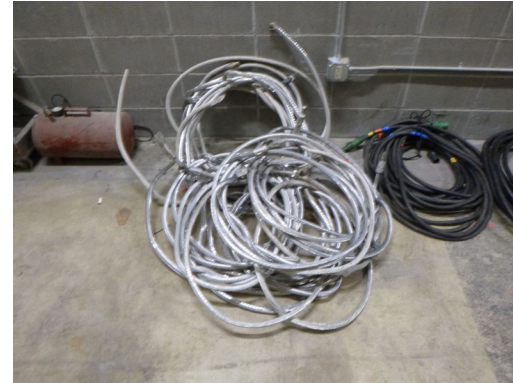
**Deficient Material:** Aluminum feeders  
Failing original aluminum feeders.

**Remedial Action:**  
Test all aluminum feeders and replace as needed.

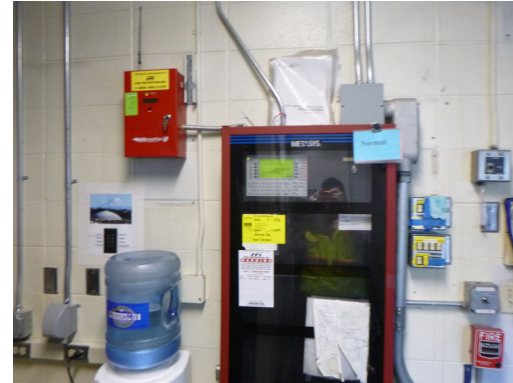
**Deficient Material:** Fire alarm

Replace with modern digital (addressable) system.

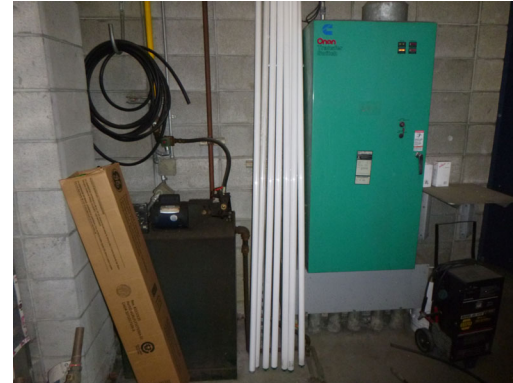
**Deficient Material:** Automatic Transfer Switch  
Aging automatic transfer switch.

**Remedial Action:**  
Budget to replace upon failure.

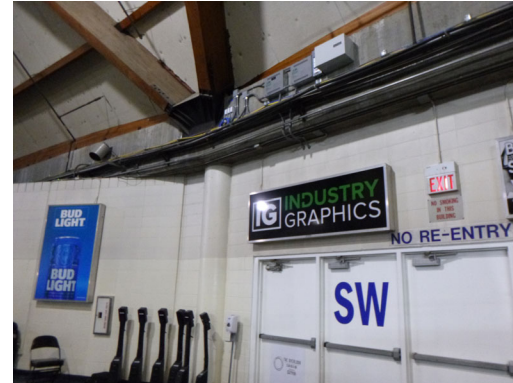
**Deficient Material:** Exit signs  
Aged exit signs.

**Remedial Action:**  
Replace with modern exit signs.

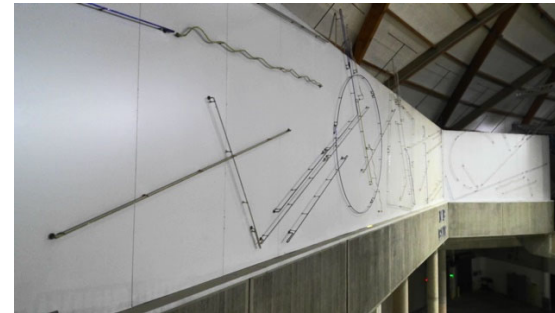
**Deficient Material:** State Funded Art

Investigate repairs needed with a neon restoration specialty company.

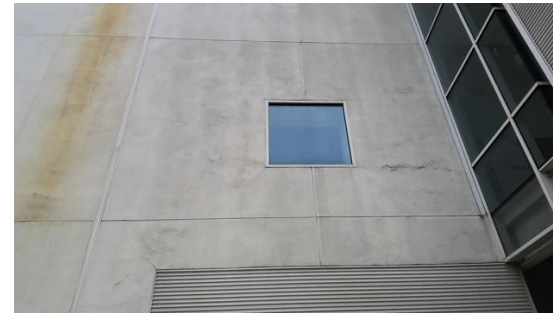
**Deficient Material:** Exterior Siding

Significant cracking and leak intrusion on cement plaster stucco walls, especially bad interior water intrusion on the west facade on the studio wall.

Remove sections of plaster to determine extent of system failure and moisture intrusion. Clean surfaces, repair damage, seal all cracks, and refinish exterior with appropriate elastomeric finish coating system.

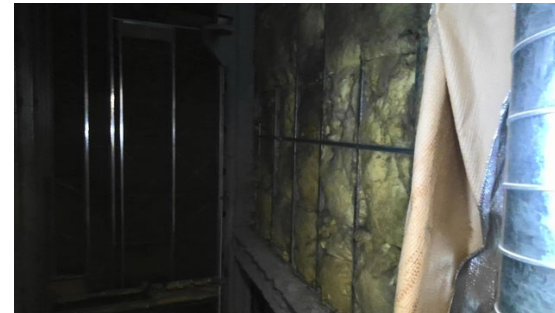
**Deficient Material:** Insulation

Vapor barrier peeling away from face of insulation at exterior wall. Dark staining of batts could indicate mold.

Investigate if dark staining is dust or mold. If mold, remove and identify source and make repairs. Otherwise, install new vapor/air barrier to back side of batt insulation.

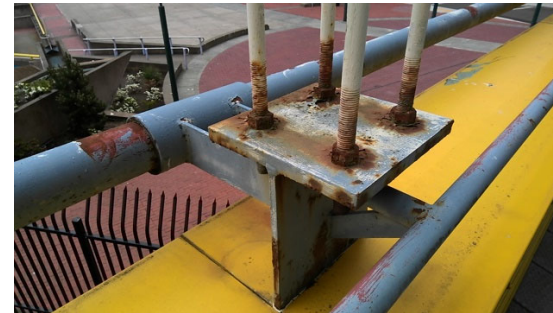
**Deficient Material:** Metals

Exterior exposed steel structural elements corroding where paint finish has degraded.

Strip off existing finish, remove and treat oxidation and corrosion, prime and repaint with industrial-grade exterior metal paint coating system.

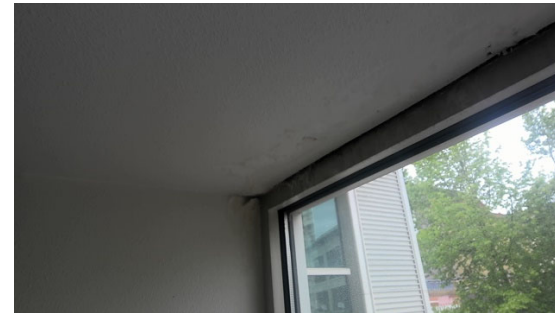
**Deficient Material:** Aluminum Windows (Flashing)

West-facing window has significant moisture intrusion during rain events.

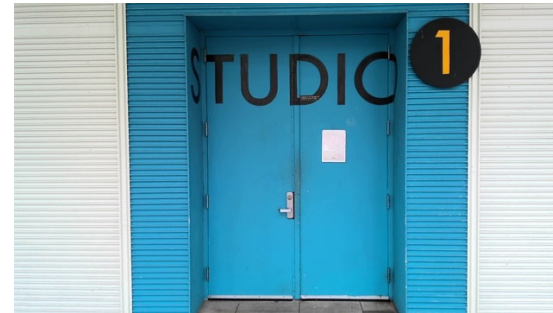
**Deficient Material:** Doors and Door Hardware

Hollow metal doors and frames, pervasive issues with closing, operations issues with hardware, and floor thresholds coming loose. Some doors with corrosion of frames.

Treat, prime, and repaint. Replace hardware including astragal and thresholds.
